Kent and East Sussex Railway.

Grooving of boiler plates.

Experience with NDT defect assessment.

Presented by Chris Greatley

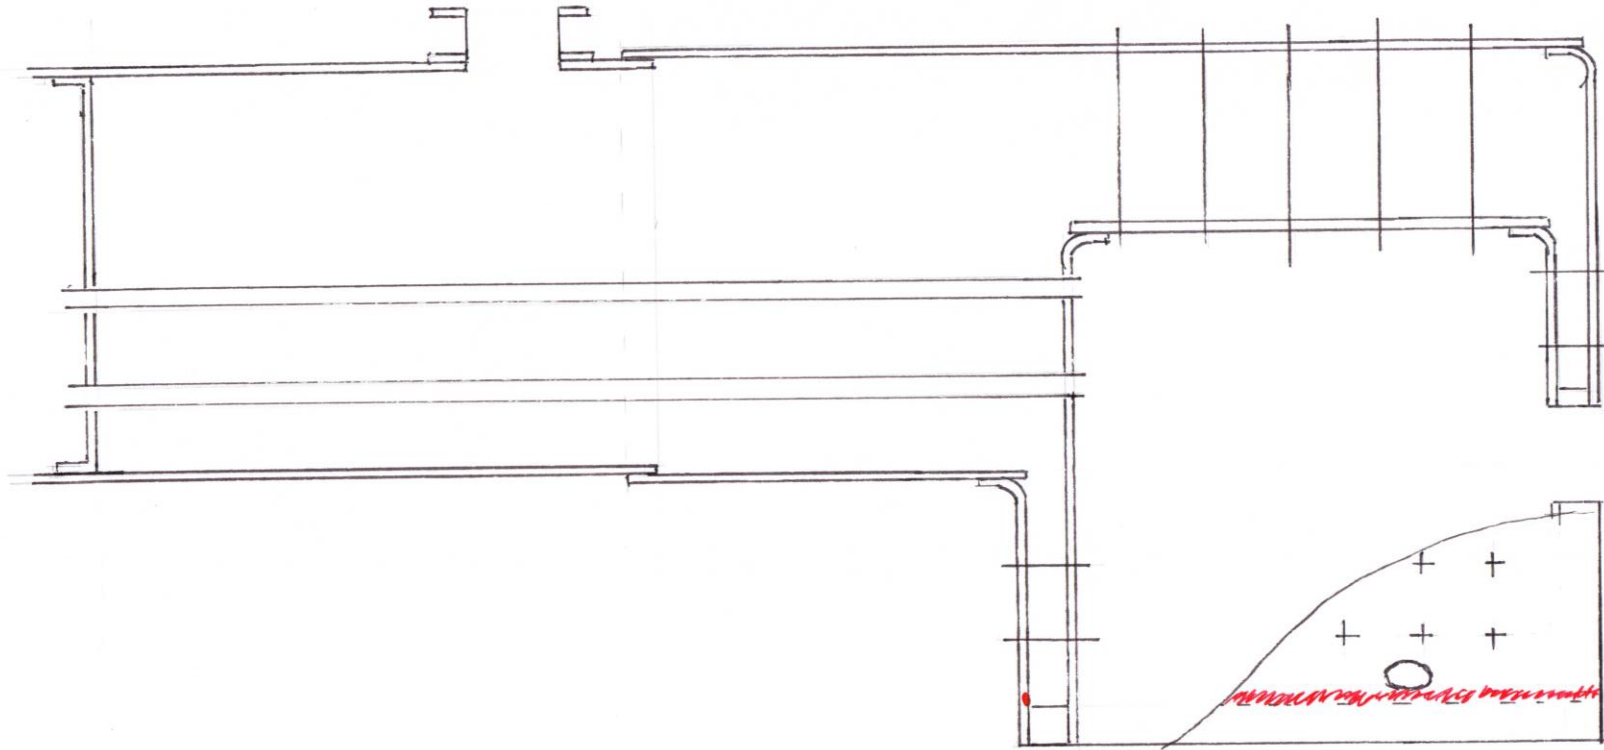
SCHEMATIC OF LOCO BOILER
SHOWING LOCATION OF GROOVING
LOCO 25 KESR

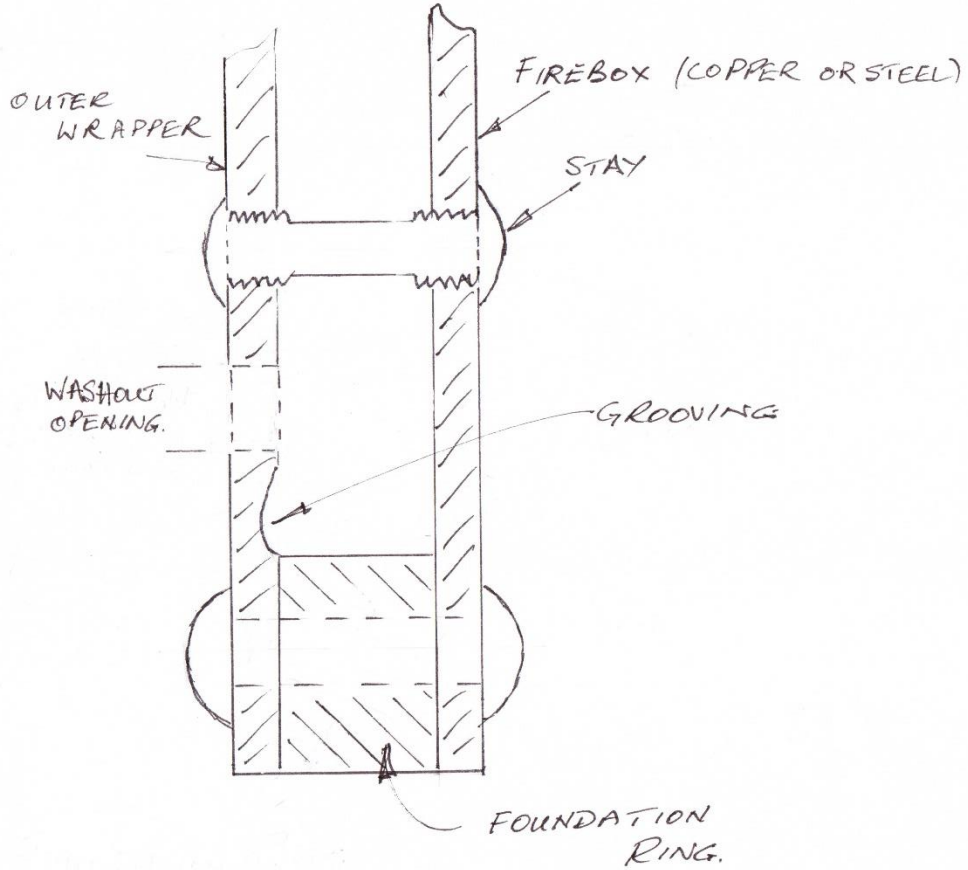
LOCO BOILER

WATER SPACE SECTIONS AT FOUNDATION RING FOR LOCOMOTIVE AND CRANE BOILERS
(SHOWING LIKELY LOCATIONS OF GROOVING.)

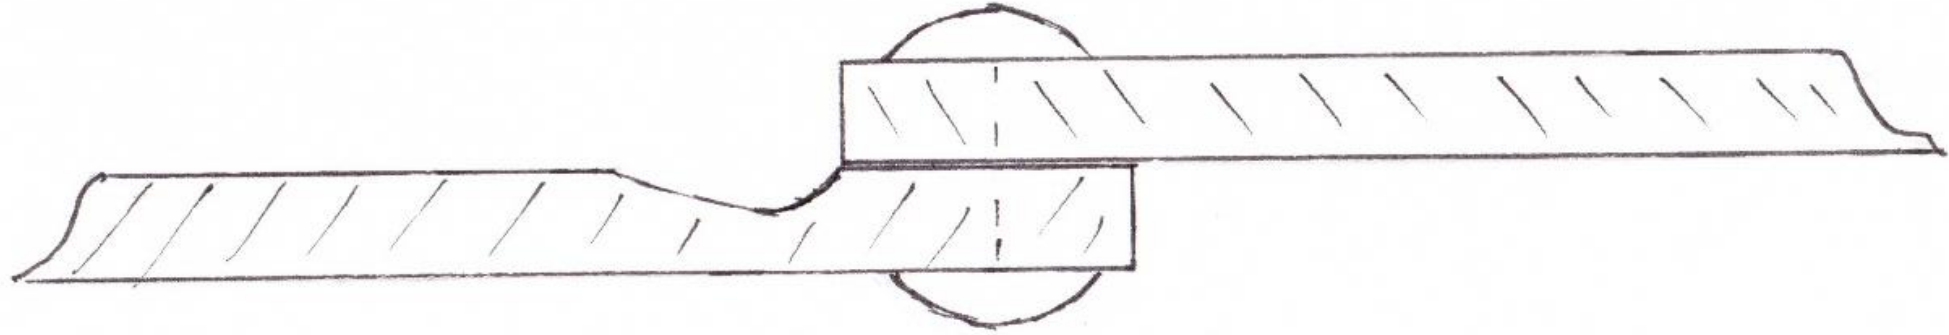
TYPICAL GROOVING AT LAP BEAMS

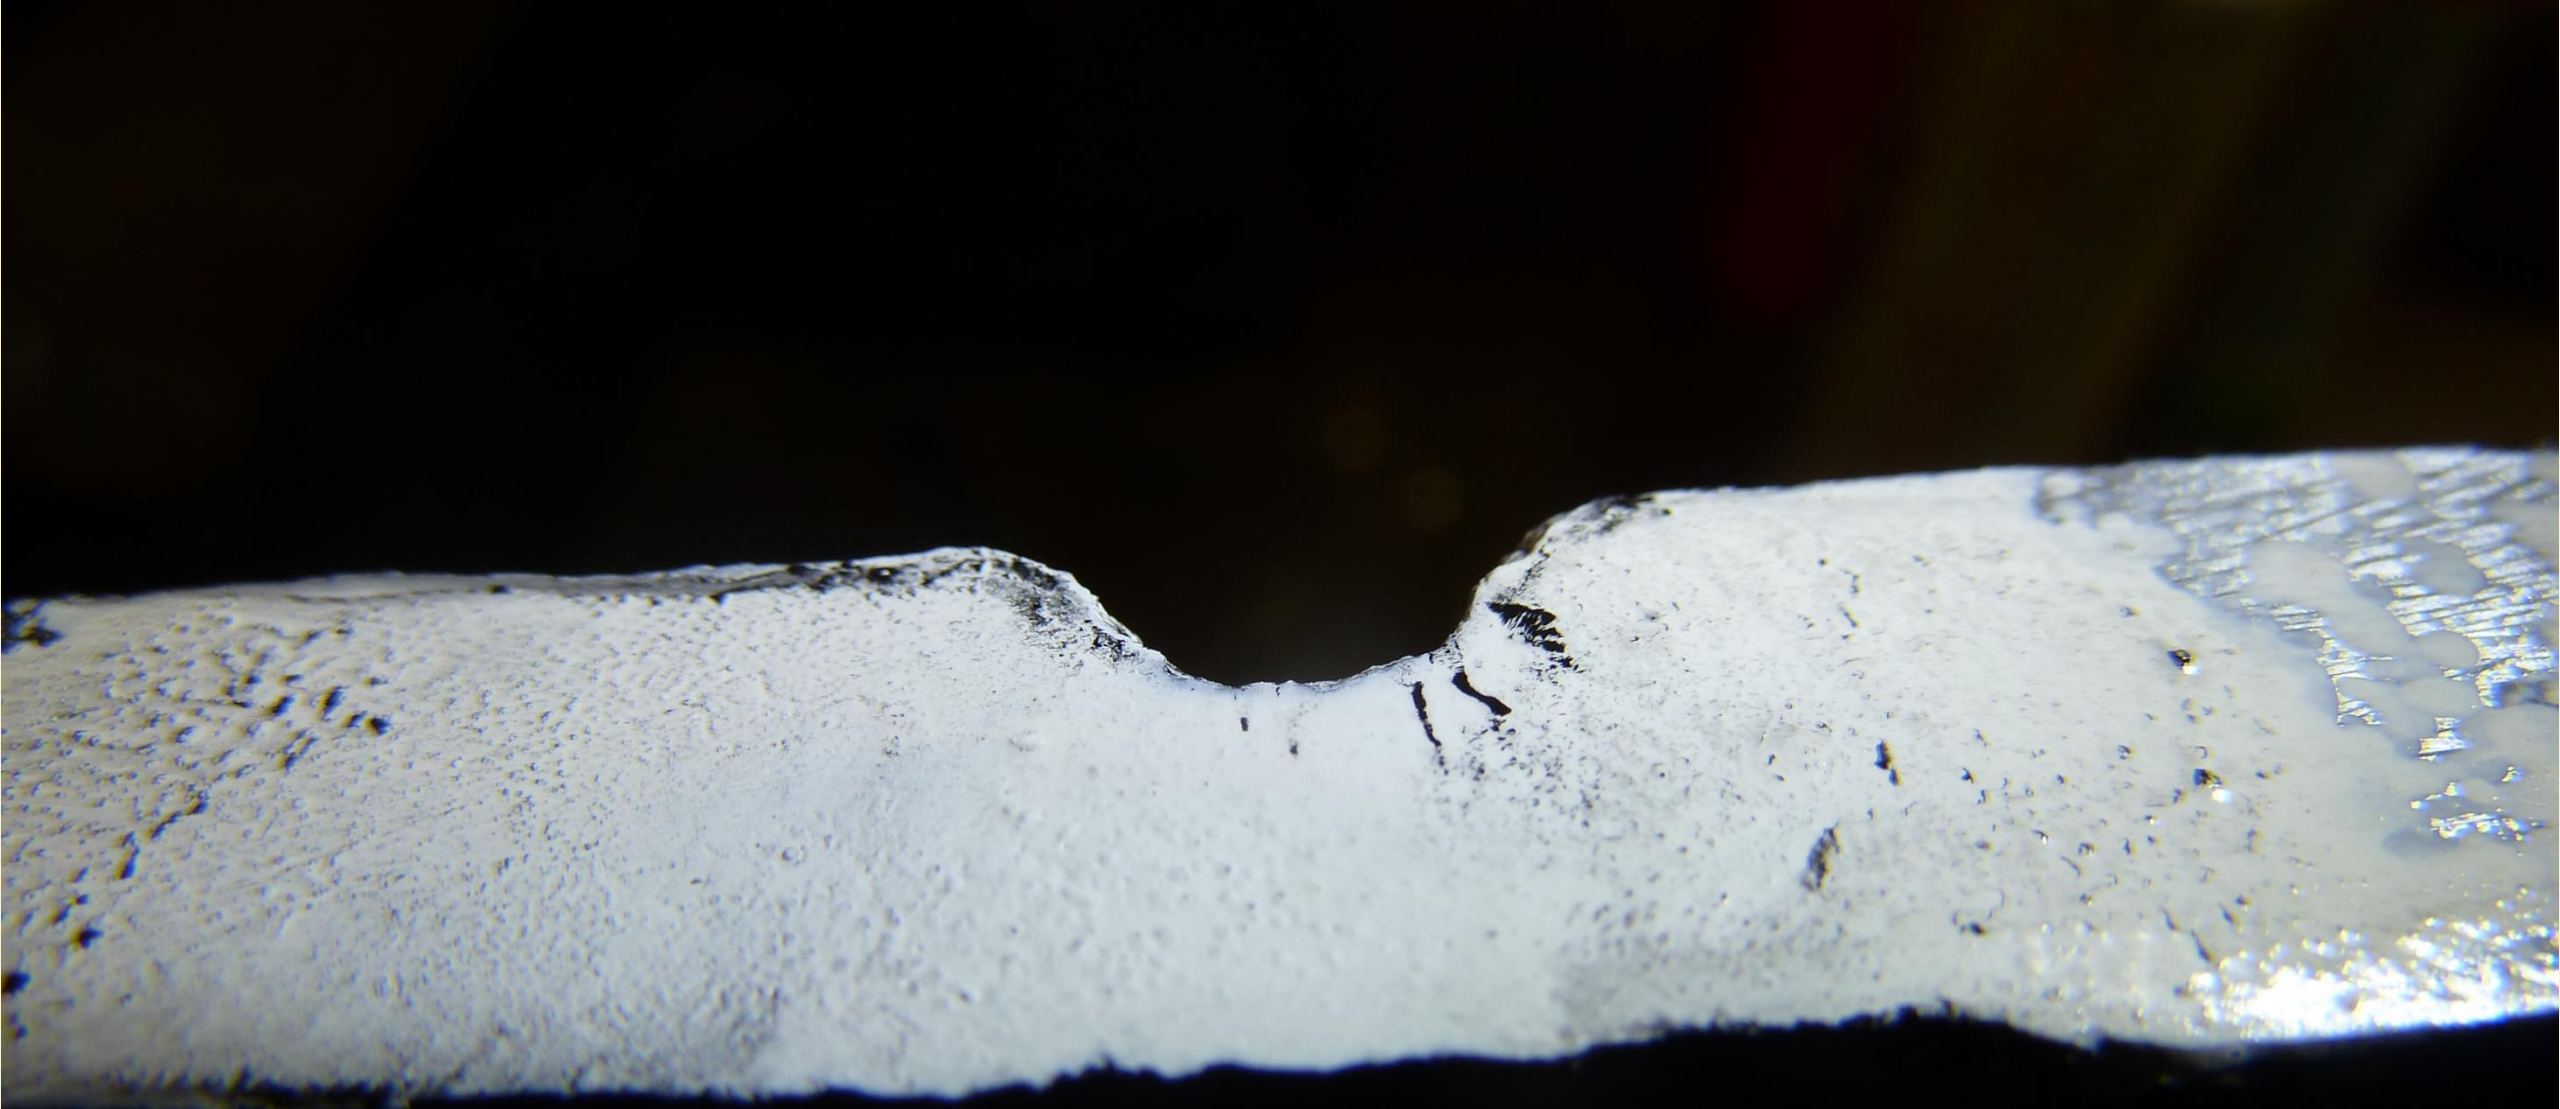
Loco 25

MPI Shows short radial cracks

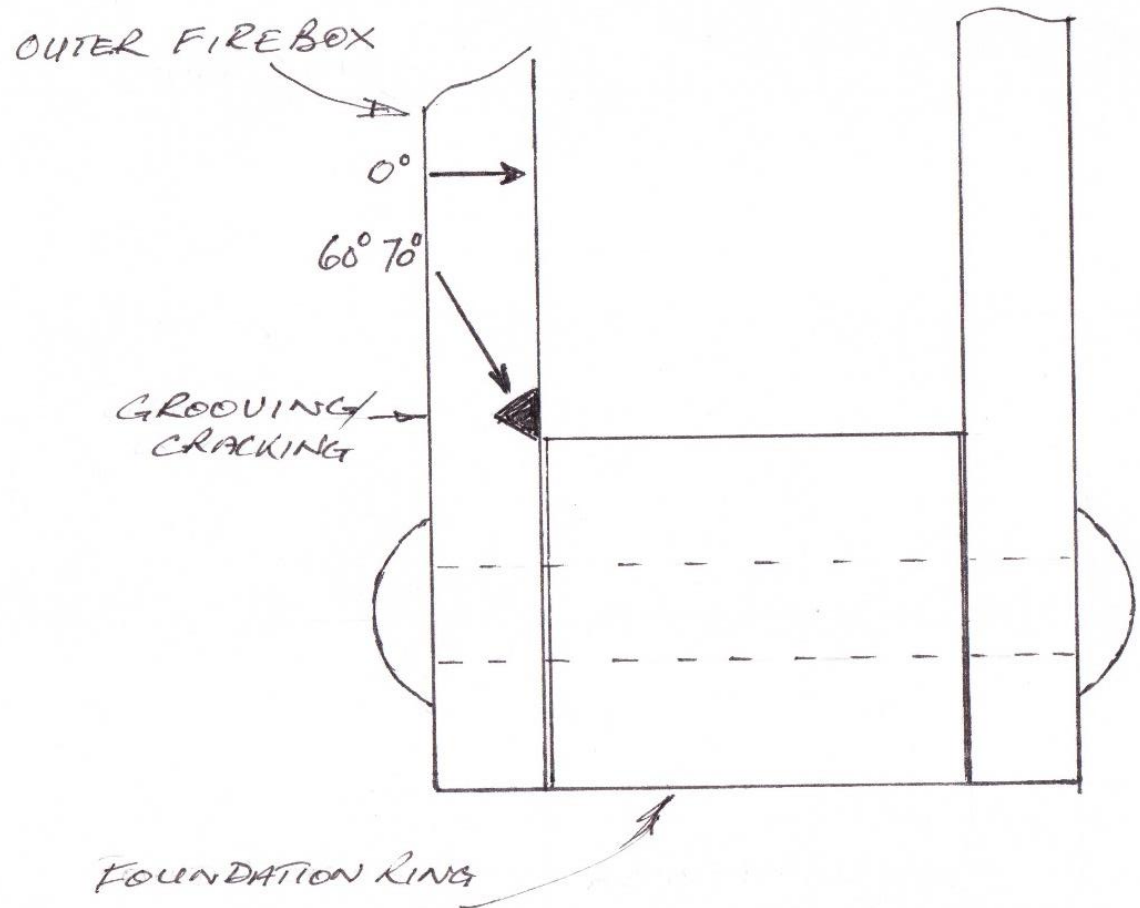
GROOVING/CRACKING DEFECTS
IDENTIFIED 2 to 6MM DEEP

ULTRASONIC INVESTIGATION LOCO 25 KESR
BY NDT INSPECTION SPECIALIST 2014

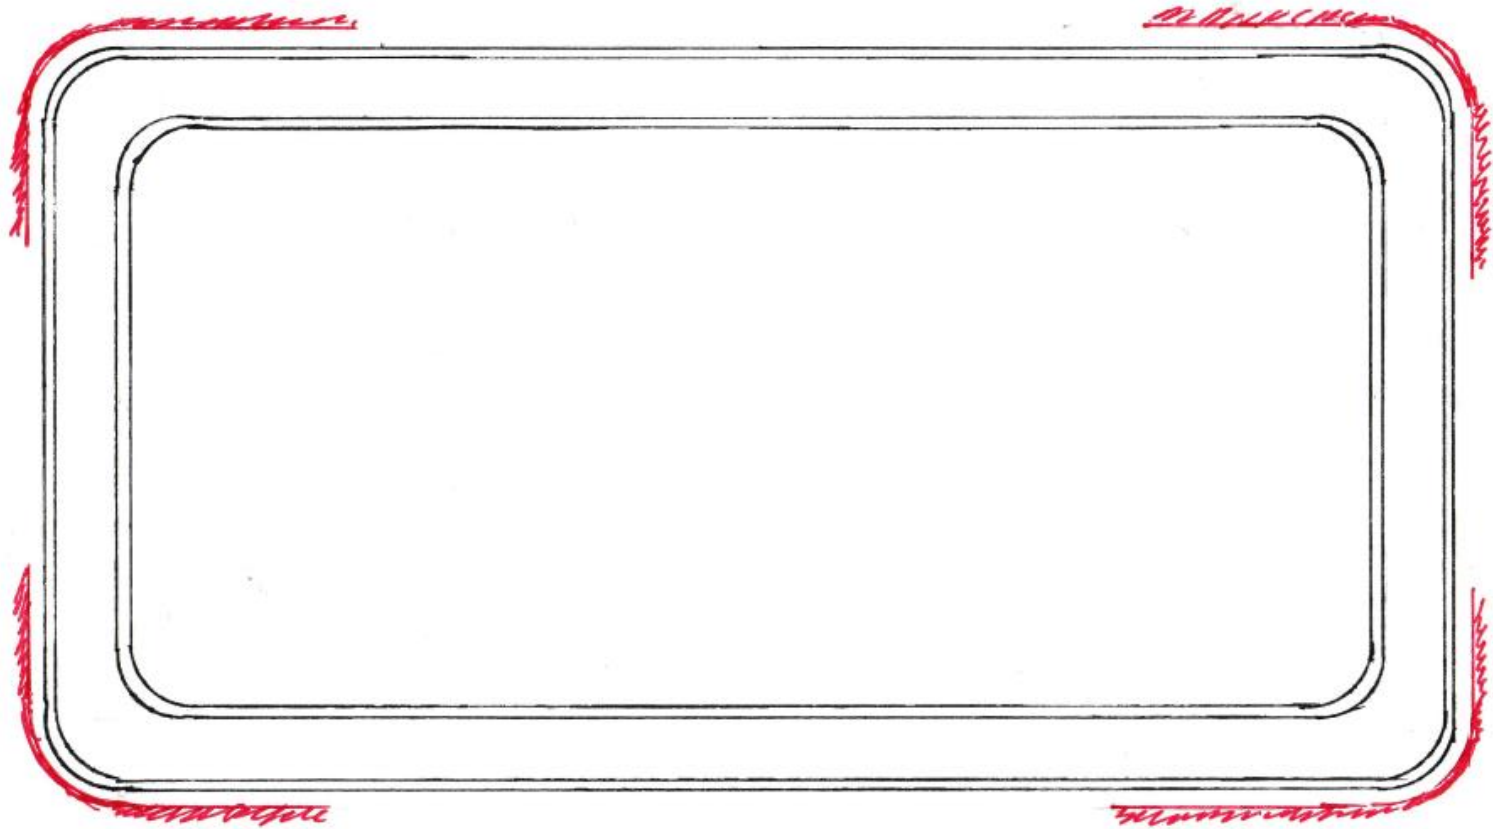
LOCO 25 PLAN VIEW OF FOUNDATION RING
SHOWS AREAS AFFECTED BY GROOVING 2 to 6MM DEEP
LENGTH OF STRAIGHT PLATE AFFECTED 160 to 300MM

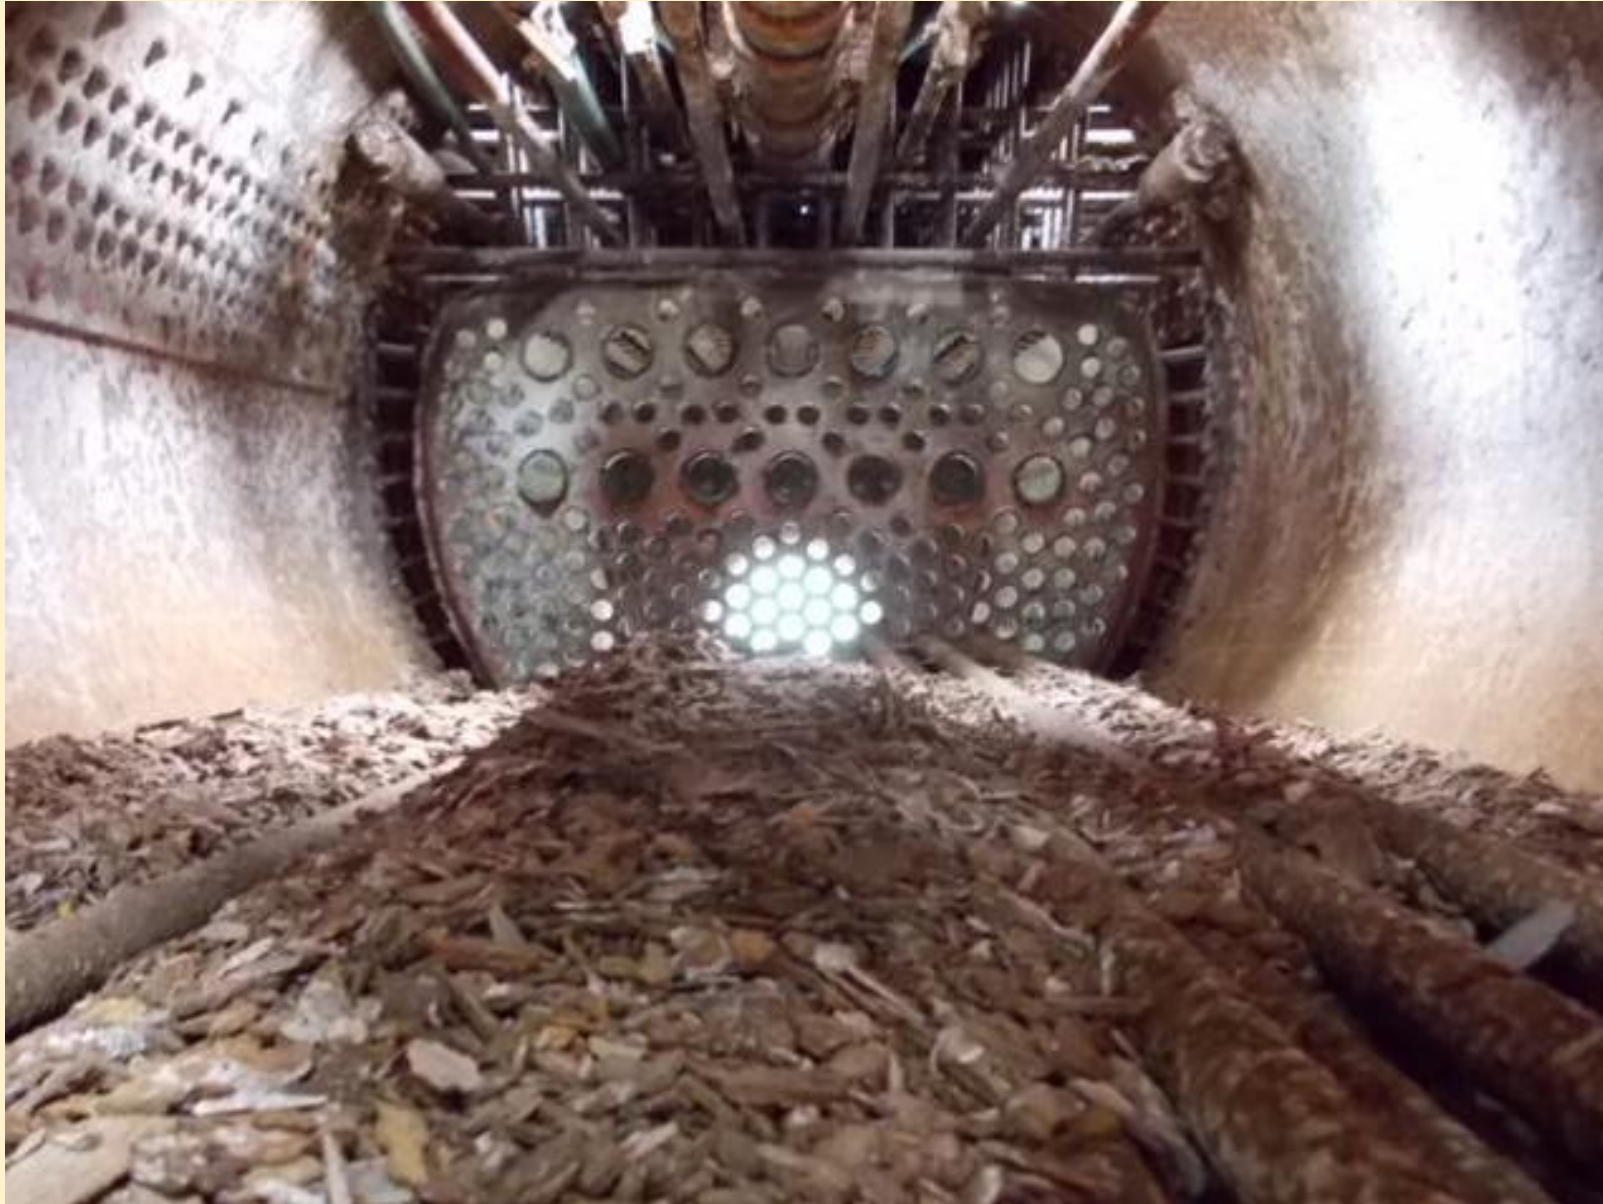
Heaps of Scale in the Boiler of 4253

No evidence of water treatment... (from British Rail days in 1963)
