# The RNLI's Experiences and Current Application of Marine Composites NDT

14<sup>th</sup> October 2021

# Severn Class Life Extension programme

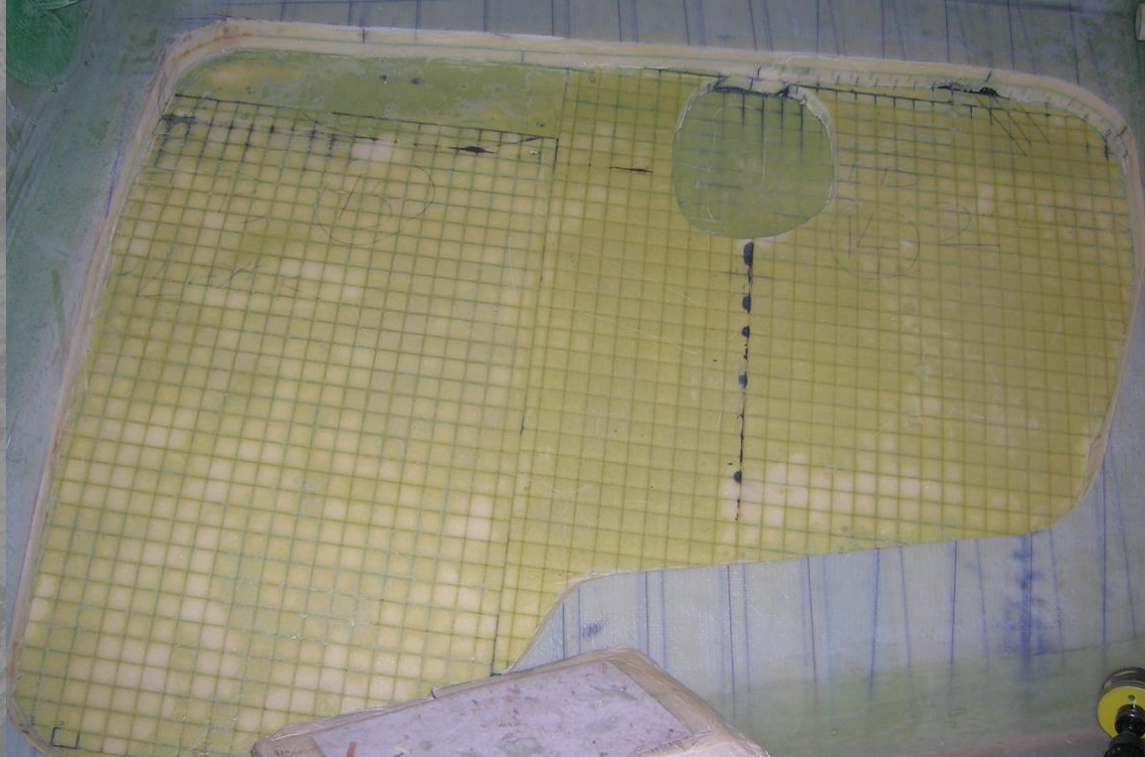
Shearography: Hull topsides – core to core disbond

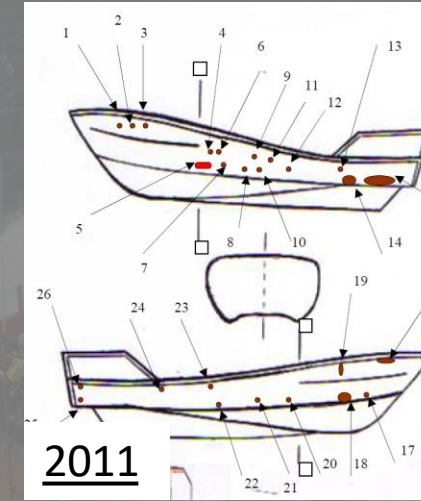
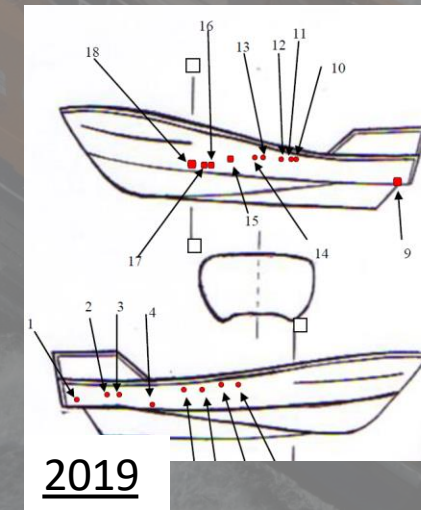
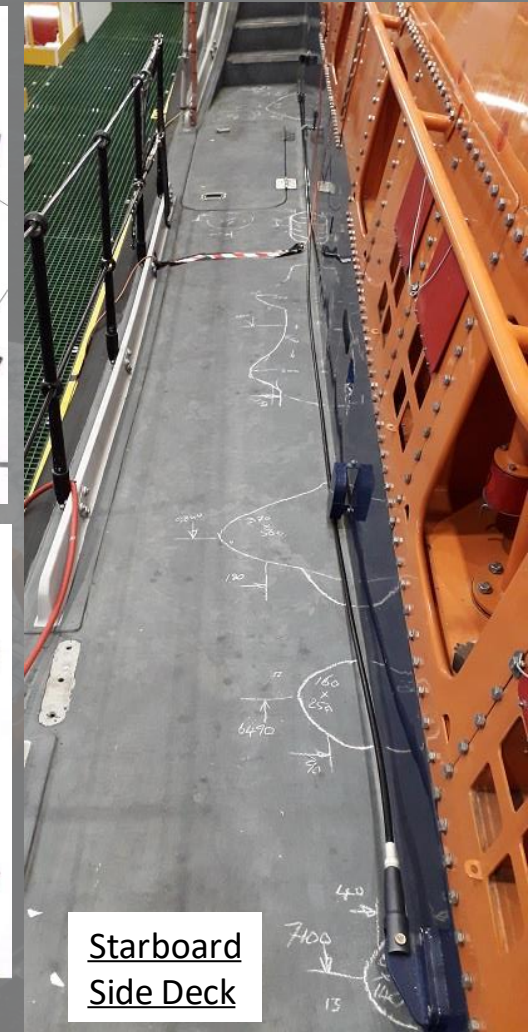
- Vacuum stressing laser Shearography was carried out on all accessible areas of cored structure
- Stripped out condition gives unique opportunity for detailed inspection
- The following areas were assessed:
  - Topsides
  - Decks
  - Wheelhouse & Superstructure
  - Internal soles
  - Bulkheads
- A total area of 225m<sup>2</sup> was inspected compared to standard Severn Refit inspection area of 65m<sup>2</sup>
- Findings
  - Internal defects were minimal
  - Majority were found externally on deck areas
  - Top side defects
