**DEFECTS ASSOCIATED WITH LOCOMOTIVE BOILERS.  
BROKEN FIREBOX STAYS**

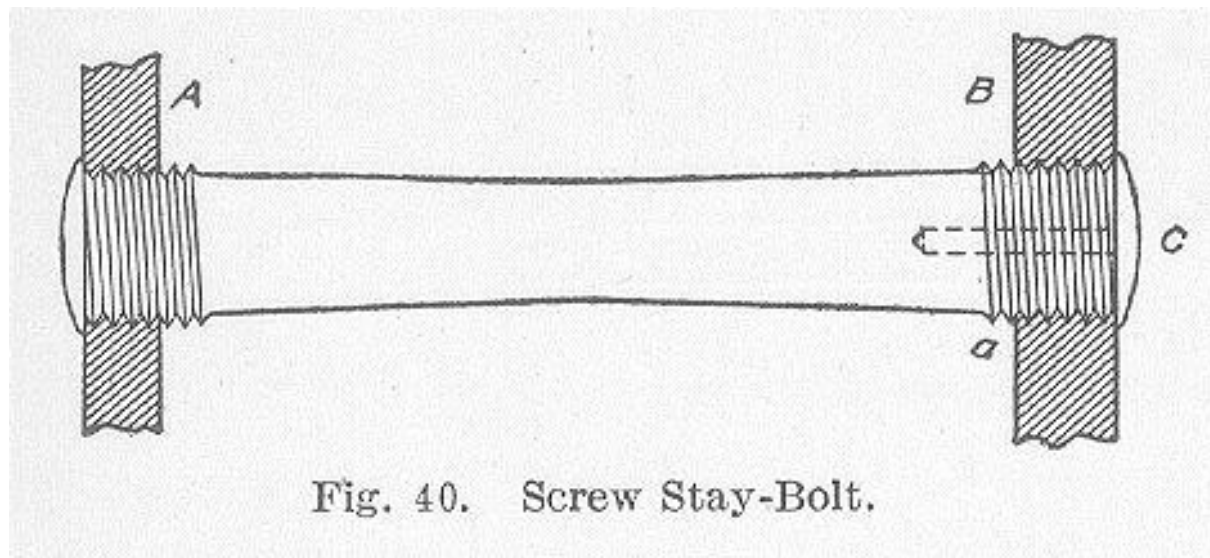
Fig. 40. Screw Stay-Bolt.

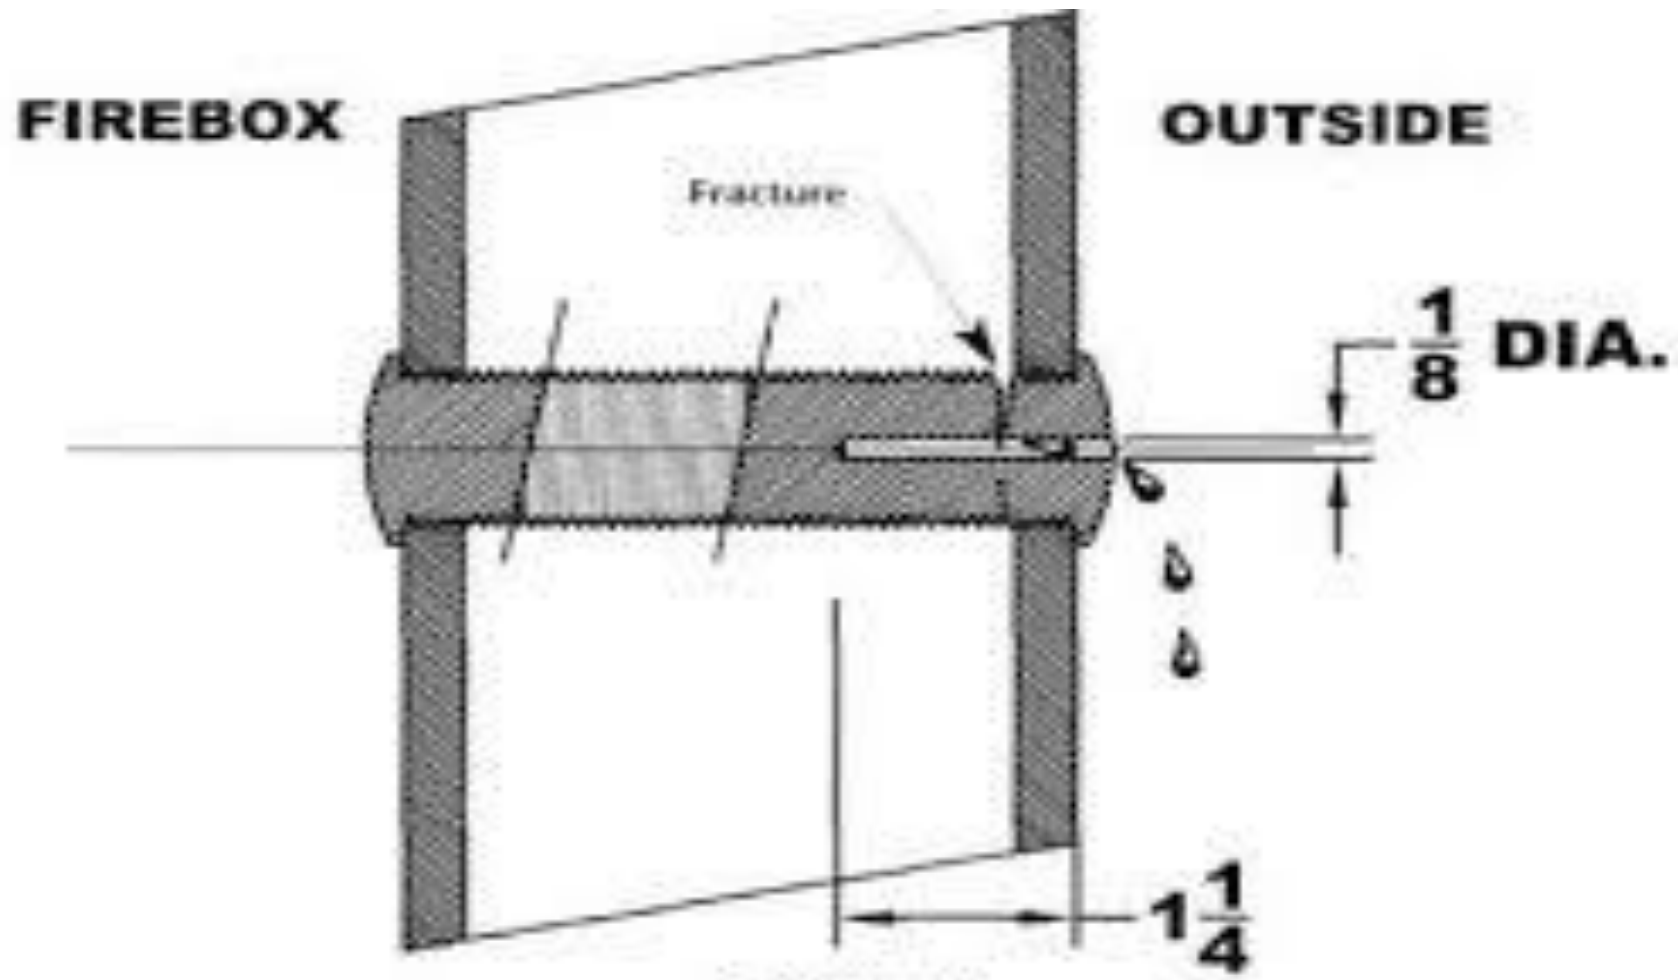
Figure 3

Stays with "Tell-Tale" Hole
