NDT Case Studies – and Quick Wins

Workshop on NDT and SHM requirements for wind turbines
13th -14th February 2019

Dr Colin Brett - Technical Head, Inspection Management
Uniper Technologies Ltd

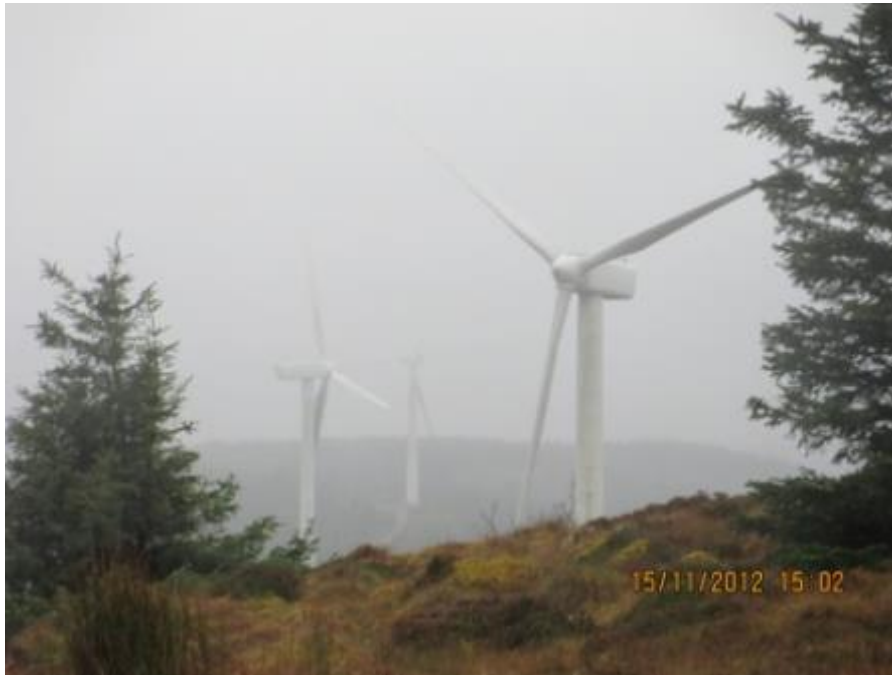
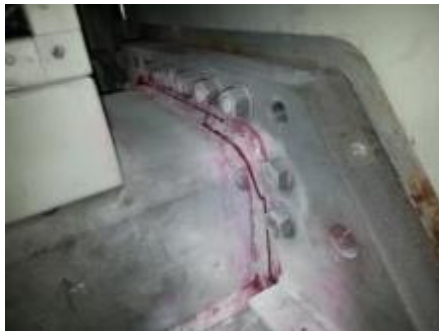
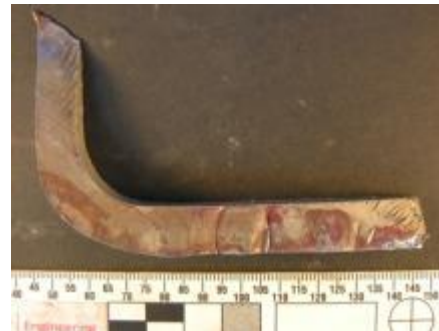
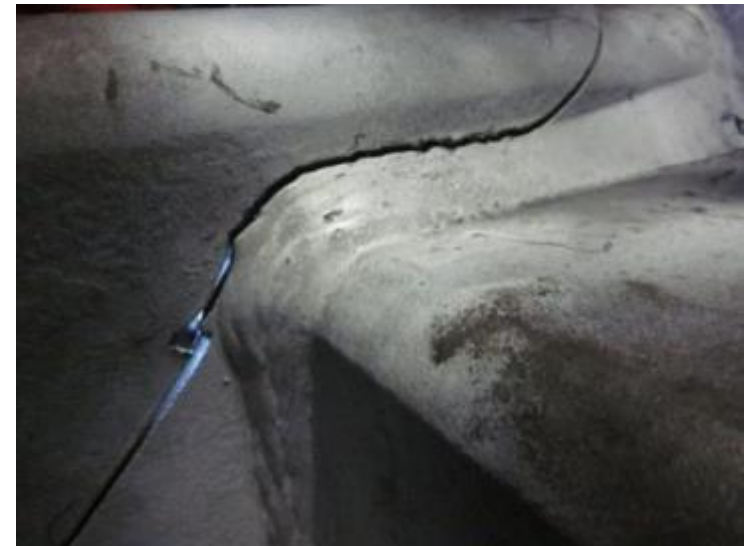
Case Study 1 - Nacelle Cracks

- Cracking in nacelle bedplate identified by visual examination
- MPI and ACPD undertaken to measure crack dimensions
- Finite element analysis to assess the integrity of the nacelle frame and to determine bolt loads during proposed repair to determine unbolting sequence
- Post-repair inspection schedule developed and implemented

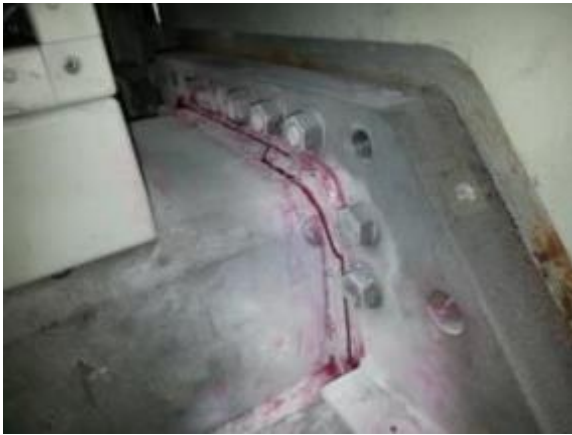
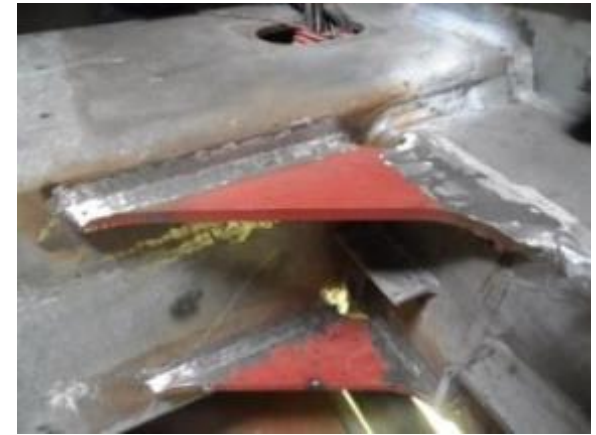
Case Study 1 - Nacelle Cracks

Problem subsequently identified at another wind farm, but poor NDT (penetrant) *by client* has led to cracks being under-sized or missed. Now a major repair programme underway in every turbine on farm.

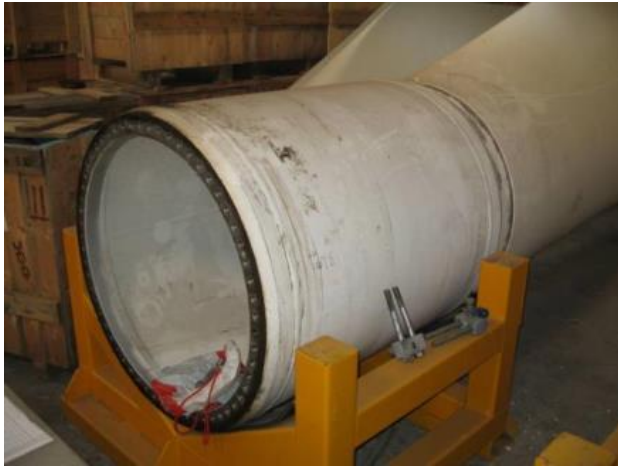
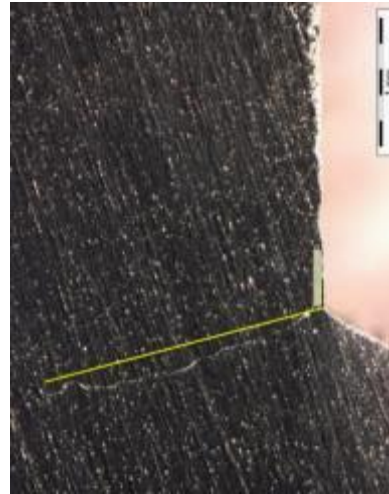
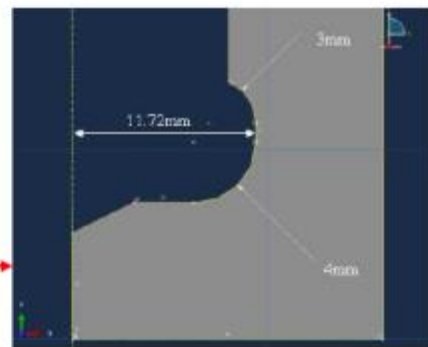
Case Study 2 - Inspection of Blade-to-Hub Mating Cans

- Blades had been shed at two wind farms in New Zealand and another in Scotland
- Detailed materials investigation identified cracks at bottom of mating can bolt holes
- Fitness for service of the OEM-proposed modification was assessed
- Design review was extended to determine an improved modification

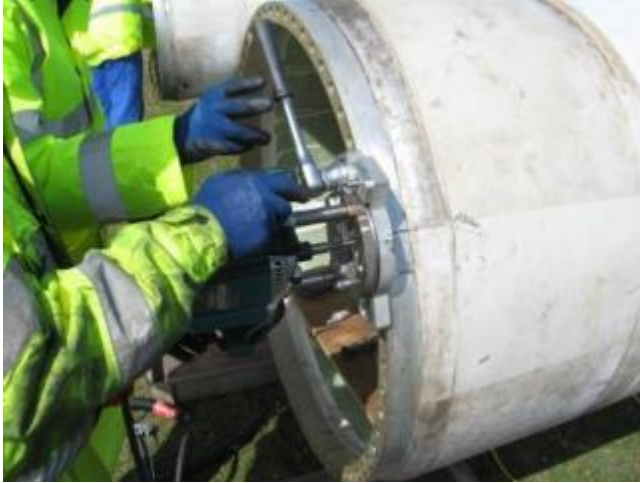
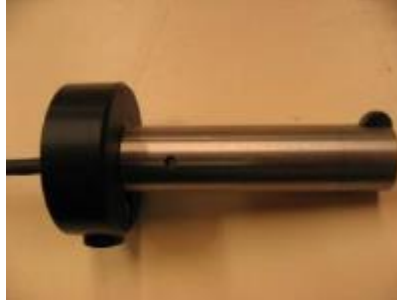
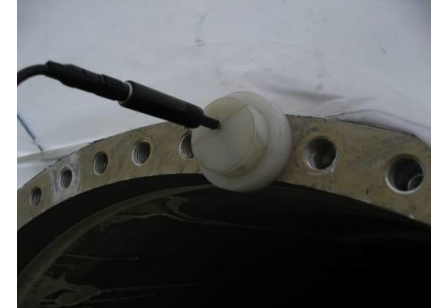
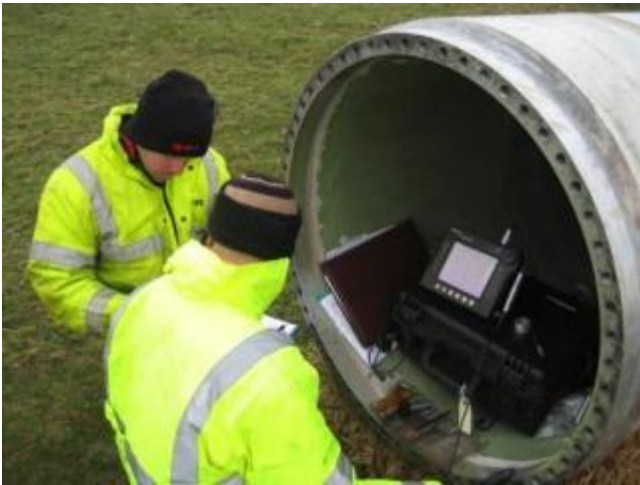
Case Study 2 - Inspection of Blade to Hub Mating Cans

- Bespoke Eddy Current Inspection solution developed and implemented to detect and size 0.2mm deep cracks.
- Pneumatic tool designed by Uniper Workshops to cut the new profile(s).
- Re-profiling and NDT carried out in the field.
- Uniper design modification resulted in significantly lower stresses and longer predicted lifetimes.

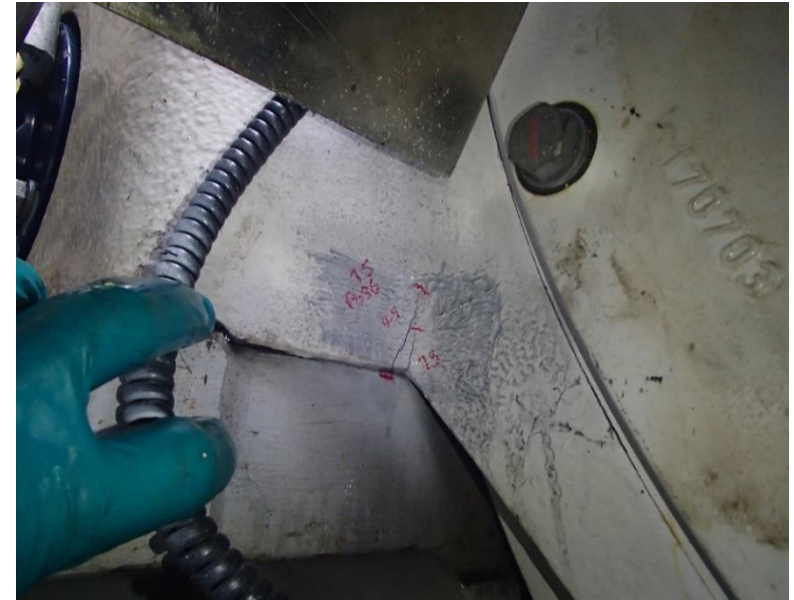
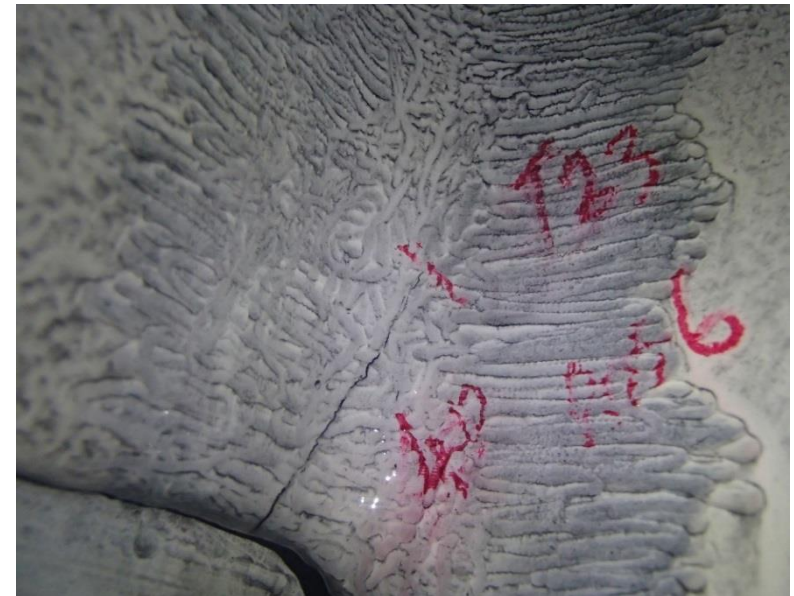
Bearing Case Corners

- Generator bearing case corners
- Cast component casings
- Many corners are “not smooth” and promote cracking.
- 24 out of 30 turbines have cracks at one site

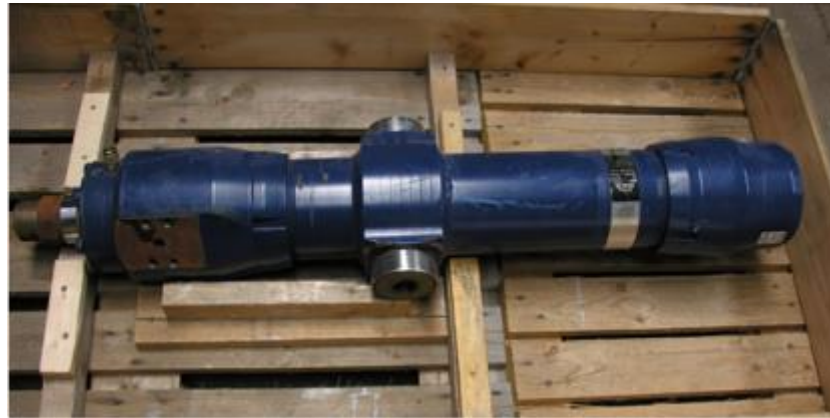
Case Study 3 - Pitch Ram Failure

- Investigation identified poor design rendering hydraulic ram susceptible to failure
- Practical ultrasonic inspection technique determined and implemented
- Third of all rams on the offshore wind farm contained a crack

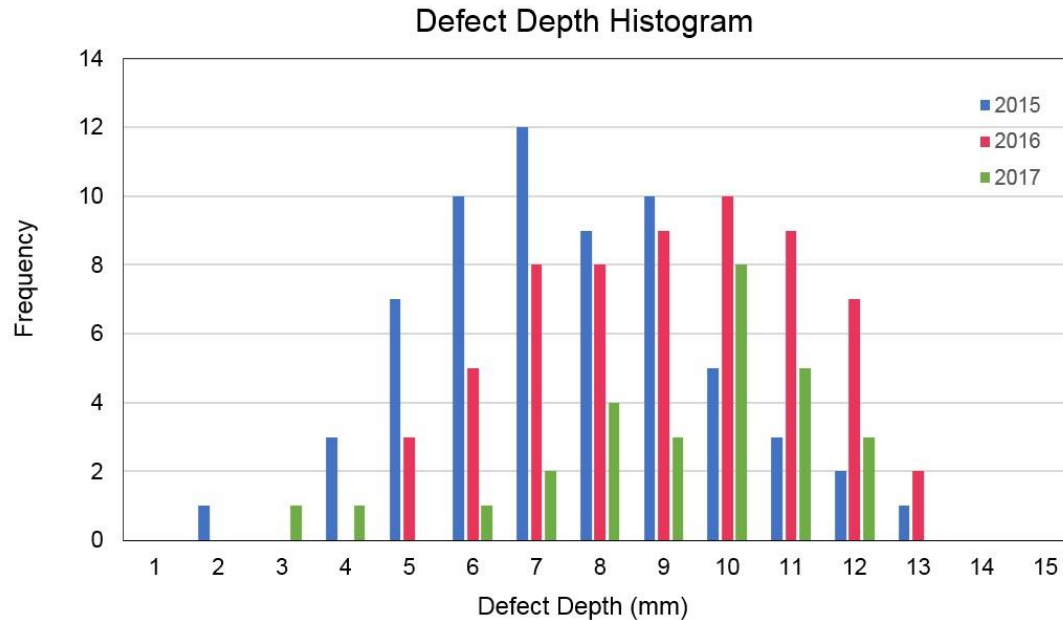
Case Study 3 - Pitch Ram Failure

- Pitch rams at most risk targeted for replacement, but like for like.
- Solution is to replace faster than they are failing!
- Tide turned in 2017: failure rate decreasing and population of cracks diminishing.
- But, in 2018, found that some replacement rams are now cracking!

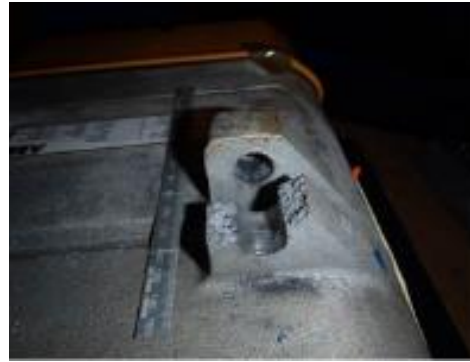
Lift Hoist Eyes

- Load splitter plate had been removed so that loads could be raised slightly higher.
- Plate not reinstated, and eventually the aluminium hoist eyes fatigued.
- Now carrying out penetrant and eddy current inspections on other units to check for cracking.

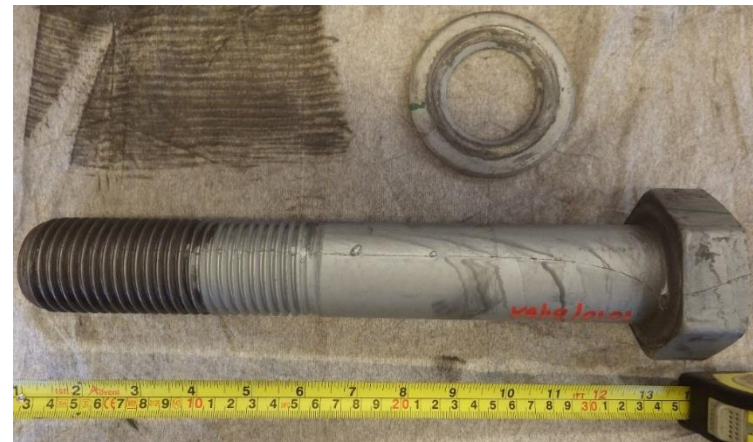
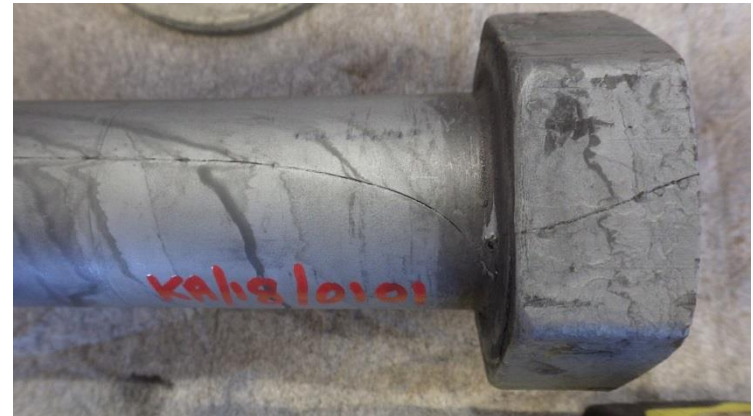
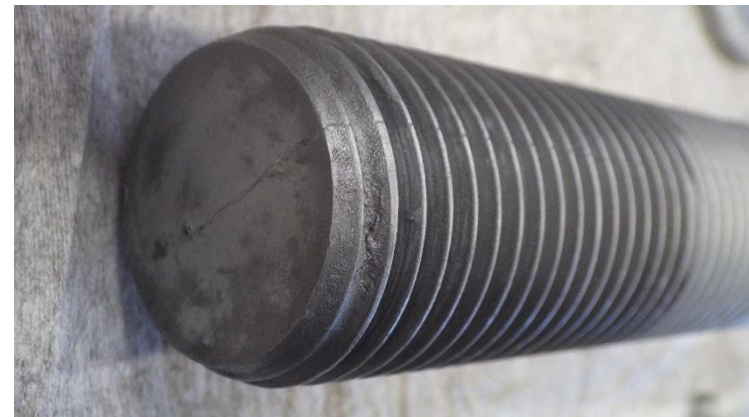
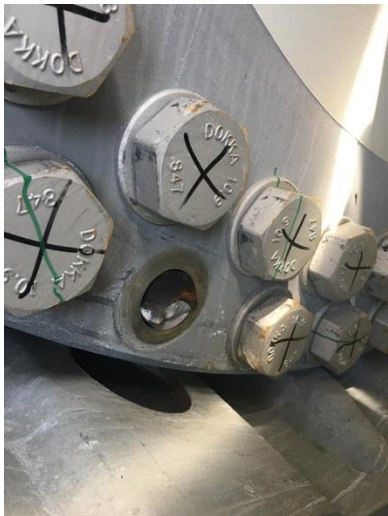
Bolts

- Axial cracks in bolts found at the blades to shaft flange. Full length of bolts.
- Zn/Al paint found inside crack
- So, missed at manufacturing, coating and installation stages?
- Client trying to trace other installed bolts through the QA and construction records
