# GRP pipework failures and NDT challenges

Robert Jenkins, NDT Specialist Engineer, Uniper Technologies Limited

# GRP Pipework on UK CCGT Power Stations

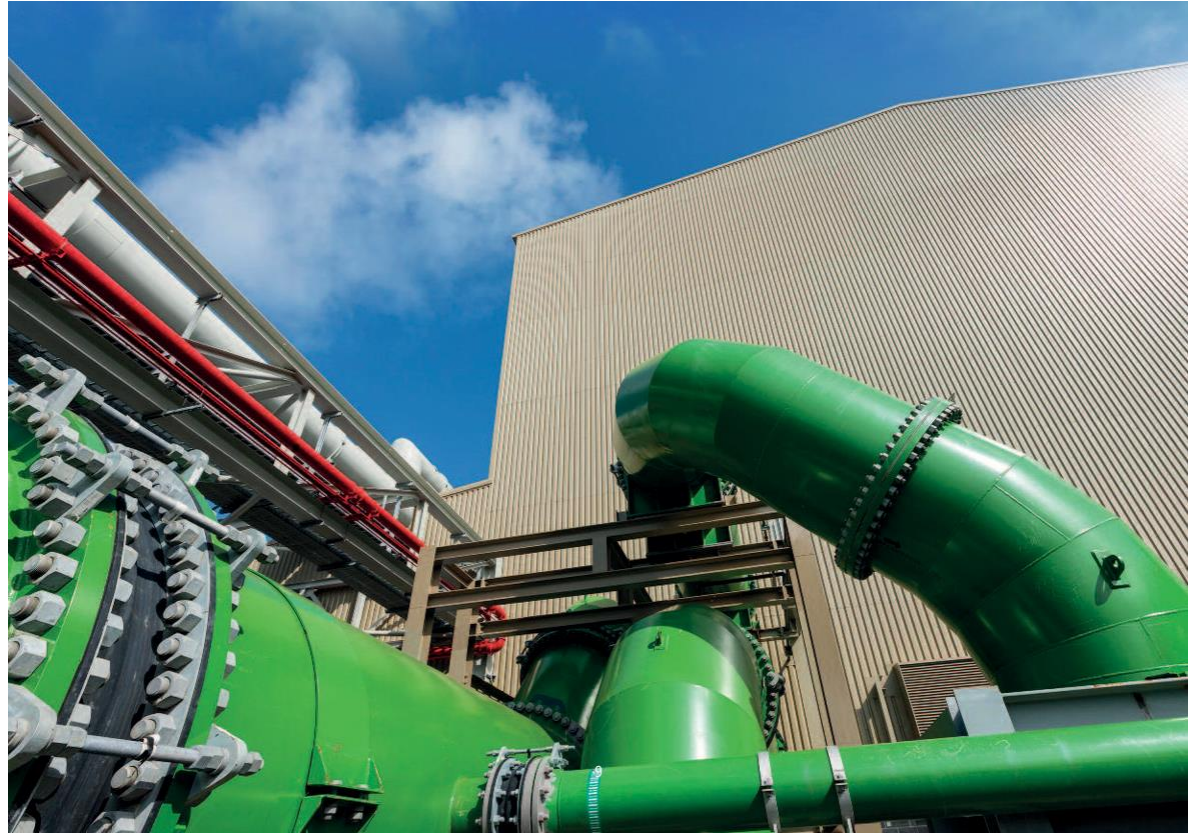
UK Combined Cycle Gas Turbine (CCGT) plants have high water demand, primarily for steam condensation within cooling systems.

Cooling water pipework is typically HDPE or GRP/FRP, selected for corrosion resistance to treated cooling water.

Most UK CCGT GRP cooling water systems are  $\geq 20$  years old and large diameter.

Over the past two years, multiple significant GRP pipe failures have disrupted operations at several UK CCGT sites.

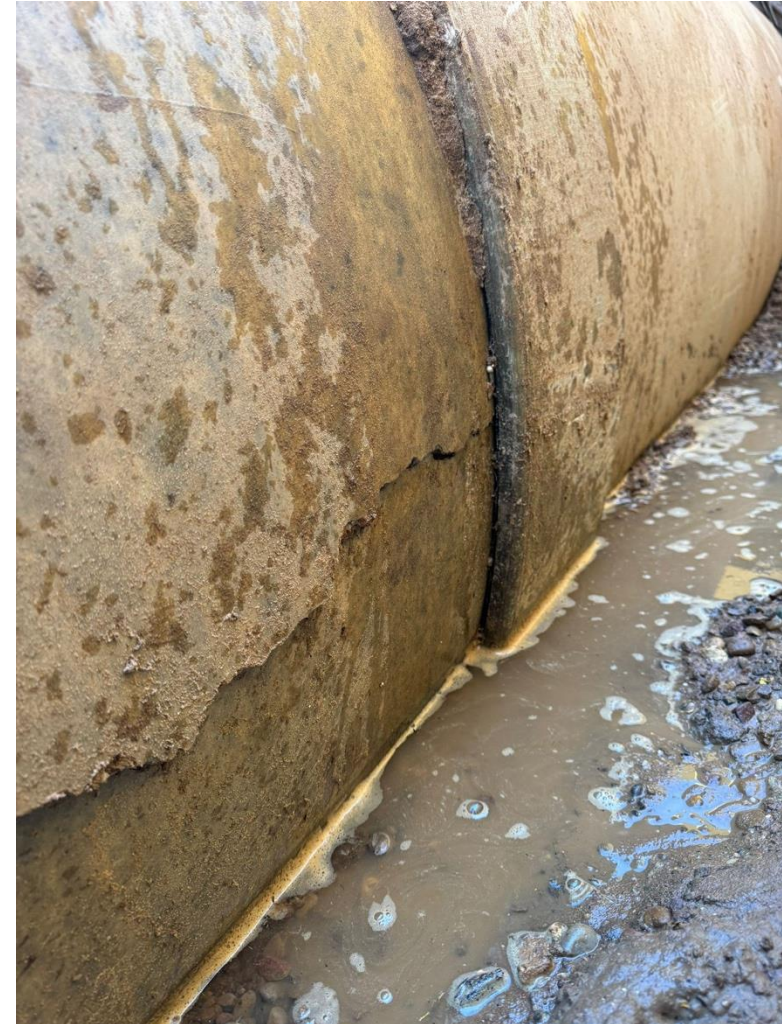
Several GRP failures have manifested as axial splitting at the 3 and 9 o'clock positions.

As these pipelines are typically buried, failures often remain undetected until surface flooding or a measurable loss of system pressure occurs.

Beyond safety and environmental risk, such failures interrupt cooling water supply, necessitating plant shutdown until repairs are completed.

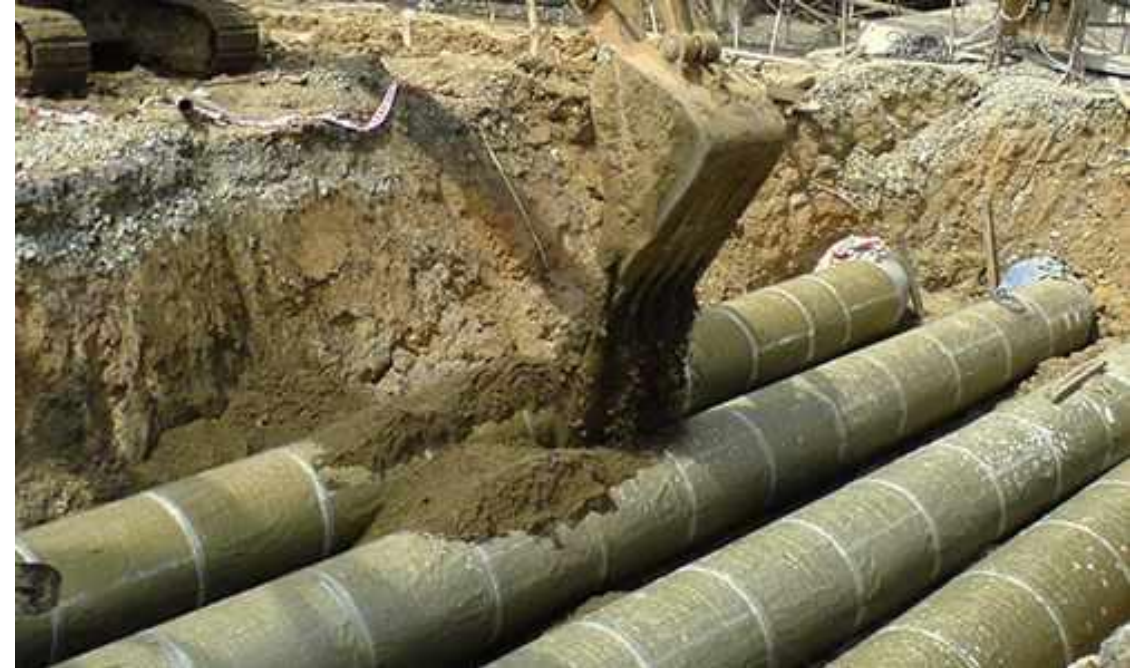
# NDT from **external** surface of GRP Pipework

External surface condition and intrinsic material properties significantly limit conventional NDT methods:

MT – Not applicable; GRP is non-conductive and non-ferromagnetic.

PT – Generally unsuitable due to surface roughness and material porosity.

ET – Not applicable; non-conductive material prevents eddy current induction.

RT – Impractical for large diameters; requires simultaneous internal and external access.

UT – Potentially feasible; however, surface condition, attenuation, and heterogeneous laminate structure may limit transmission and defect detectability.

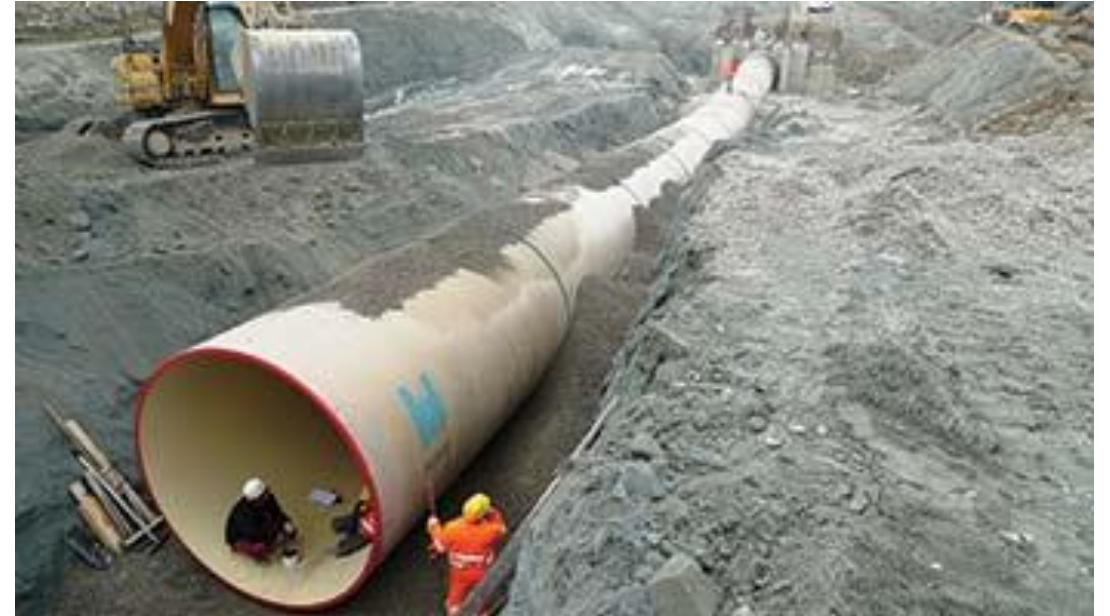
# NDT from **internal** surface of GRP Pipework

The same fundamental material limitations apply; however, internal surfaces typically do not exhibit the external roughness issues.

MT – Not applicable; GRP is non-conductive and non-ferromagnetic.

PT – Generally unsuitable due to material porosity (surface roughness less limiting internally).

ET – Not applicable; non-conductive material prevents eddy current induction.

RT – Impractical for large diameters; requires simultaneous internal and external access.

UT – Potentially feasible; attenuation and laminate heterogeneity may still limit wave transmission and defect resolution

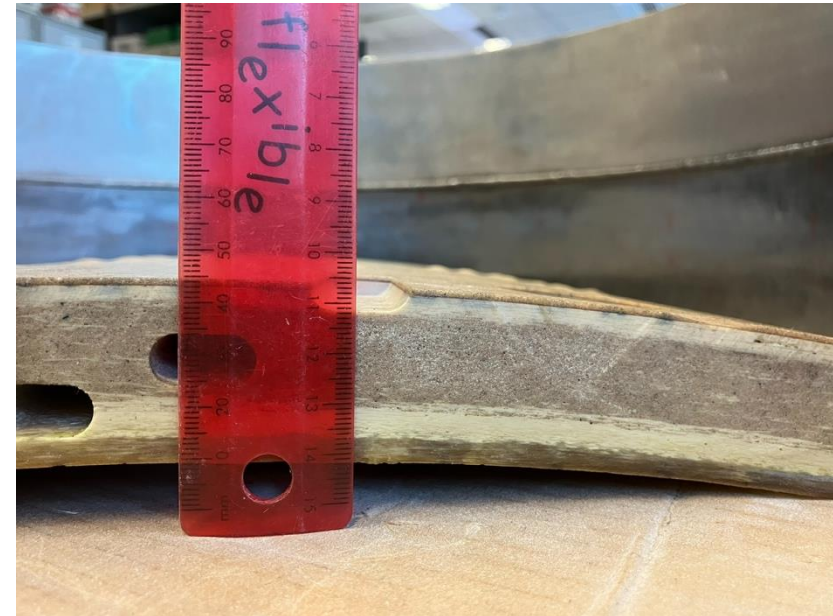
UT was selected, with the following considerations:

Calibration using representative GRP blocks or pipe sections

Use of appropriate probe frequency or advanced UT method to balance penetration and resolution

Scanning strategy to compensate for variable laminate thickness and orientation

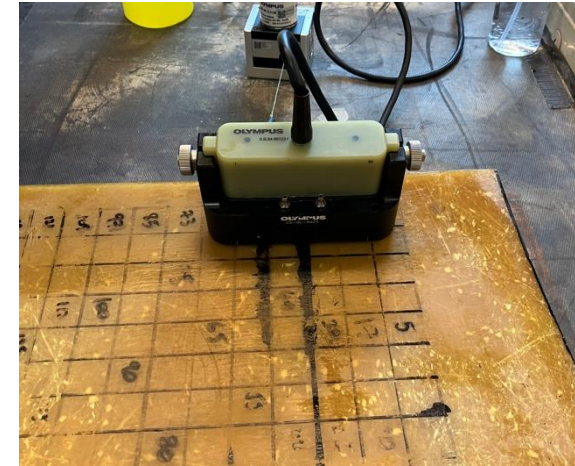
1. An effective volumetric NDT technique was required for the testing of GRP pipework.
2. Low Frequency PAUT was trialled in the Workshop, Site trials planned for 2026
3. Shown to be adequate in detecting planar flaws parallel to the surface in GRP pipework, such as delamination, in the workshop.
4. Site trials required to determine if suitable for bulk pipework screening.

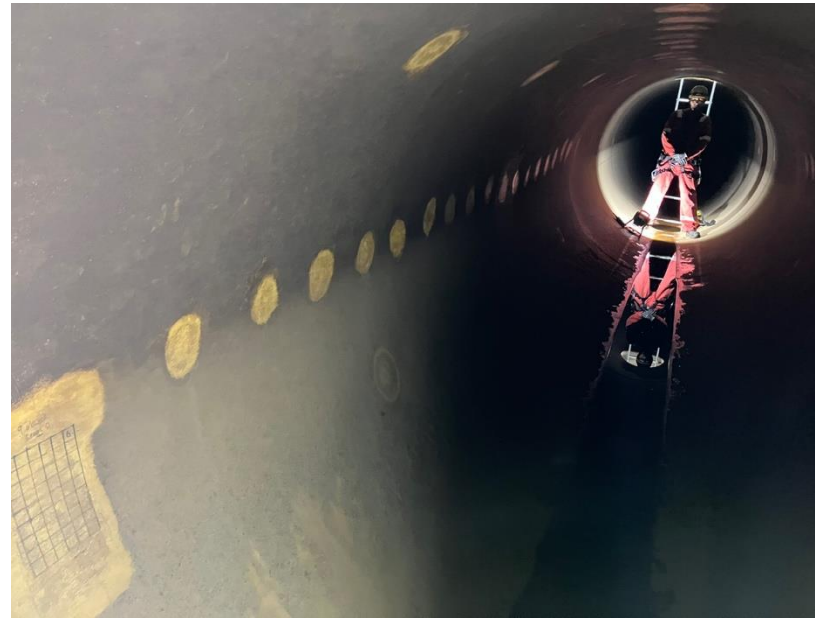
1. An effective volumetric NDT technique was required for the testing of large areas of GRP pipework.
