Wind turbine design factors for long-term management

13/02/19David Thompson / Tony Fong

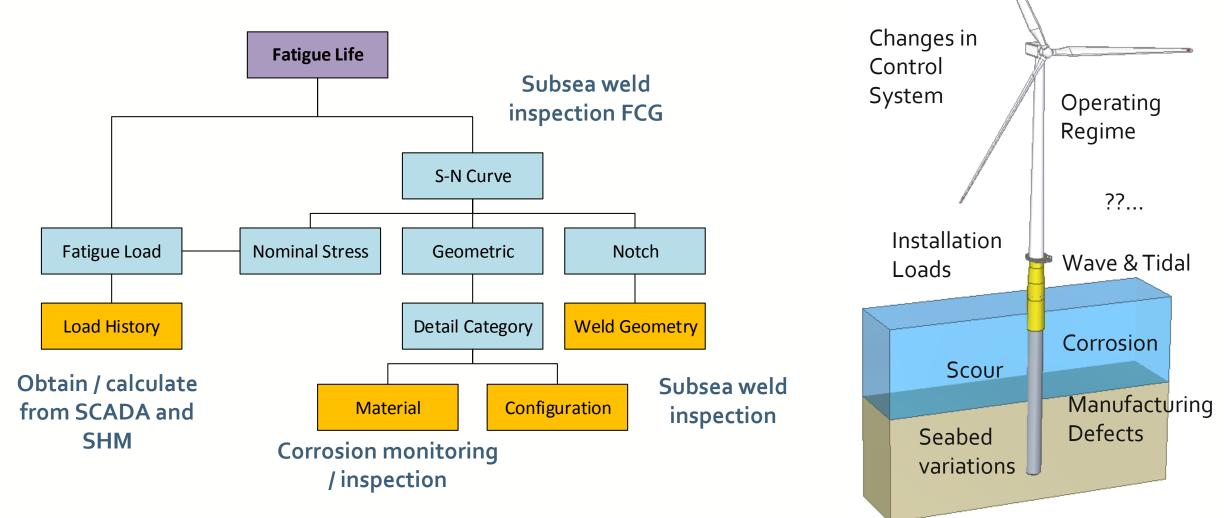
Monopiles are fatigue driven.

Evaluation of remaining life for integrity management or life extension

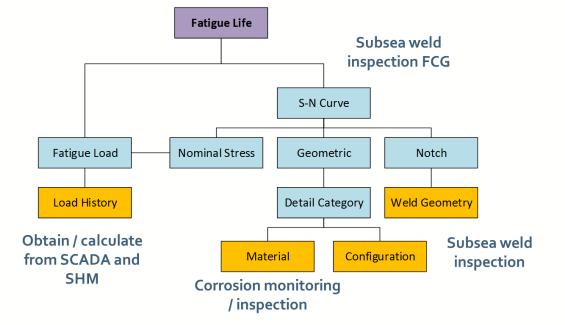
Manufacturing quality concessions on foundation welded joints. Assets commissioned with known defects.

- Load:
 - Monitor strains on foundation
 - Estimate of bending moment
 - Compare with design
- Resistance:
 - Assets with severe defects diver inspected annually
 - Acoustic sensors fitted to detect crack growth on high risk assets

Assets continue to operate safely. Cost of complete remediation avoided. Safety justified by evaluating reality against design.

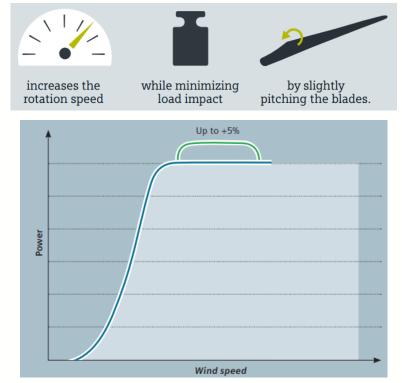
Turbine OEM offers opportunity to uprate the turbine up to 4% AEP, however the substructures have already been designed

- Logging of SCADA and environmental data
- Monitoring of corresponding tower loads through strain gauging
- Run turbine across entire operating range and capture data
- Analysis carried out to evaluate real load vs. design forecast

Loads compared with design specification to ensure they are within the substructure limits \rightarrow justification of maintained integrity

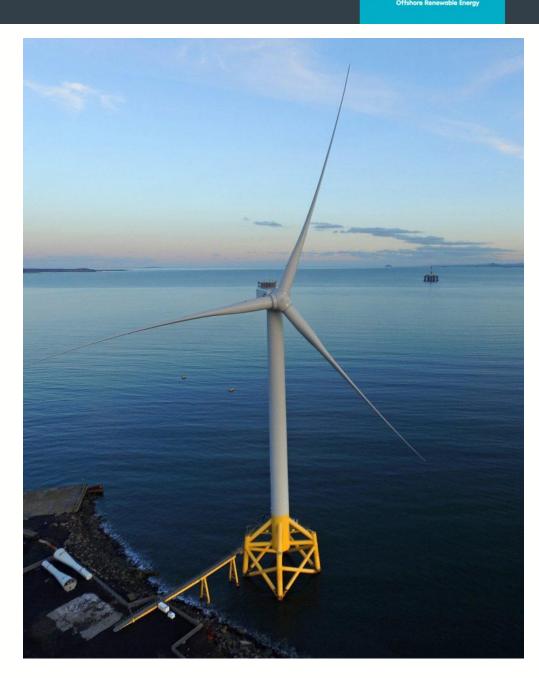
Levenmouth Demonstration Turbine has a jacket structure designed by Ramboll .

- Strain gauging across the jacket, tower, blades
- Accelerometers across tower
- Bolt tension sensors
- LIDAR... and other

Gathered data to be used to validate original design models and perform optimisation

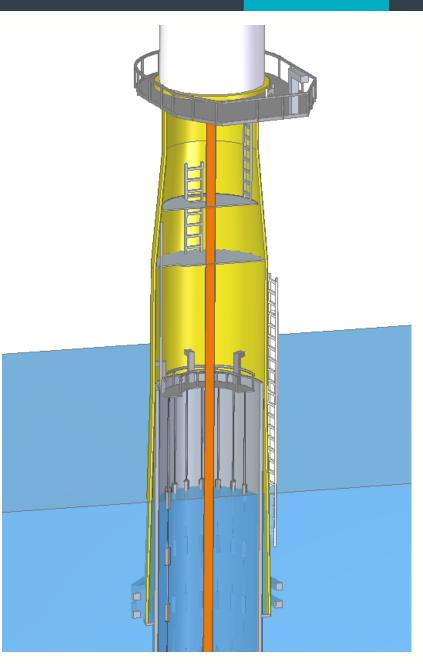
Optimistic assumptions in early foundation design resulted in common failure of grouted connections between TP and MP

Use of ROV equipped with ultrasonic inspection sensor to inspect the integrity of the grouted joint, through the steel structure

- Sensor could be deployed either outside of inside the pile
- Marine growth removal will be required
- Interpretation of sensor data required

Enables check of grout interface integrity and drive the need for remediation. Design standards revised to incorporate failure learnings and mitigate grouted connection failures for future designs
