Assessment of Corrosion on Rail Axles

Abstract

Corrosion fatigue has been the reason for failure of rail axles in a number of accidents. This has led to stringent requirements to remove axles from service when corrosion is present. However the assessment of the corrosion is uncertain and mainly limited to a simple visual test which is heavily dependent on the inspector.

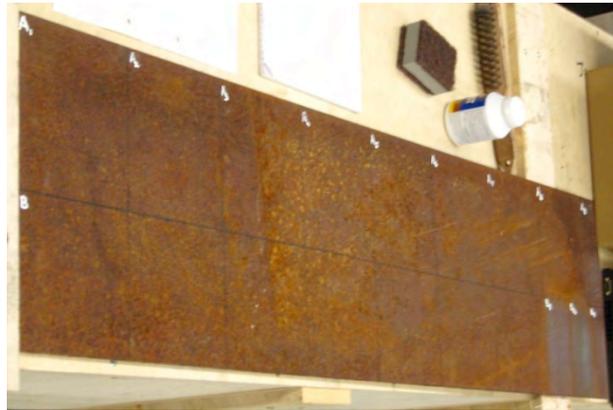
Figure 3. Heavily rusted plate

A series of tests were carried out on a heavily rusted plate to establish an optimum mechanical and chemical procedure for rust removal. Figure 3 displays the plate on which several rust removal technique were tried to establish the most convenient method to use with the microscope.

The mechanical procedure requires that a minimum of scratching occurs since scratches would be picked up clearly by the microscope and the cracks would not be visible. And the chemical removal must leave no residue in order to have a better image of the specimen's surface and a better image of potential cracks. The tests established a suitable procedure for this purposes.

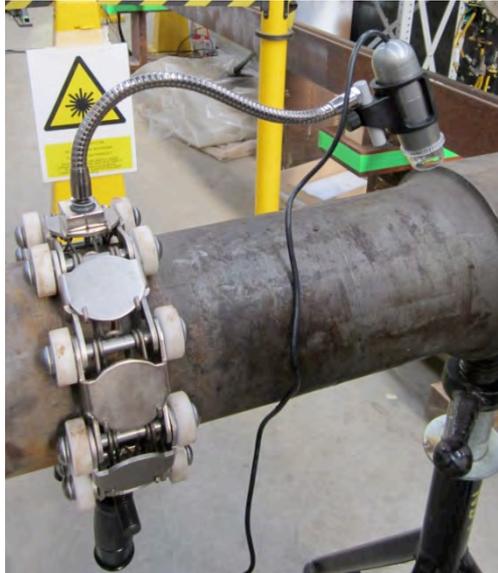
Figure 4. Support system of microscope on train axle

The positioning of the microscope above the sample needs to be assured and this was achieved using a belt system as shown in Figure 4. In order to acquire clear and exploitable images, the microscope needs to be normal to the specimen's surface. The cracks or other objects should be located at the centre of the image as to have the microscope focus on those features.

The belt allows as well the rotation of the microscope all around the axle whilst maintaining stability and height.
