# Unmanned Aerial Vehicle for Autonomous Non-Destructive Testing Inspections

Dayi Zhang  
9<sup>th</sup> April 2019

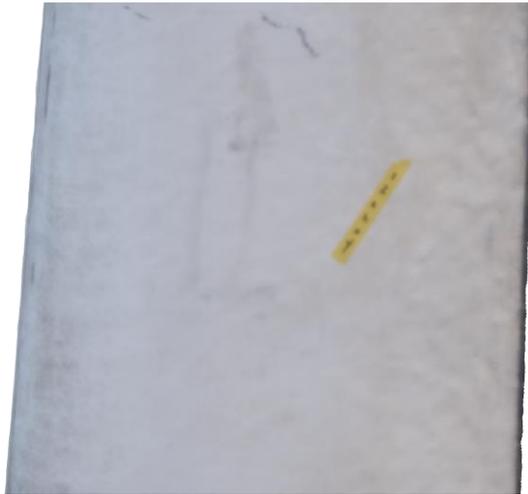
- We developed an autonomous UAV system to conduct:
  - Close-range photogrammetric inspections
  - Contact-based ultrasonic thickness measurements

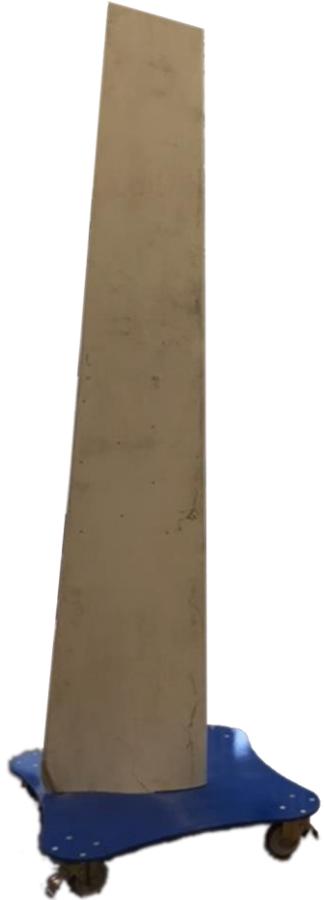
## Wind Turbine Blade

- 3.1m height
- 386mm wide (top); 619mm wide (bottom)
- Prior-prepared Surface

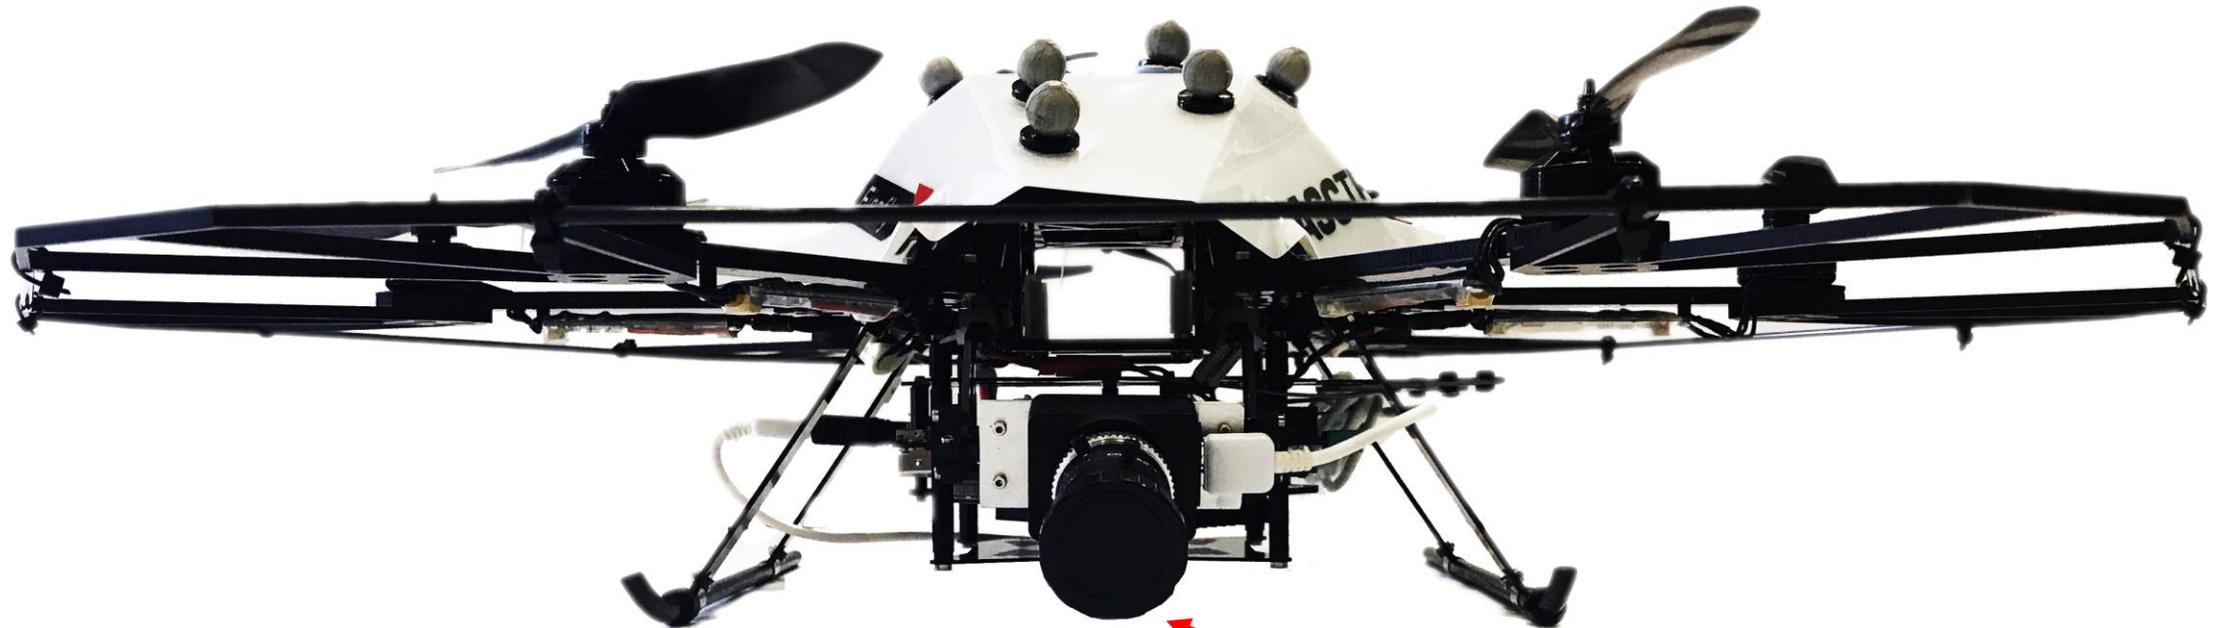
AscTec Firefly UAV

**5 MP Machine  
Vision Camera**

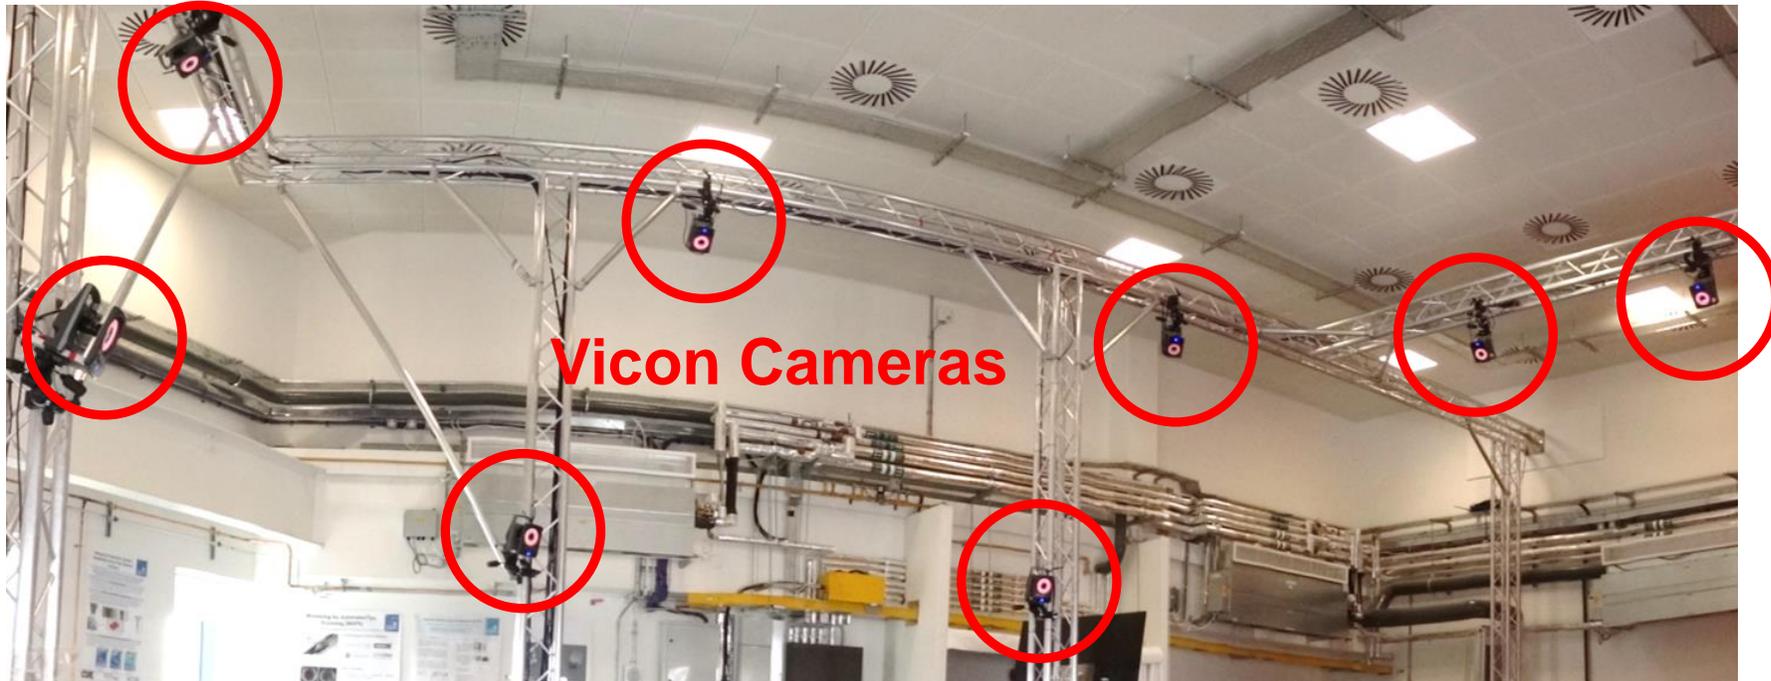
## Measurement Sensor - Vicon Tracking System

- 12 Vicon cameras mounted on the frame
- Vicon Tracking System provides position and orientation of the UAV (similar to GPS and accelerometer)

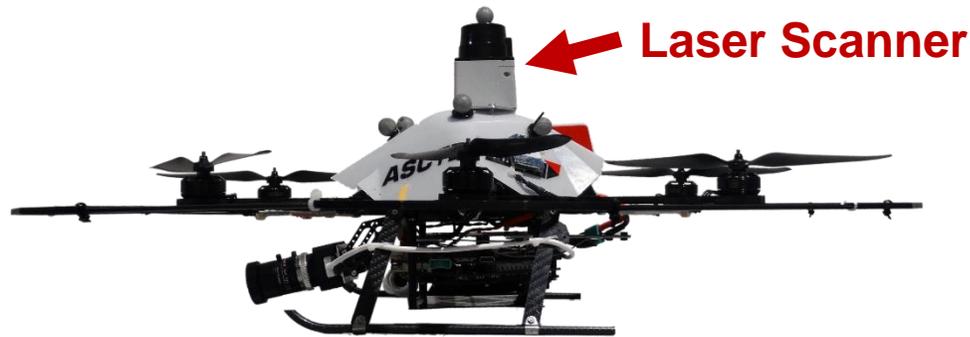
## Laser Maintained Standoff

- During the close-range inspections, camera depth of field is typically narrow (319.7 mm). Varying standoff can introduce focal blur and influence inspection accuracy.
- Hokuyo URG04-LX scanner on top of the UAV is utilised to map surroundings, maintain constant standoff during inspections.

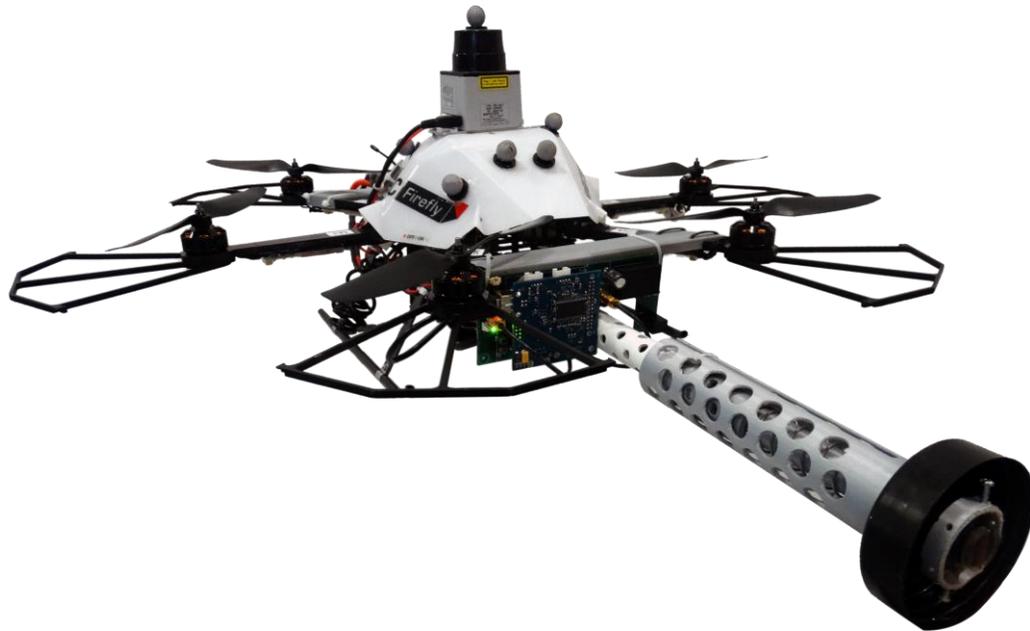
- To perform detailed and internal structural inspections, we developed an autonomous UAV system to deploy ultrasonic thickness measurement of a vertical aluminium sample.
