# INTERNATIONAL NDT

Phased array ultrasonics  
for enhanced evaluation and monitoring

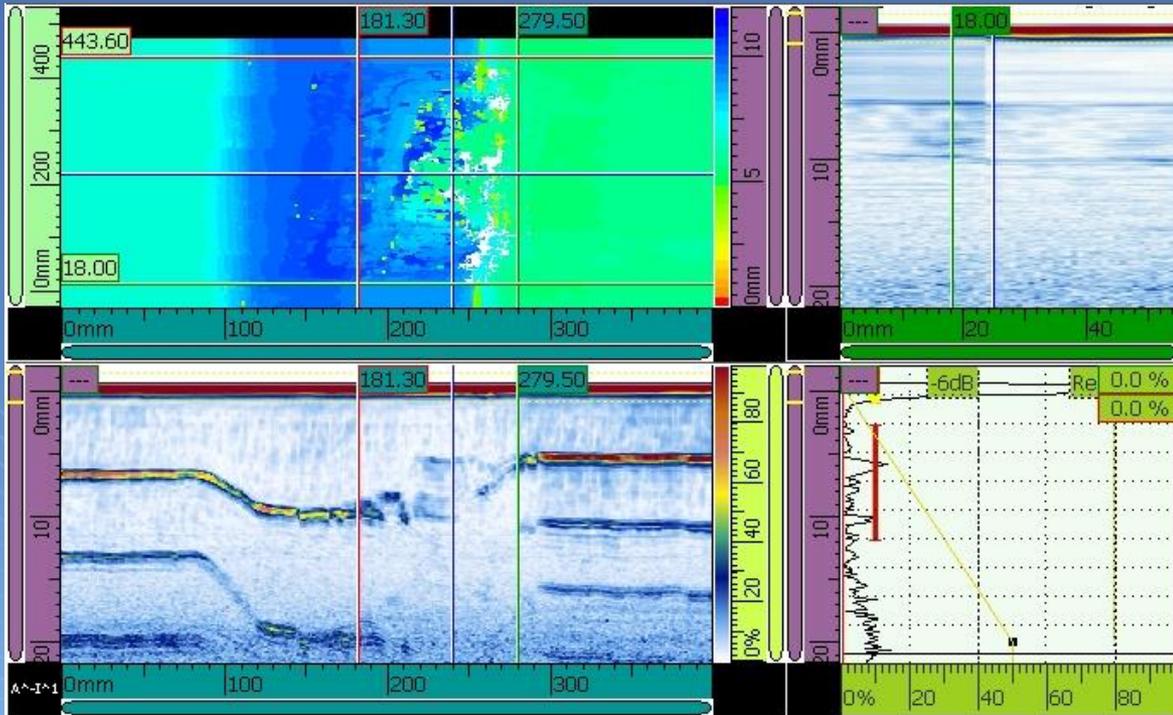
## Phased Array Ultrasonic - High quality monolithic CFRP

- C-scan recording

- Detailed analysis
- Advanced analysis
- Accurate sizing
- Repeatable

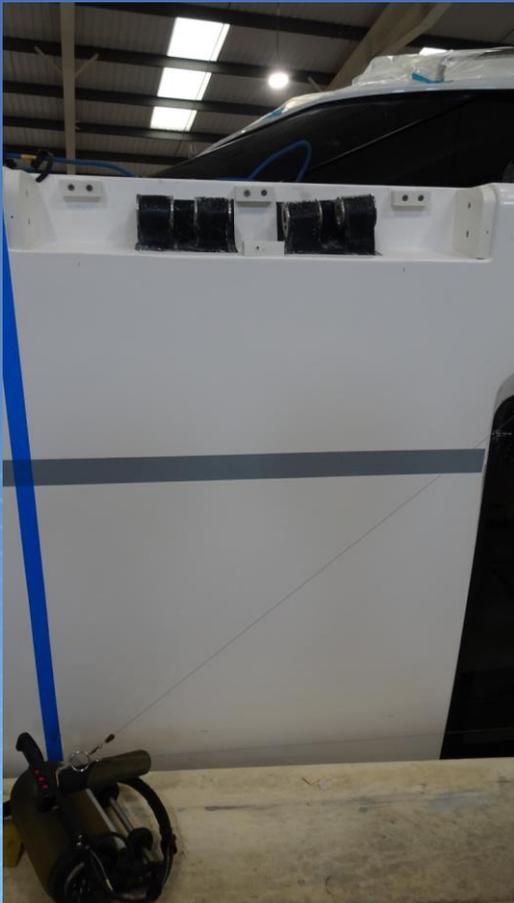
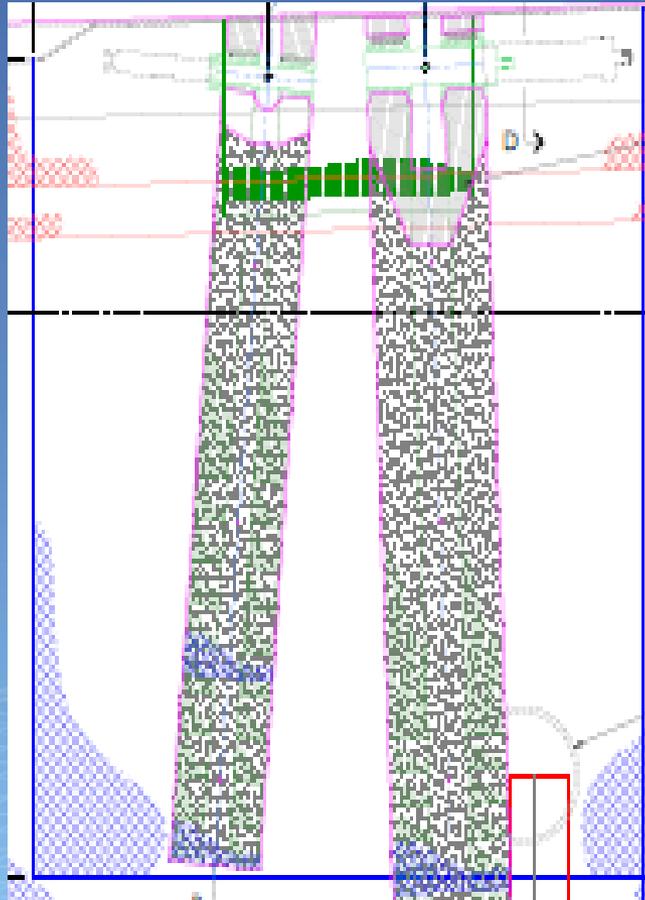
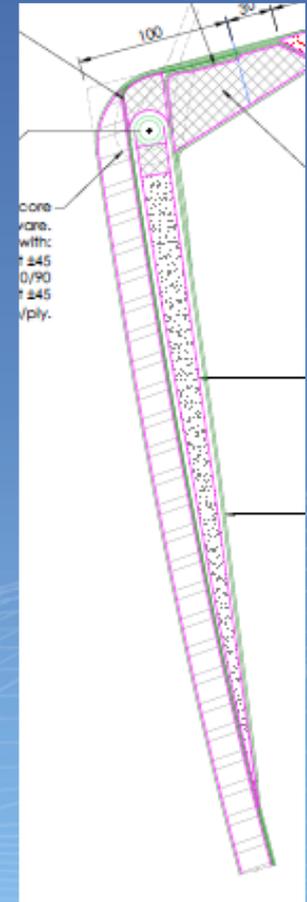
- Composite component – bonded and laminated into hull
- Mixed materials – GRP + CFRP + Foam + bonding

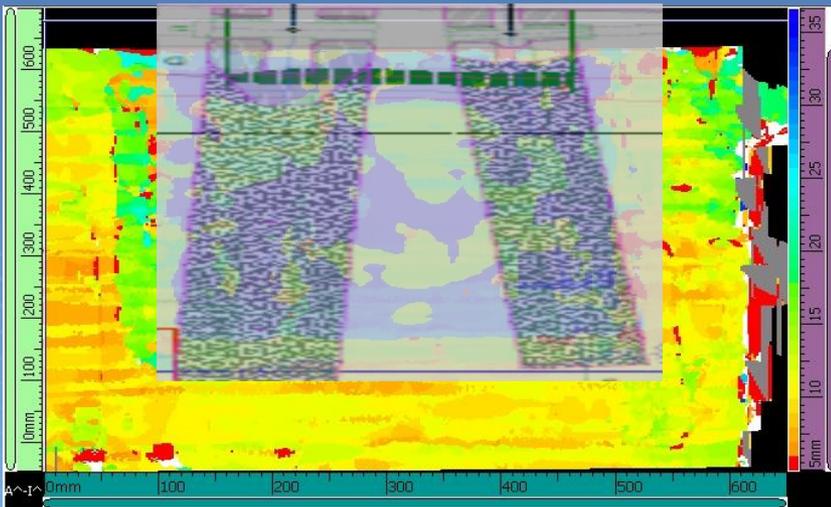
Starboard side

- Differences Port vs Starboard
- Monolithic skin thicknesses
  - Variability across main area

- Colours represent indications at varying depths
- Further analysis to determine position and classification

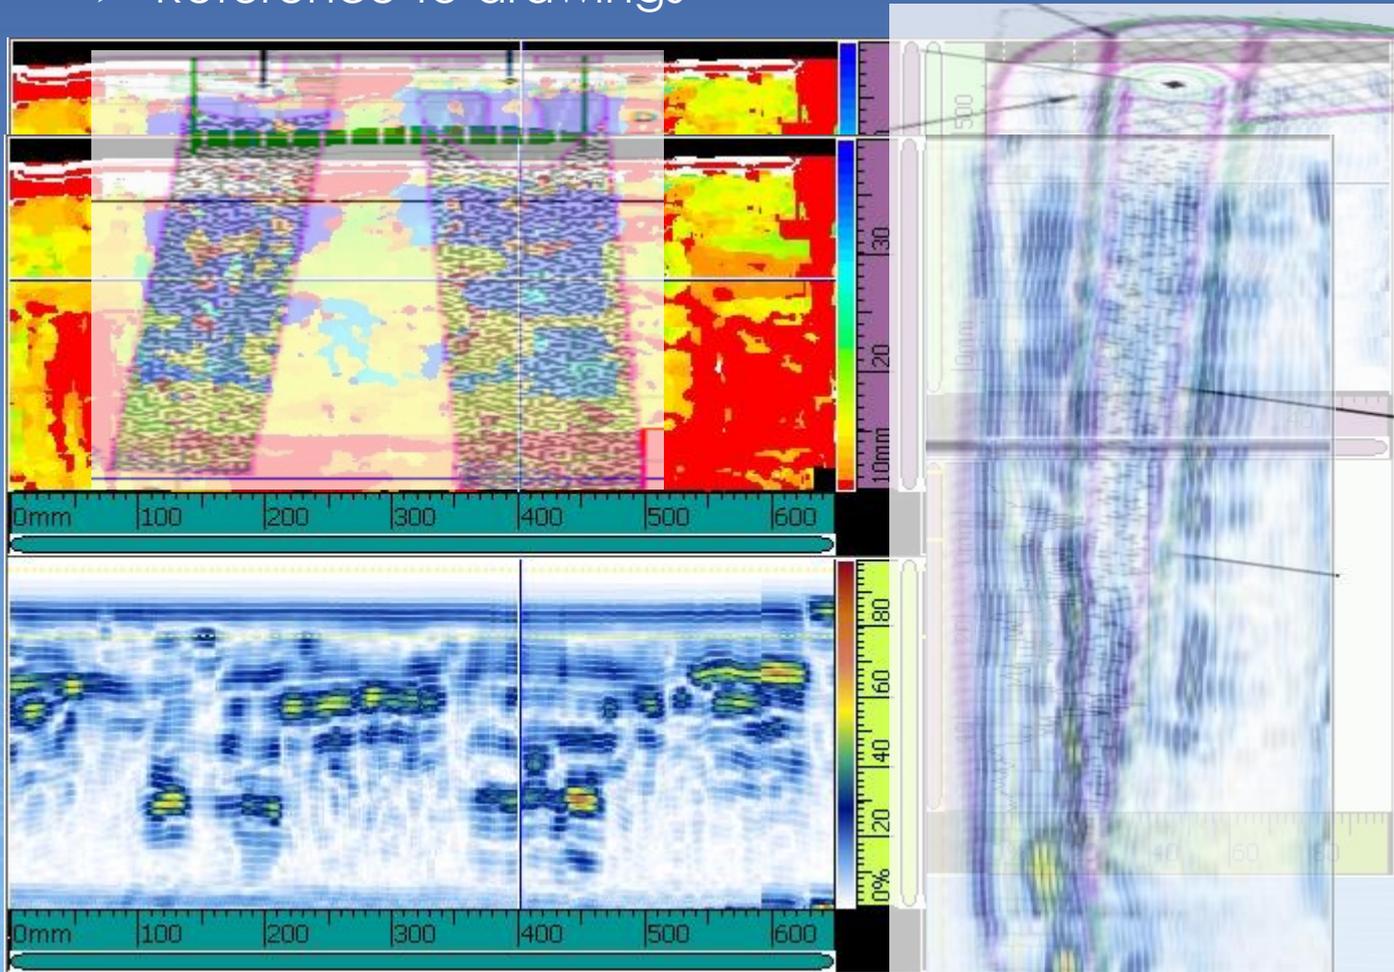
Further analysis

- Reference to drawings

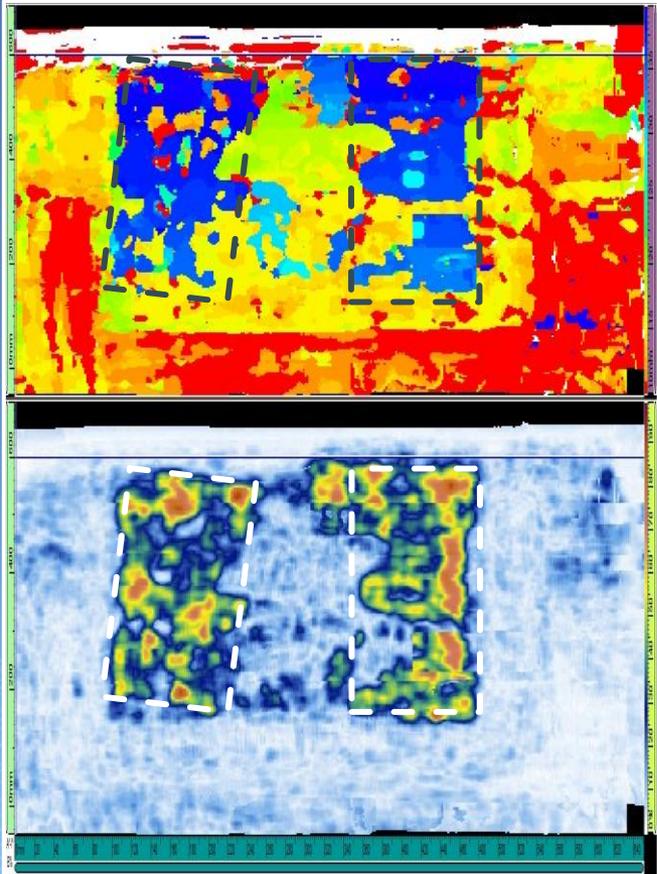
Blue – Full thickness through structure

Light blue – Far side former to QI infill interface

Green – Near side former to QI infill interface

Yellow – Skin tie to Chainplate structure interface

Red - Near surface (skin) indication

Orange – Strong amplitude response from full thickness

Blue – Moderate response from backwall

White – Very poor response from backwall indicating high impact of intermediate signals

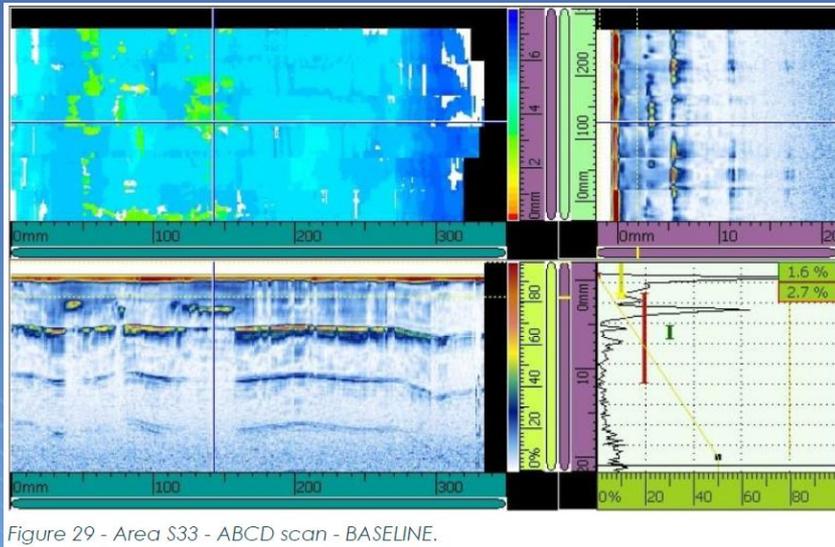
High modulus, pre-preg, autoclaved, monolithic CFRP

Figure 29 - Area S33 - ABCD scan - BASELINE.

1. Baseline Inspection
  - Complex indications
  - Assess scan images
  - Clustered voids on layer
  - Refer to OEM for analysis

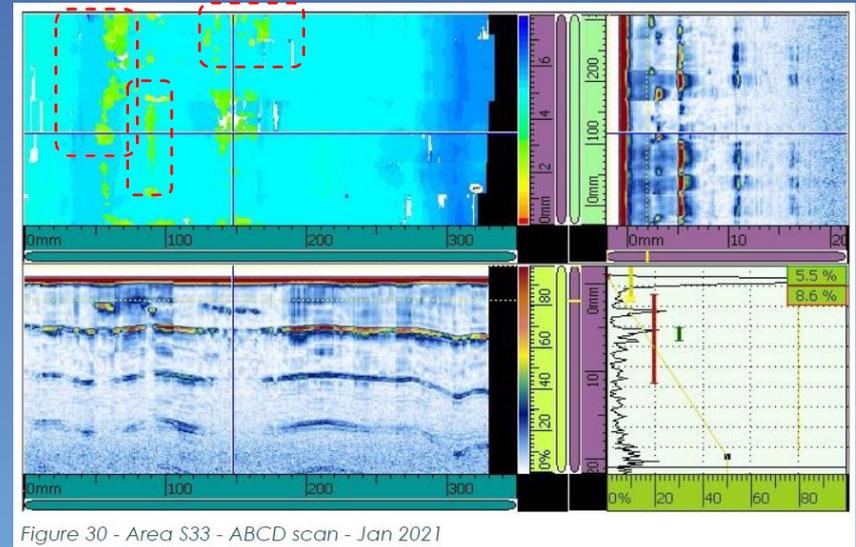
Figure 30 - Area S33 - ABCD scan - Jan 2021

2. Monitoring Inspection
  - Compare images
  - Growth/new indications
  - Refer to OEM for decision

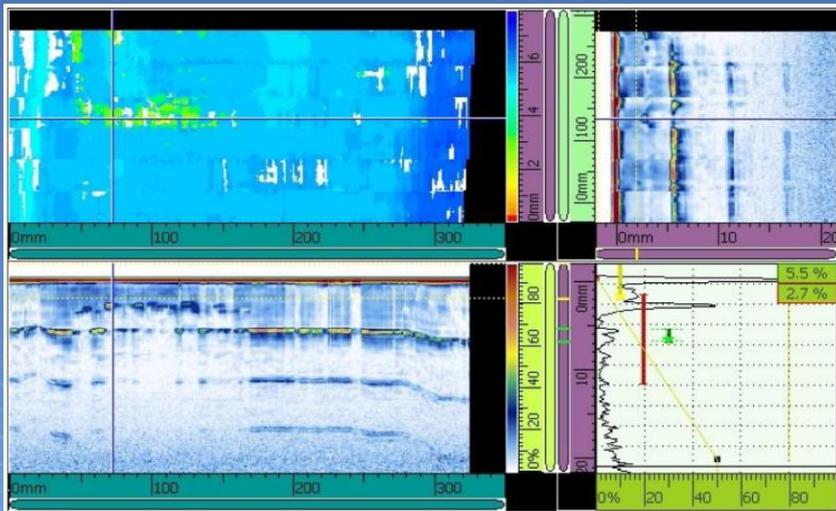
Figure 9 - Area P35 – ABCD scan - BASELINE.

- Some indications propagating
- Some indications stable
- Detailed information to OEM

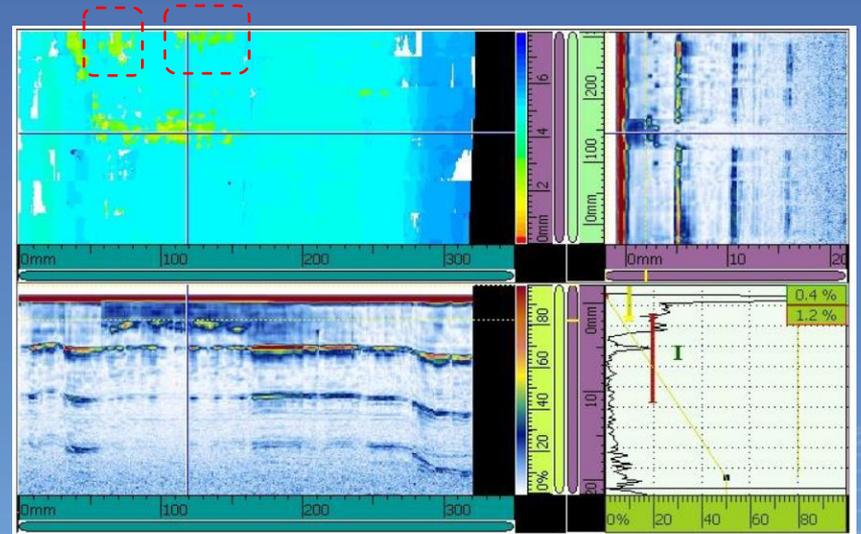
Figure 10 -- Area P35 – ABCD scan - Jan 2021

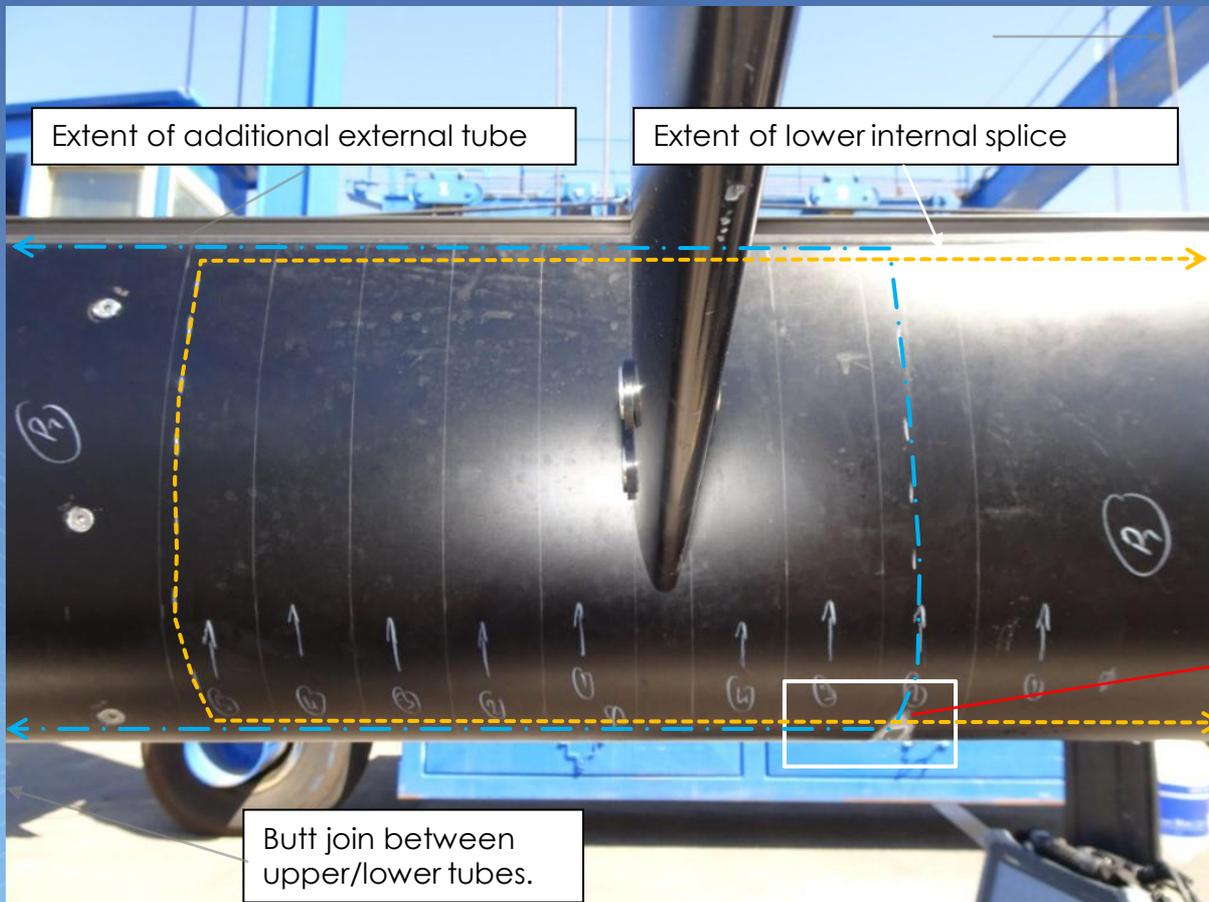
High quality monolithic CFRP tube

- Blind-bonded sleeve joint

- Lacking stiffness
- Leaking water
- Tricky construction
- One of several similar parts
- No other reported issues

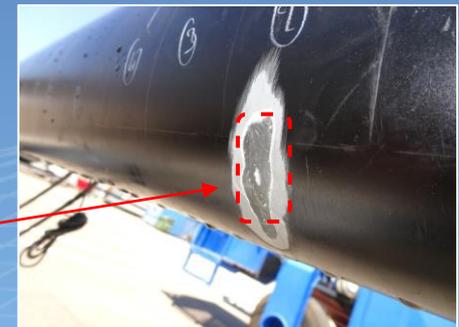
Figure 2 - Surface crack (ground back) where water leaks.

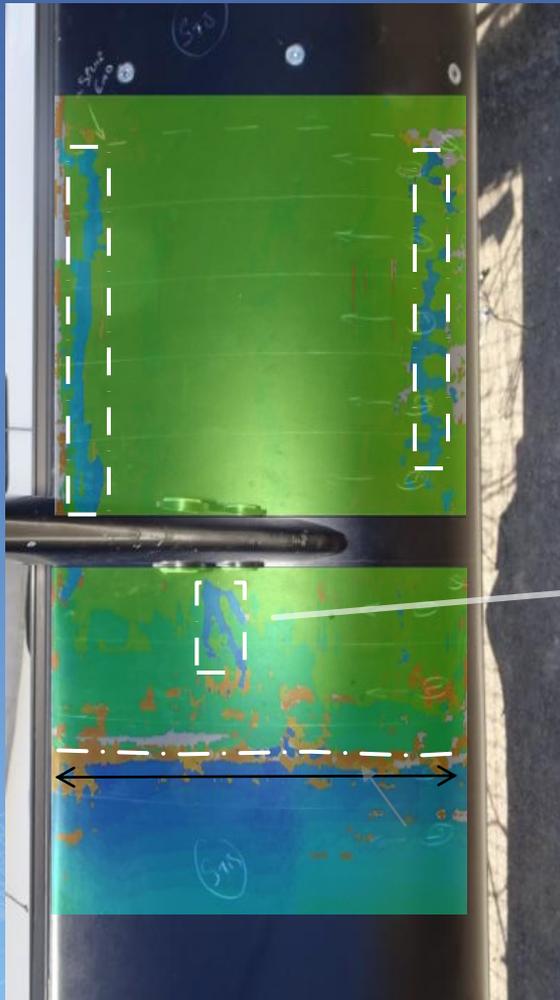
Mast A – Starboard side

- Detailed analysis
- Accurate sizing
- Comparison to existing
- Communicate findings
- Future comparison
