## **Report from the Workshop on NDT Requirements for Heritage Railway Boilers**

**13 February 2018**

**Alresford Goods Shed, Mid Hants Railway**

# Workshop on NDT Requirements for Heritage Railway Boilers

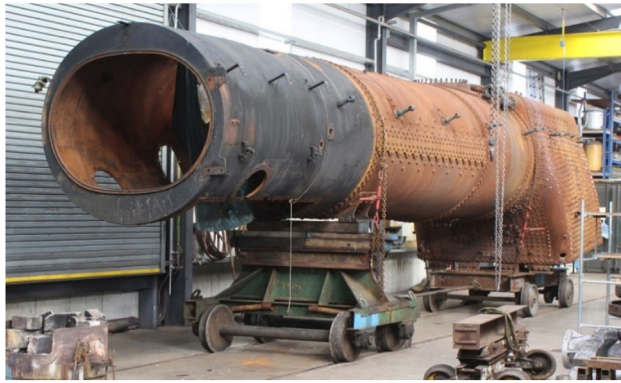
Figure 4. (a) Merchant Navy class boiler; and (b) sectioned Merchant Navy class locomotive at the National Railway Museum

While there are numerous types of defect that can affect a boiler, three main types will be concentrated on in this workshop: internal boiler corrosion (water side) in the firebox area, cracking and fracture of stays, cracking between stay bolts and grooving near to the foundation plate or at lap joints. Only steel fireboxes will be discussed, not copper, concentrating on the throatplate, outer firebox, backplate and the stays. While Figure 3 shows a simple firebox, the more complex type shown in Figure 4 is the focus of this discussion and contains the same problem areas.

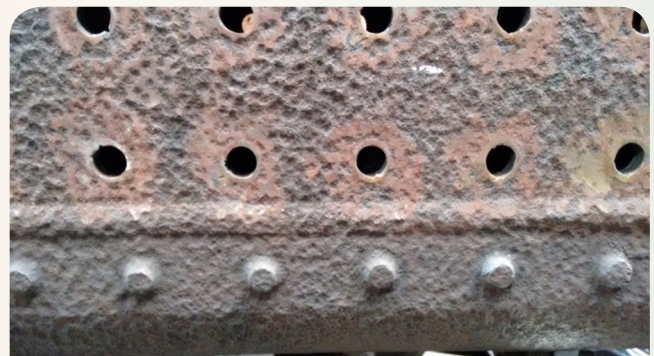
Figure 8. Exterior corrosion making ultrasonic coupling difficult

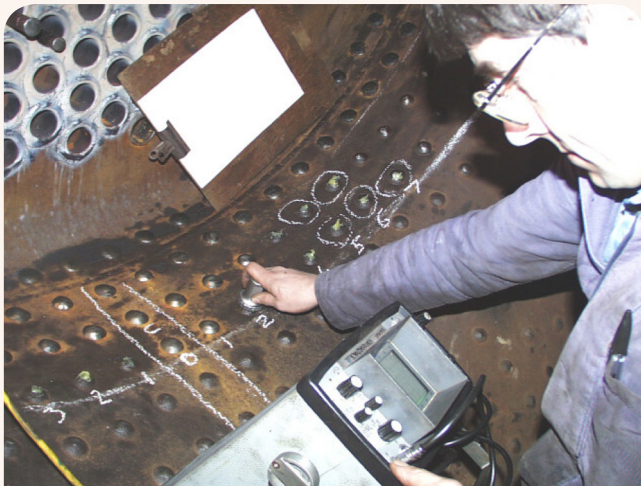
Figure 12. Ultrasonic testing of stays after surface preparation

Recently, ultrasound has been used on both steel and copper stays (Figure 12) but the process is painfully slow because of the surface preparation required. Interpretation of the ultrasound response is crucial and false calls are costly because the boiler lagging then needs to be removed. Therefore, well trained and qualified staff are required. However, washout intervals are too short to employ NDT technicians, so training of in-house personnel is required. (Note: This could be an NDT 'Level 1 limited' activity where people are trained on a very limited number of inspections.)

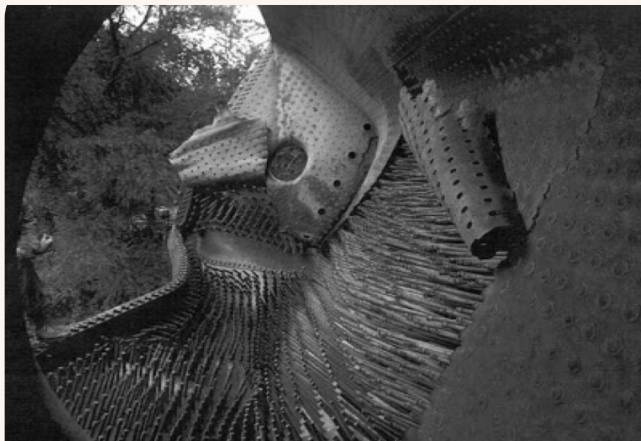
Figure 13. A firebox after a boiler explosion in the USA

causing them to also fail; consequently, an avalanche effect can be created causing bulging of the flat plates until the load tears off the plate from the supporting stays, which is what led to the boiler explosion in Figure 13. Therefore, broken stays need to be detected early and cannot wait until the annual, five-year or ten-year examinations. Increasing the reliability of NDT methods would increase confidence in the map of broken stays and may reduce the costly replacement of stays between out-of-frame maintenance periods.

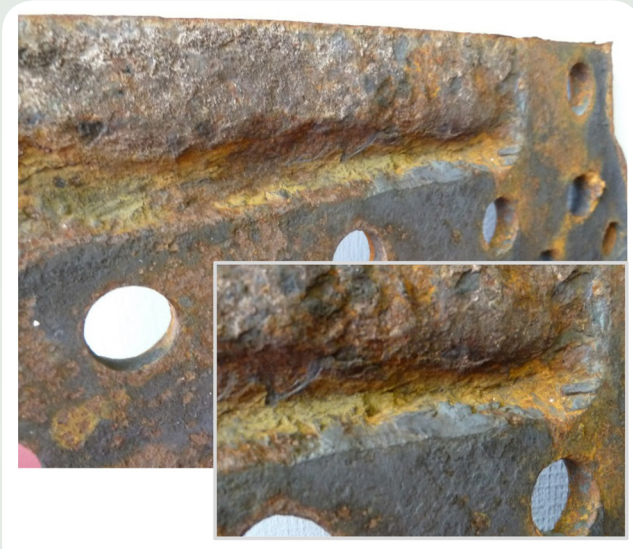
Figure 15. Grooving above the foundation ring on an 80-year-old outer firebox

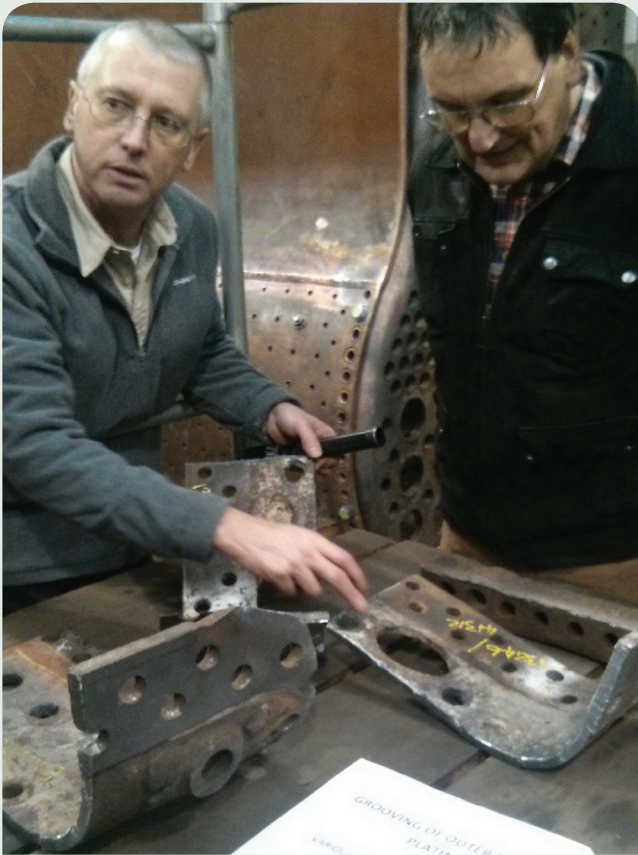
Figure 19. Andy Netherwood (left) explaining the evolution of grooving in the outer firebox

- HRA guidance notes – NDT needs to be included and there is not enough detail on problem areas.
- Grooving (Figure 19) appears to be a function of the boiler design, operating conditions and maintenance history. There is a need to establish the extent and monitor it over years to determine the rate of metal loss.
