Composite NDT Requirements in Sports Cars

Workshop on NDT Requirements for Automotive Composites

Jan Olav Endrerud
CEO DolphiTech
janolav@dolphitech.com
+47 90150293

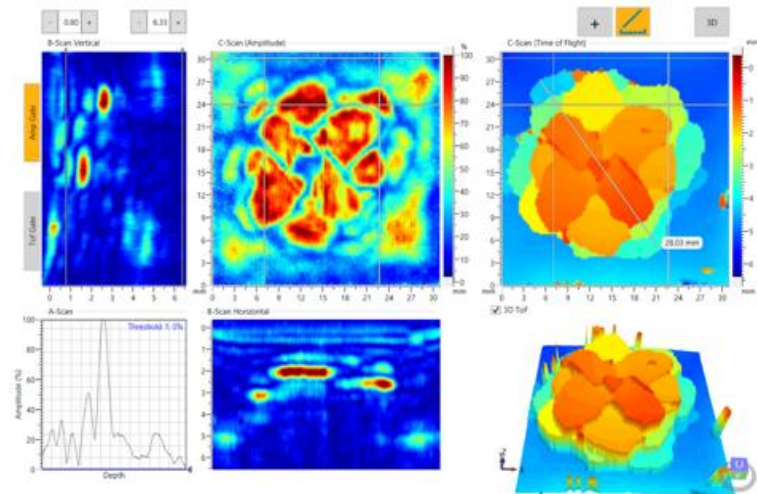
Impact damage

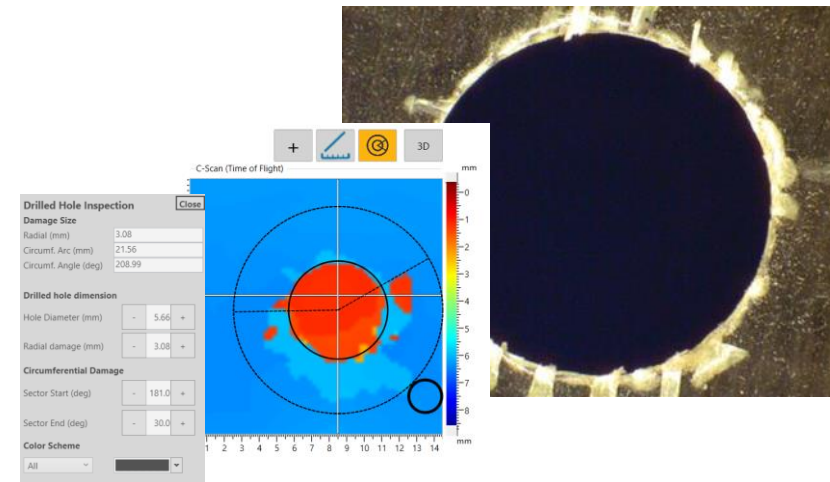
Drilled hole delamination

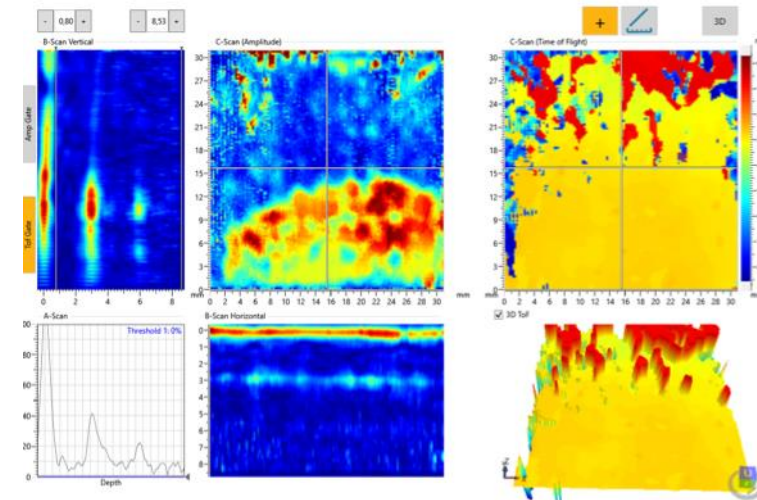
Bond line

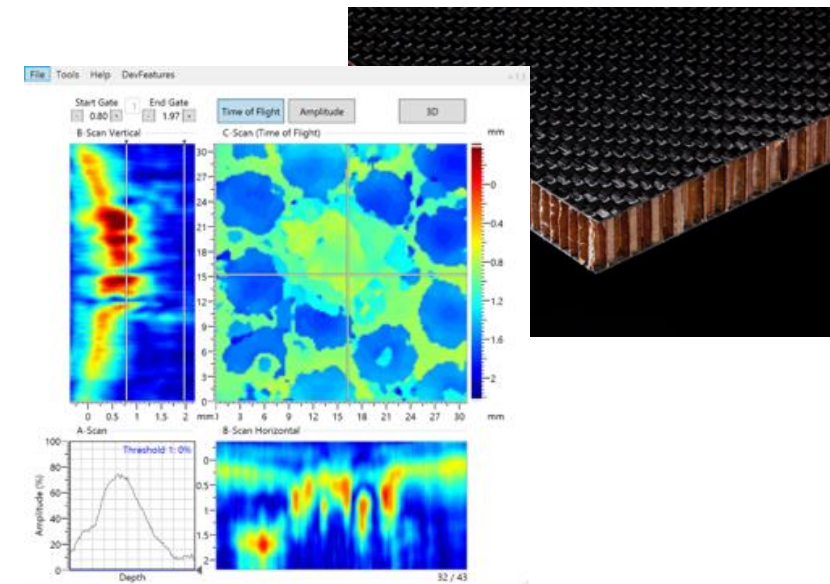
Laminate to core disbond

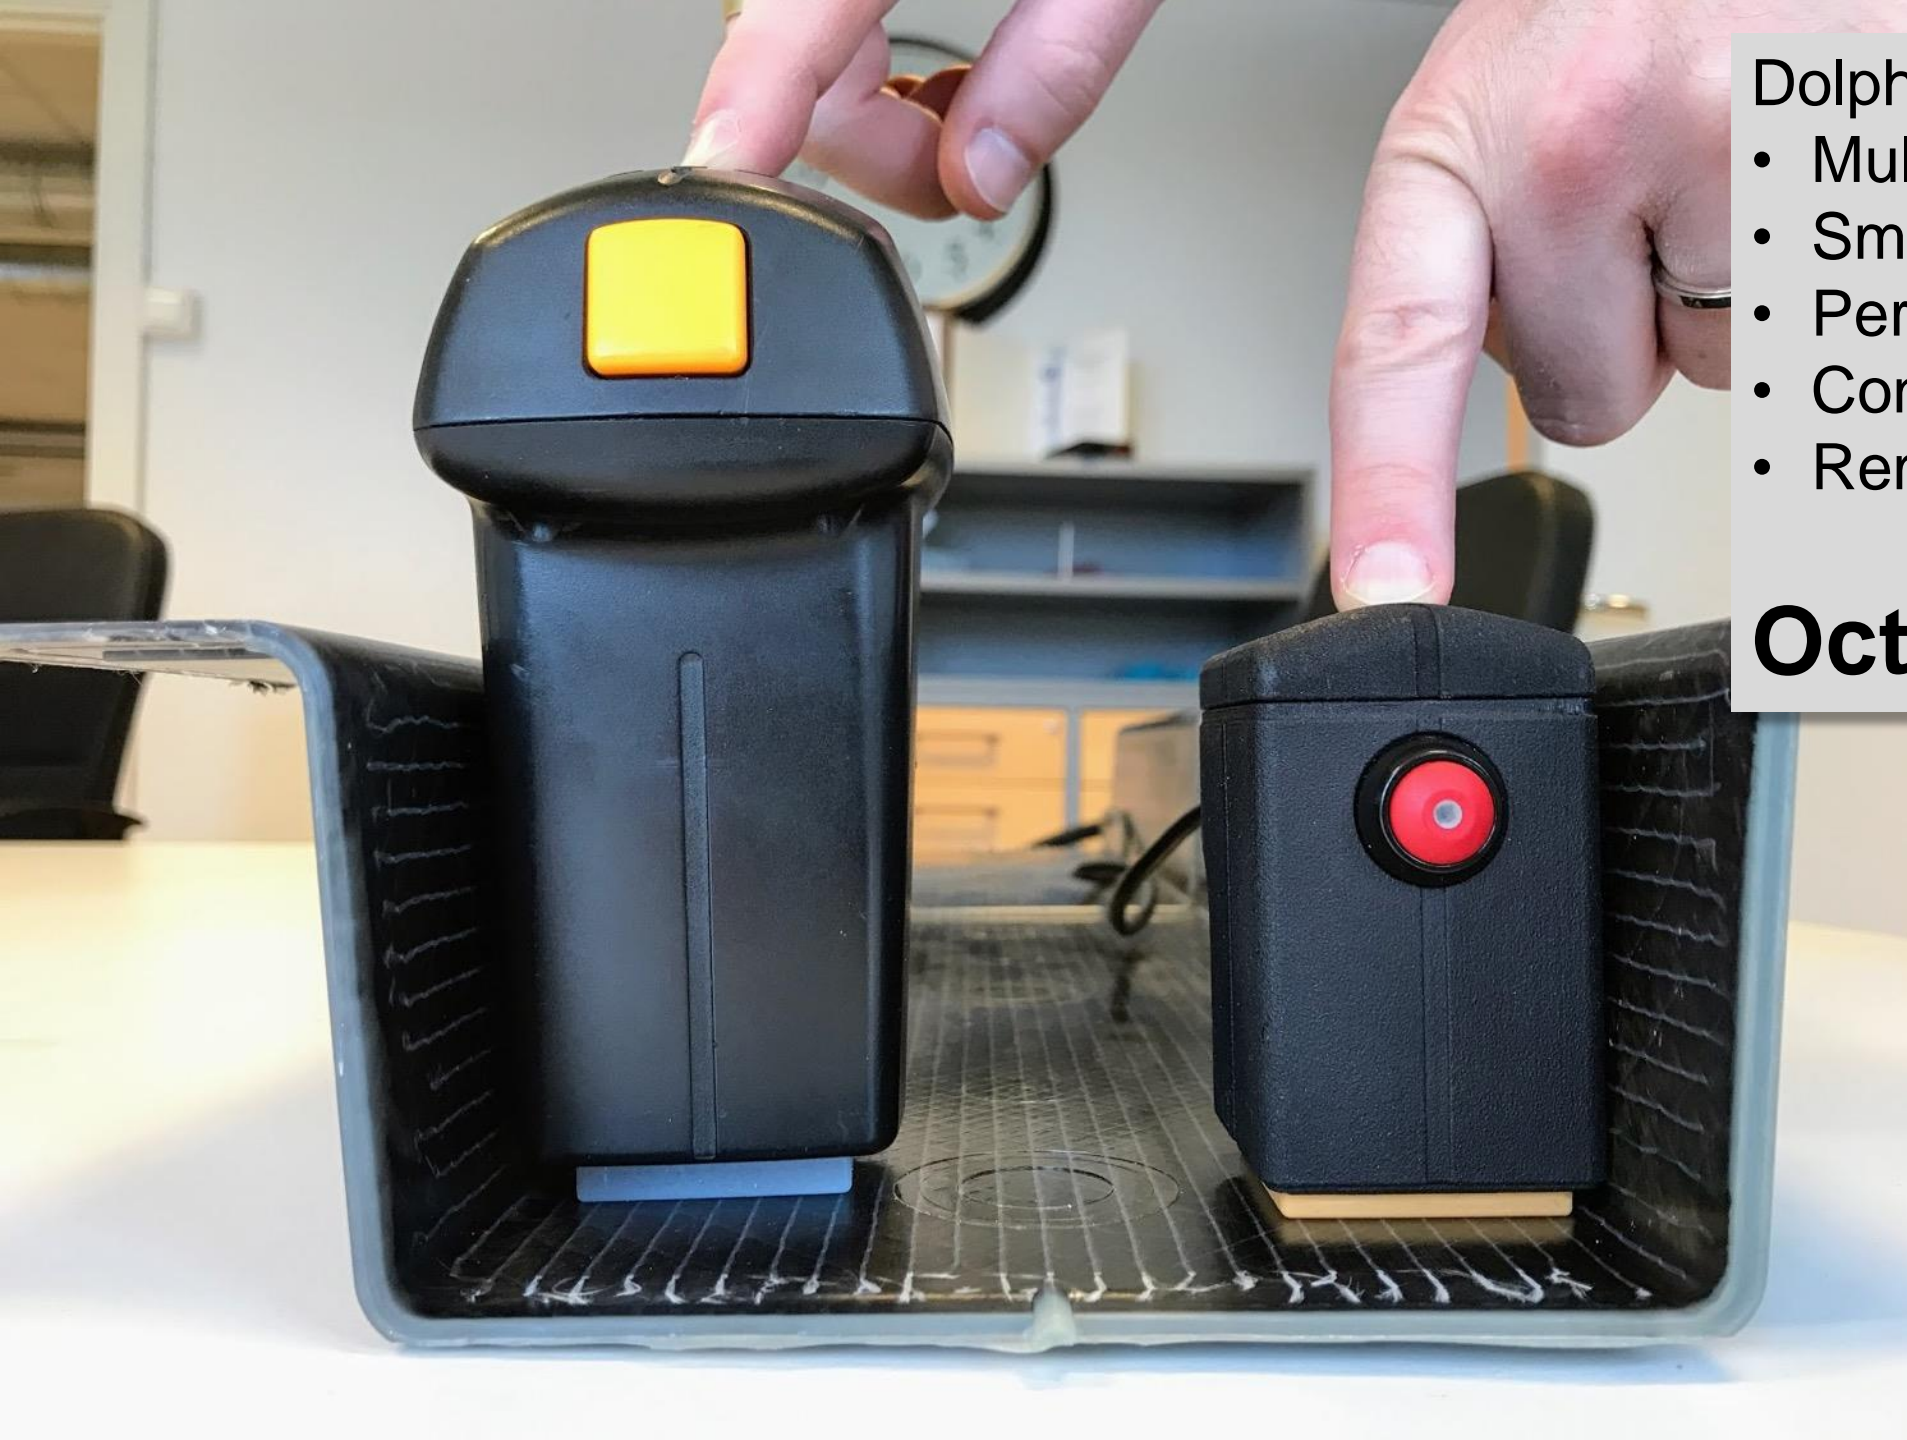
DolphiCam II

- Multimaterial
- Smaller footprint
- Performance
- Connectivity
- Remote NDT

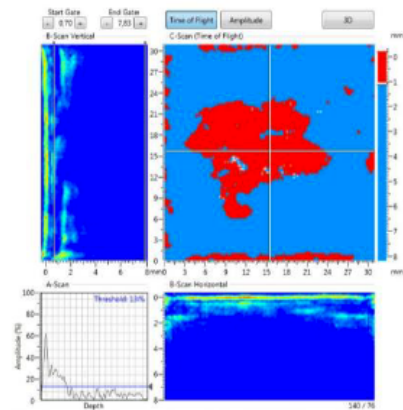
▼ *local delamination after an impact-accident*

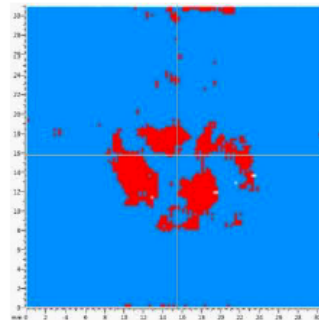
▲ *porosities of structural cfrp-parts*

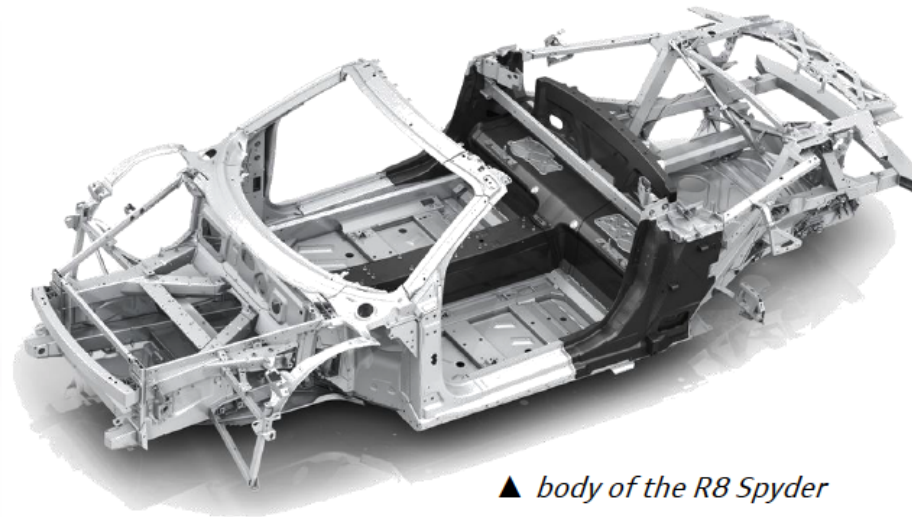
▲ *body of the R8 Spyder*

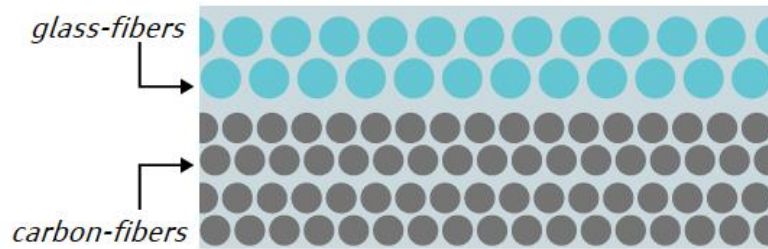
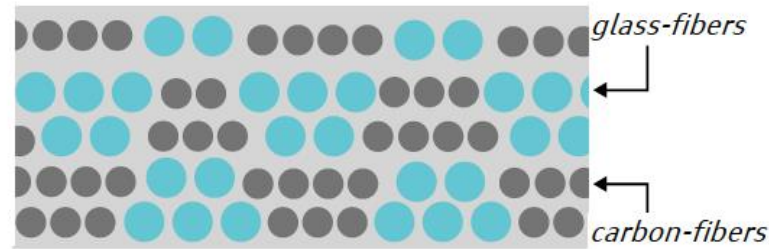
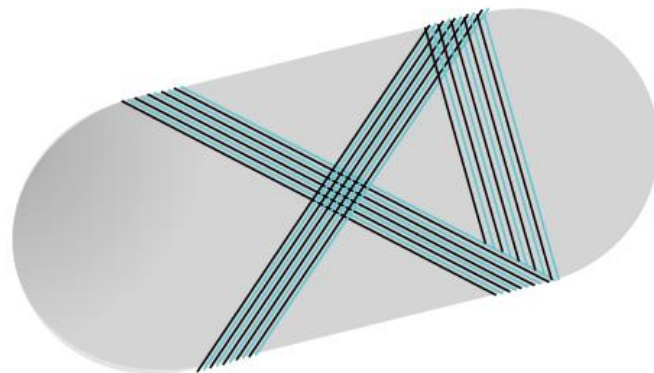
- Ultrasound inspection on structural FRP-Parts with an multi-fibre-mix like glass/carbon
 - e.g. Type 4 CNG-Tanks after ECE R 110
 - different Types of Composites and thicknesses up to 25mm
 - pole winding surface of the composite

▲ *single CNG-Tank*

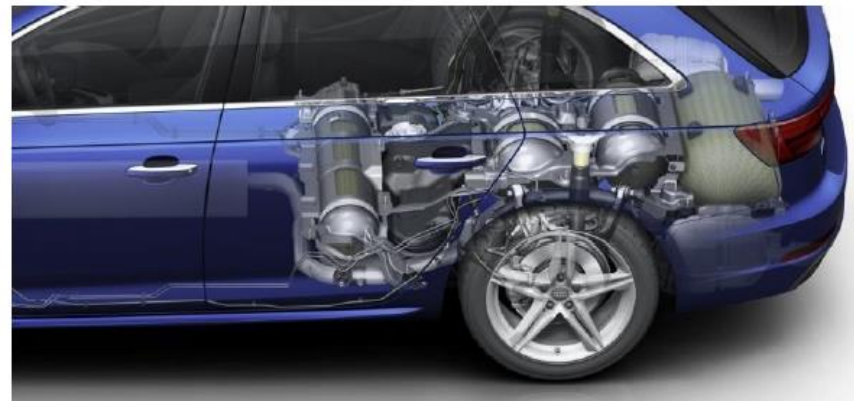
▲ *CNG-unit of Audi A4*

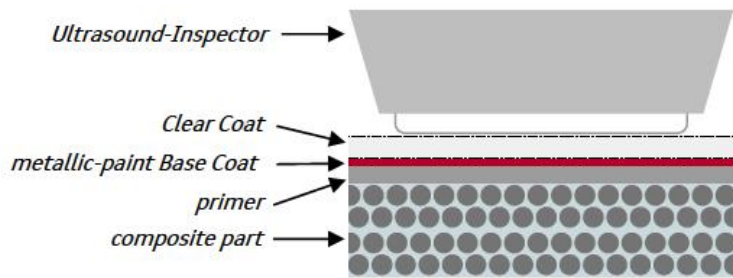
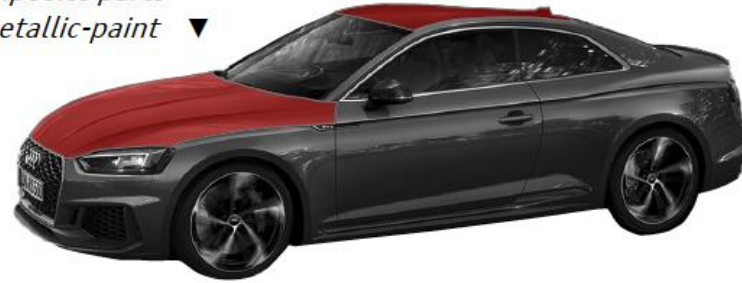
*possible composite parts
with metallic-paint ▼*

- › current situation: metallic-paint Base Coat is blocking the Ultrasound-Signal
- › inspection of the composite with Ultrasound is not possible

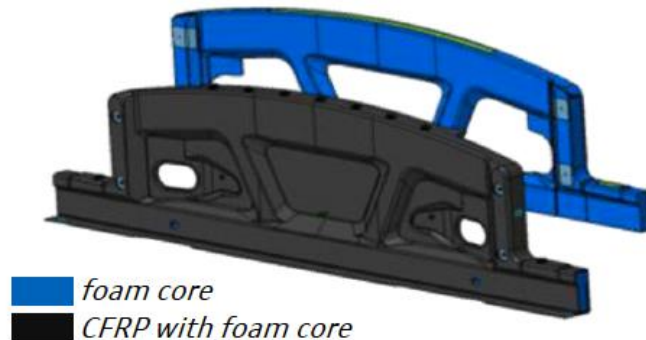
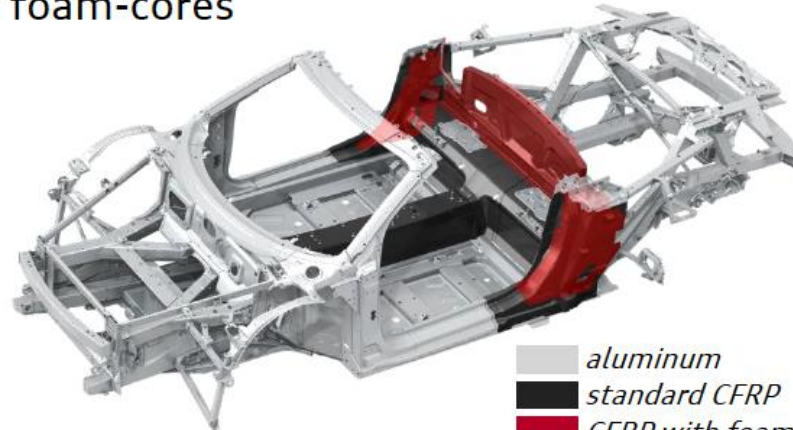
› Inspection of complex CFRP-Parts with foam-cores

aluminum
standard CFRP
CFRP with foam core
