# Optical Marine Composite NDT to determine defects and residual life in a structure

John R Tyrer

Professor of Optical Instrumentation  
Department of Mechanical Engineering  
Loughborough University &  
Laser Optical Engineering Ltd

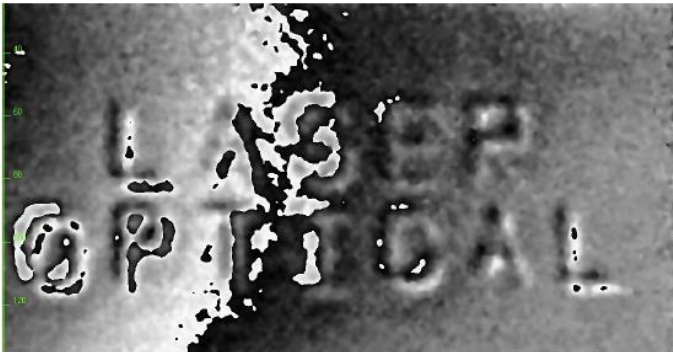
Shearography image:  
Resin enriched detail  
In composite panel

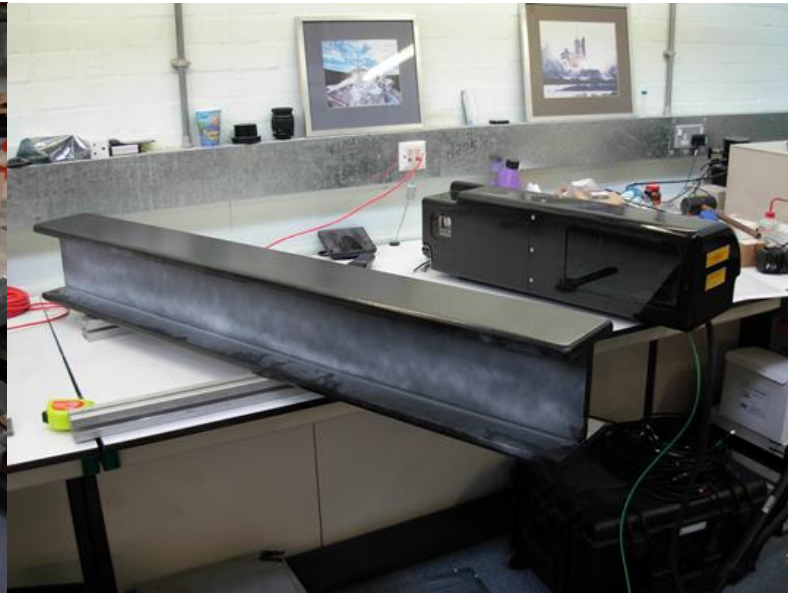
# Manufacturing a composite beam with suitable resin enrichment

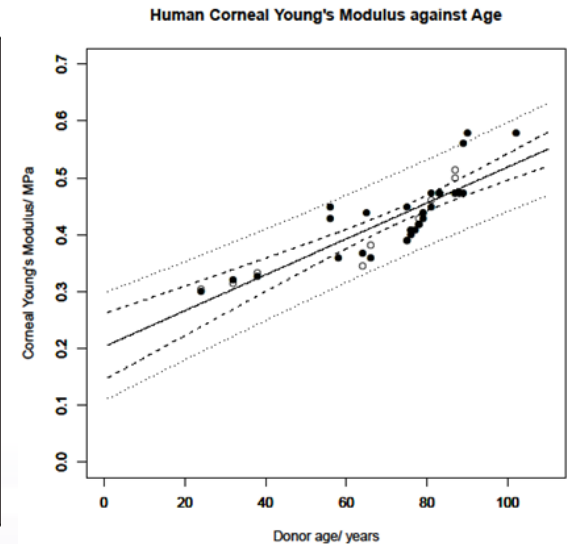
Age related stiffening of the cornea

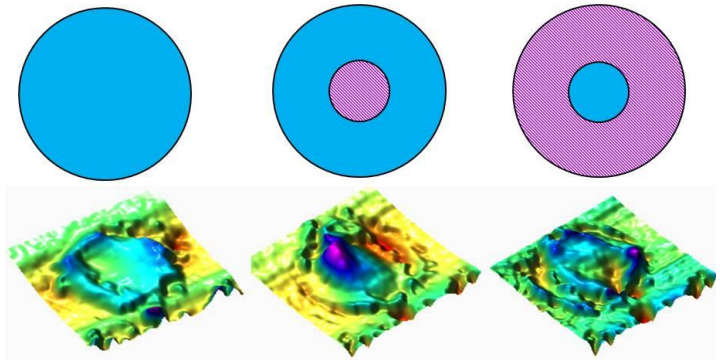
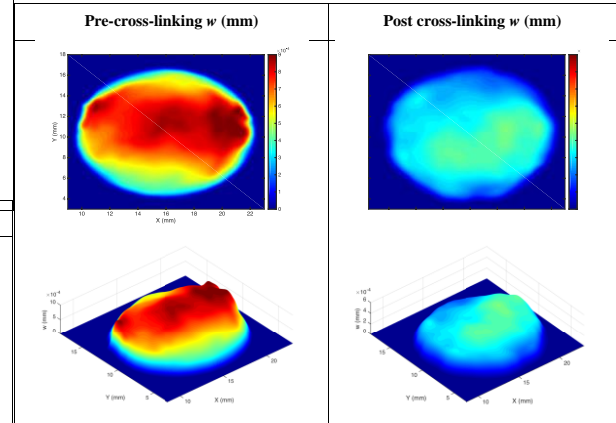
# Non-surgical structural changes to the cornea

Central and annular ring cross linking

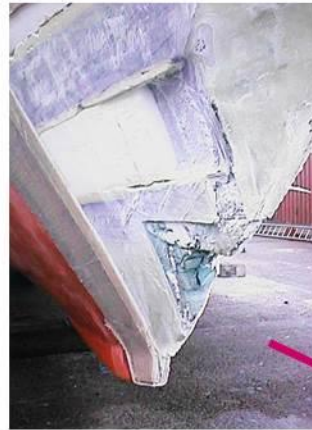
- Operational Damage

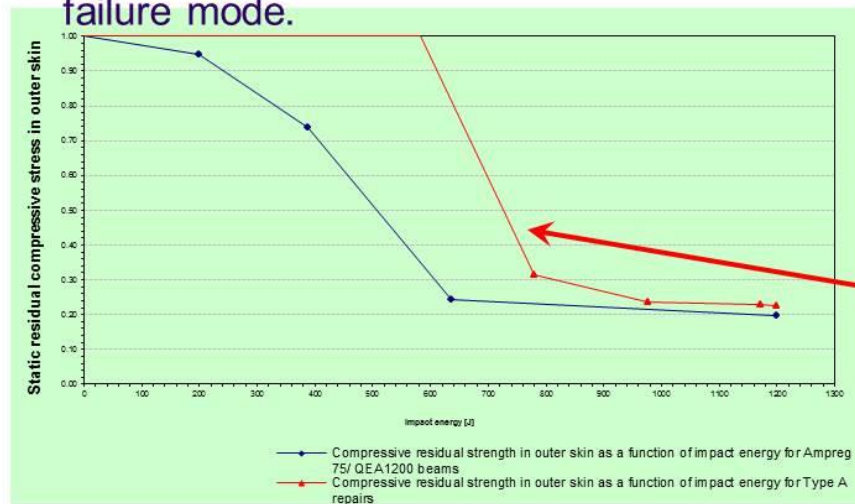
- Four-point bending test used to evaluate the static and fatigue performance of (1) Pristine beams, (2) Beams with structural repairs, and (3) Beams with damaged structural repairs
- In the pristine and repaired beams, core shear is the dominate failure mode.
- In the damaged beams and damage repaired beams, outer skin buckling was the dominate failure mode.

Rapid decline of compressive strength of both the virgin beam and the damaged repair beams (to buckling load). However, it appears that the repair is more damage tolerant than the virgin beam.

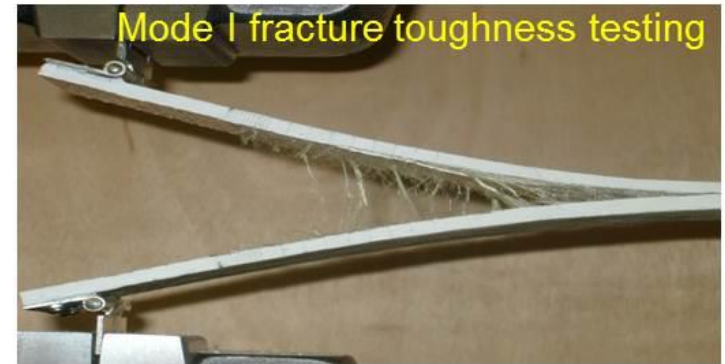
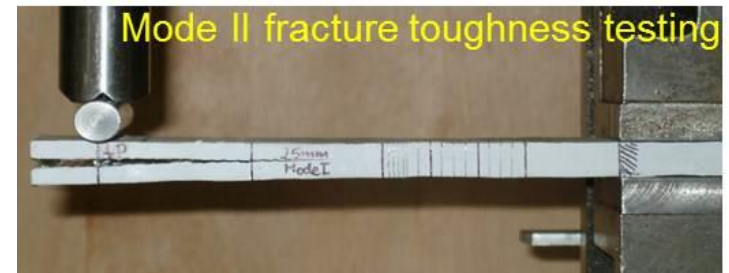
Experimental fracture toughness assessment using different mixed-mode fracture toughness ratios

Determination of the energy threshold required for the formation of delamination damage in the repair interface, the repair and parent laminates.

The repair laminate requires the greatest energy to 'drive' the crack, i.e. it is the most damage tolerant.

The parent laminate is the least damage tolerant.

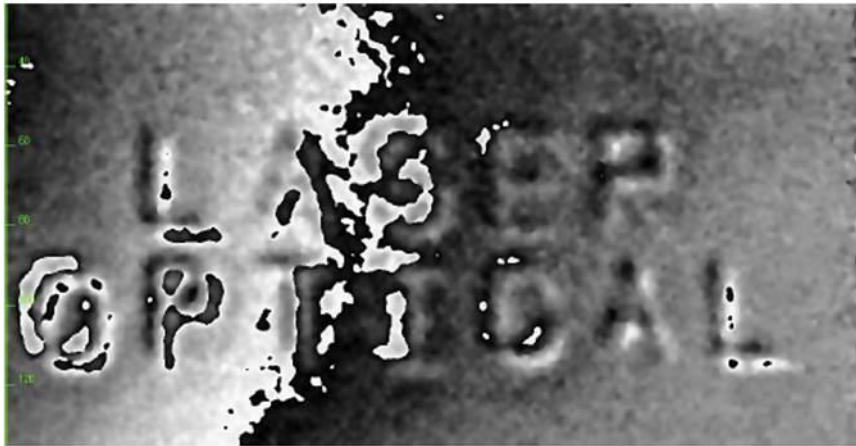
# Results: manufacturing defects – resin enrichment

Wrapped image:  
Resin enriched

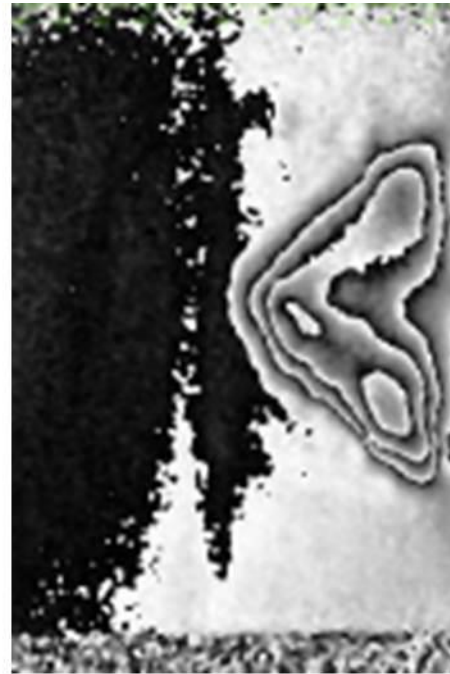
Wrapped image:  
Resin enriched

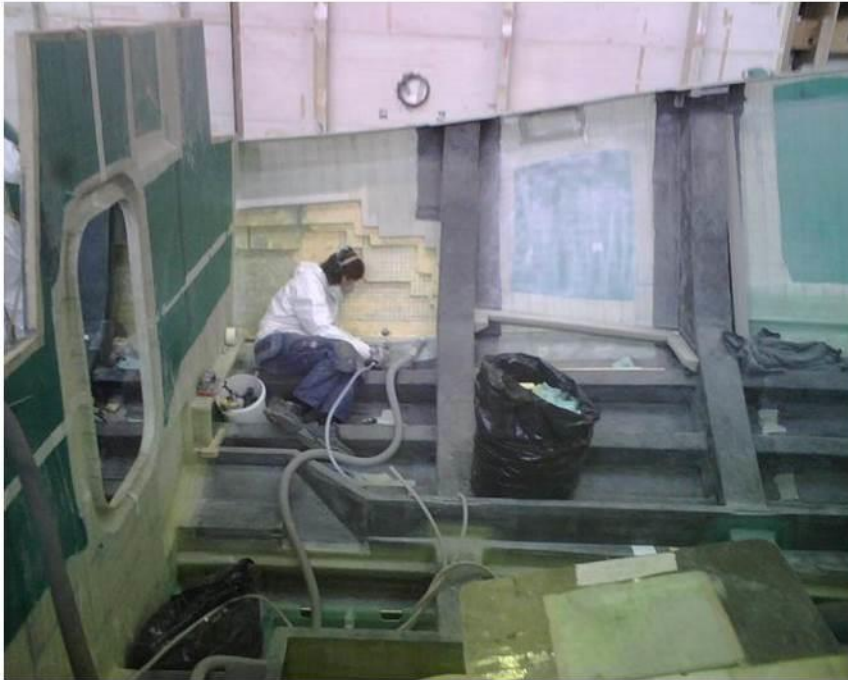
Internals of a Tamar being removed after defect found from the outside, goes either side of the bulkhead

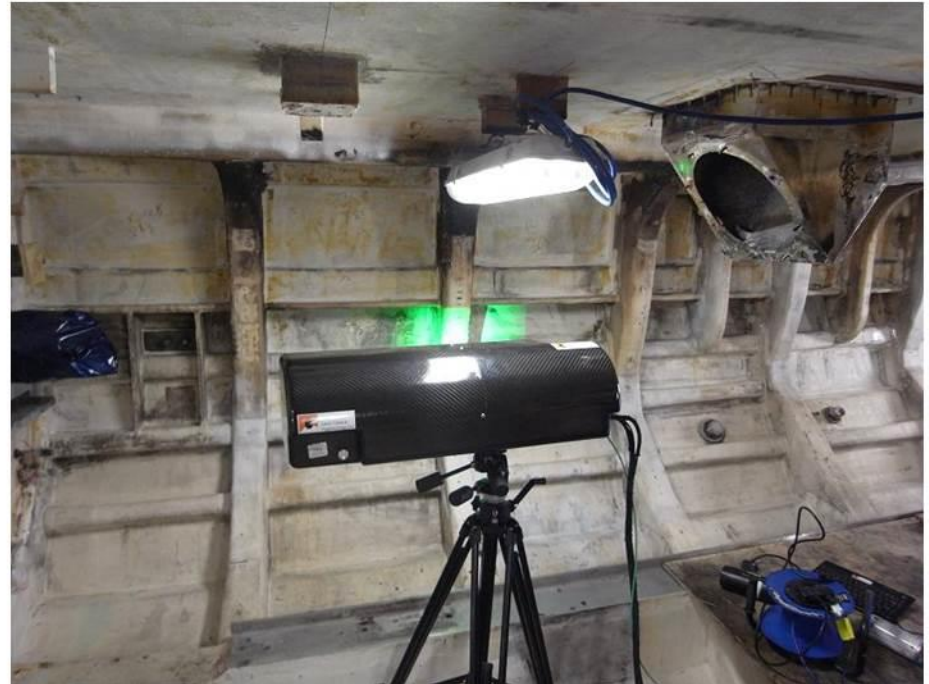
Internals of a pilot boat that had a fire in the engine room and the automatic fire prevention system didn't kick in.

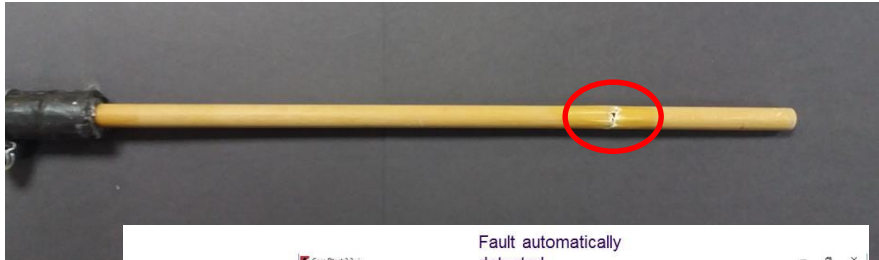
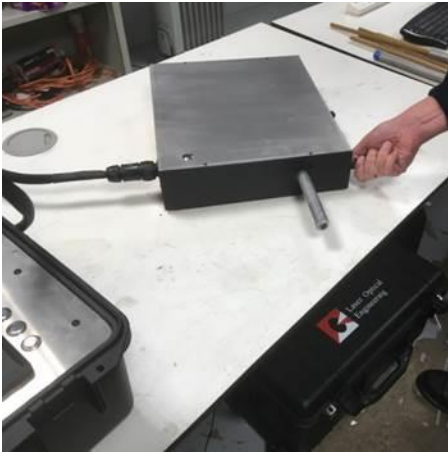
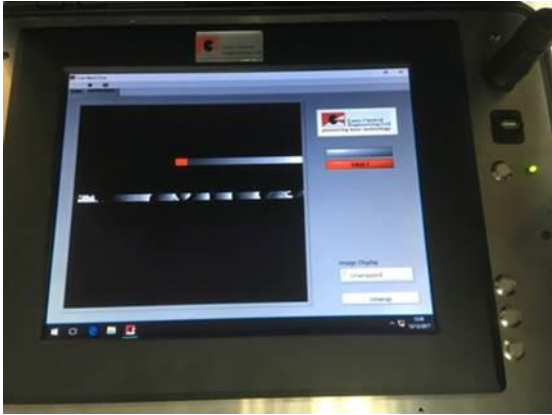
# Fully Automatic Solid Carbon Cable NDT
