# *NDT Requirements* **Workshop**

## **Report from the Workshop on NDT Requirements for Heritage Railway Boilers**

**13 February 2018**

# Workshop on NDT Requirements for Heritage Railway Boilers

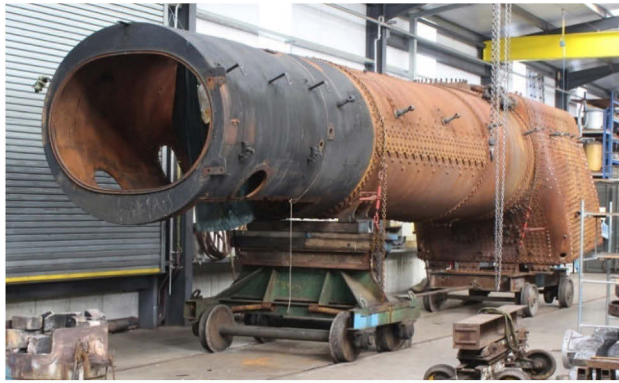
Figure 4. (a) Merchant Navy class boiler; and (b) sectioned Merchant Navy class locomotive at the National Railway Museum

While there are numerous types of defect that can affect a boiler, three main types will be concentrated on in this workshop: internal boiler corrosion (water side) in the firebox area, cracking and fracture of stays, cracking between stay bolts and grooving near to the foundation plate or at lap joints. Only steel fireboxes will be discussed, not copper, concentrating on the throatplate, outer firebox, backplate and the stays. While Figure 3 shows a simple firebox, the more complex type shown in Figure 4 is the focus of this discussion and contains the same problem areas.

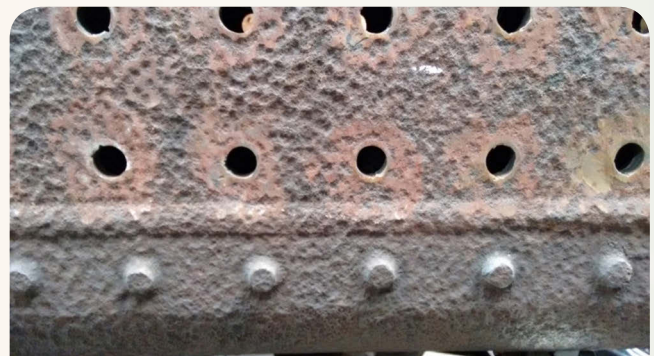
Figure 8. Exterior corrosion making ultrasonic coupling difficult

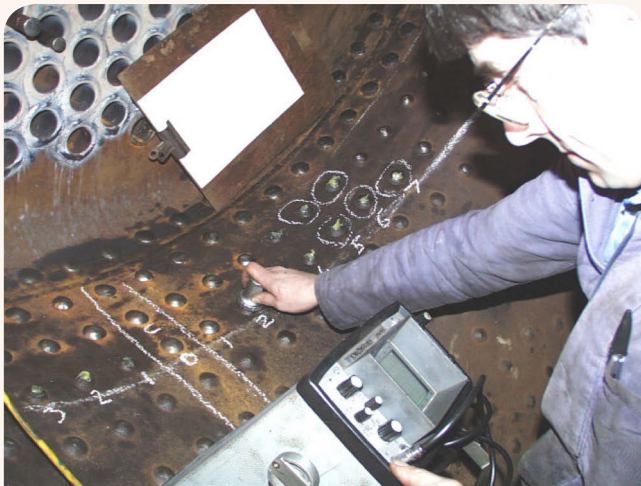
Figure 12. Ultrasonic testing of stays after surface preparation

Recently, ultrasound has been used on both steel and copper stays (Figure 12) but the process is painfully slow because of the surface preparation required. Interpretation of the ultrasound response is crucial and false calls are costly because the boiler lagging then needs to be removed. Therefore, well trained and qualified staff are required. However, washout intervals are too short to employ NDT technicians, so training of in-house personnel is required. (Note: This could be an NDT 'Level 1 limited' activity where people are trained on a very limited number of inspections.)

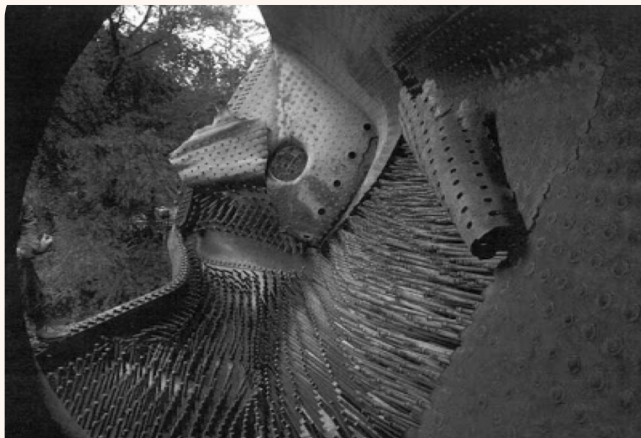
Figure 13. A firebox after a boiler explosion in the USA

causing them to also fail; consequently, an avalanche effect can be created causing bulging of the flat plates until the load tears off the plate from the supporting stays, which is what led to the boiler explosion in Figure 13. Therefore, broken stays need to be detected early and cannot wait until the annual, five-year or ten-year examinations. Increasing the reliability of NDT methods would increase confidence in the map of broken stays and may reduce the costly replacement of stays between out-of-frame maintenance periods.

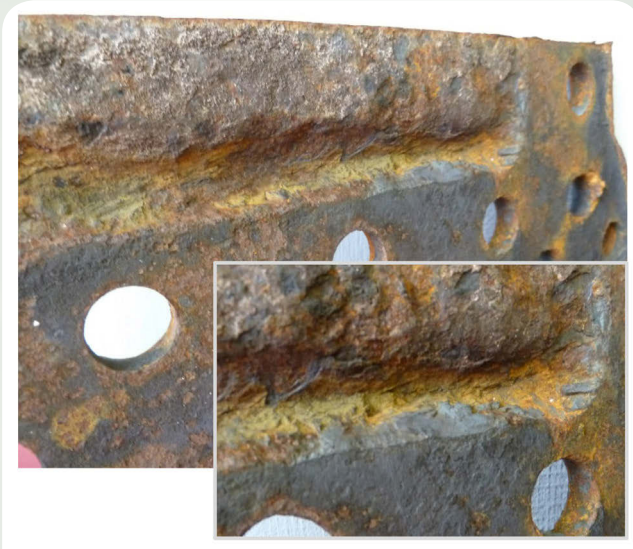
Figure 15. Grooving above the foundation ring on an 80-year-old outer firebox

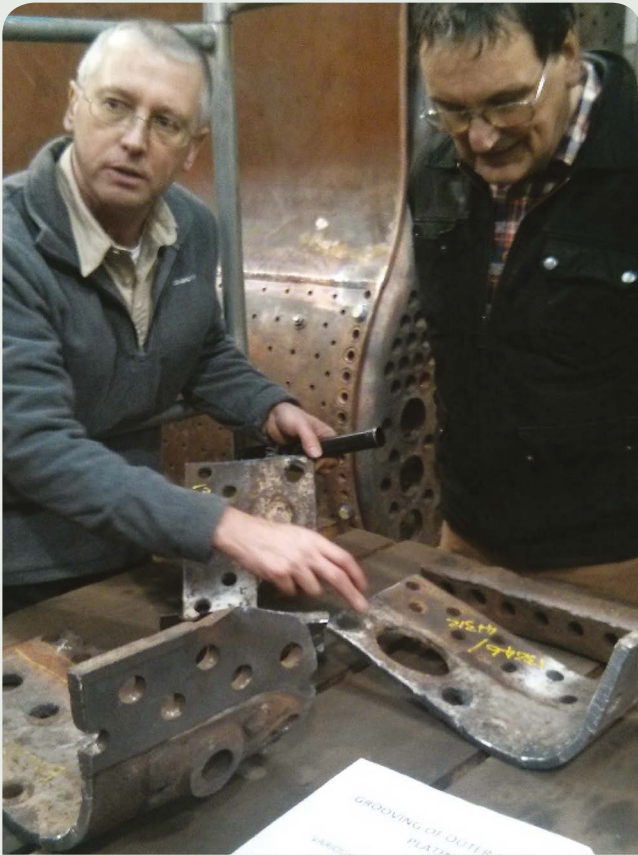
Figure 19. Andy Netherwood (left) explaining the evolution of grooving in the outer firebox

- HRA guidance notes – NDT needs to be included and there is not enough detail on problem areas.
- Grooving (Figure 19) appears to be a function of the boiler design, operating conditions and maintenance history. There is a need to establish the extent and monitor it over years to determine the rate of metal loss.
