How Drones Are Being Used for Inspection In Industrial Environments

Presented by Phil Buchan BEng, MSc, CEng, MIMechE, MBA Director

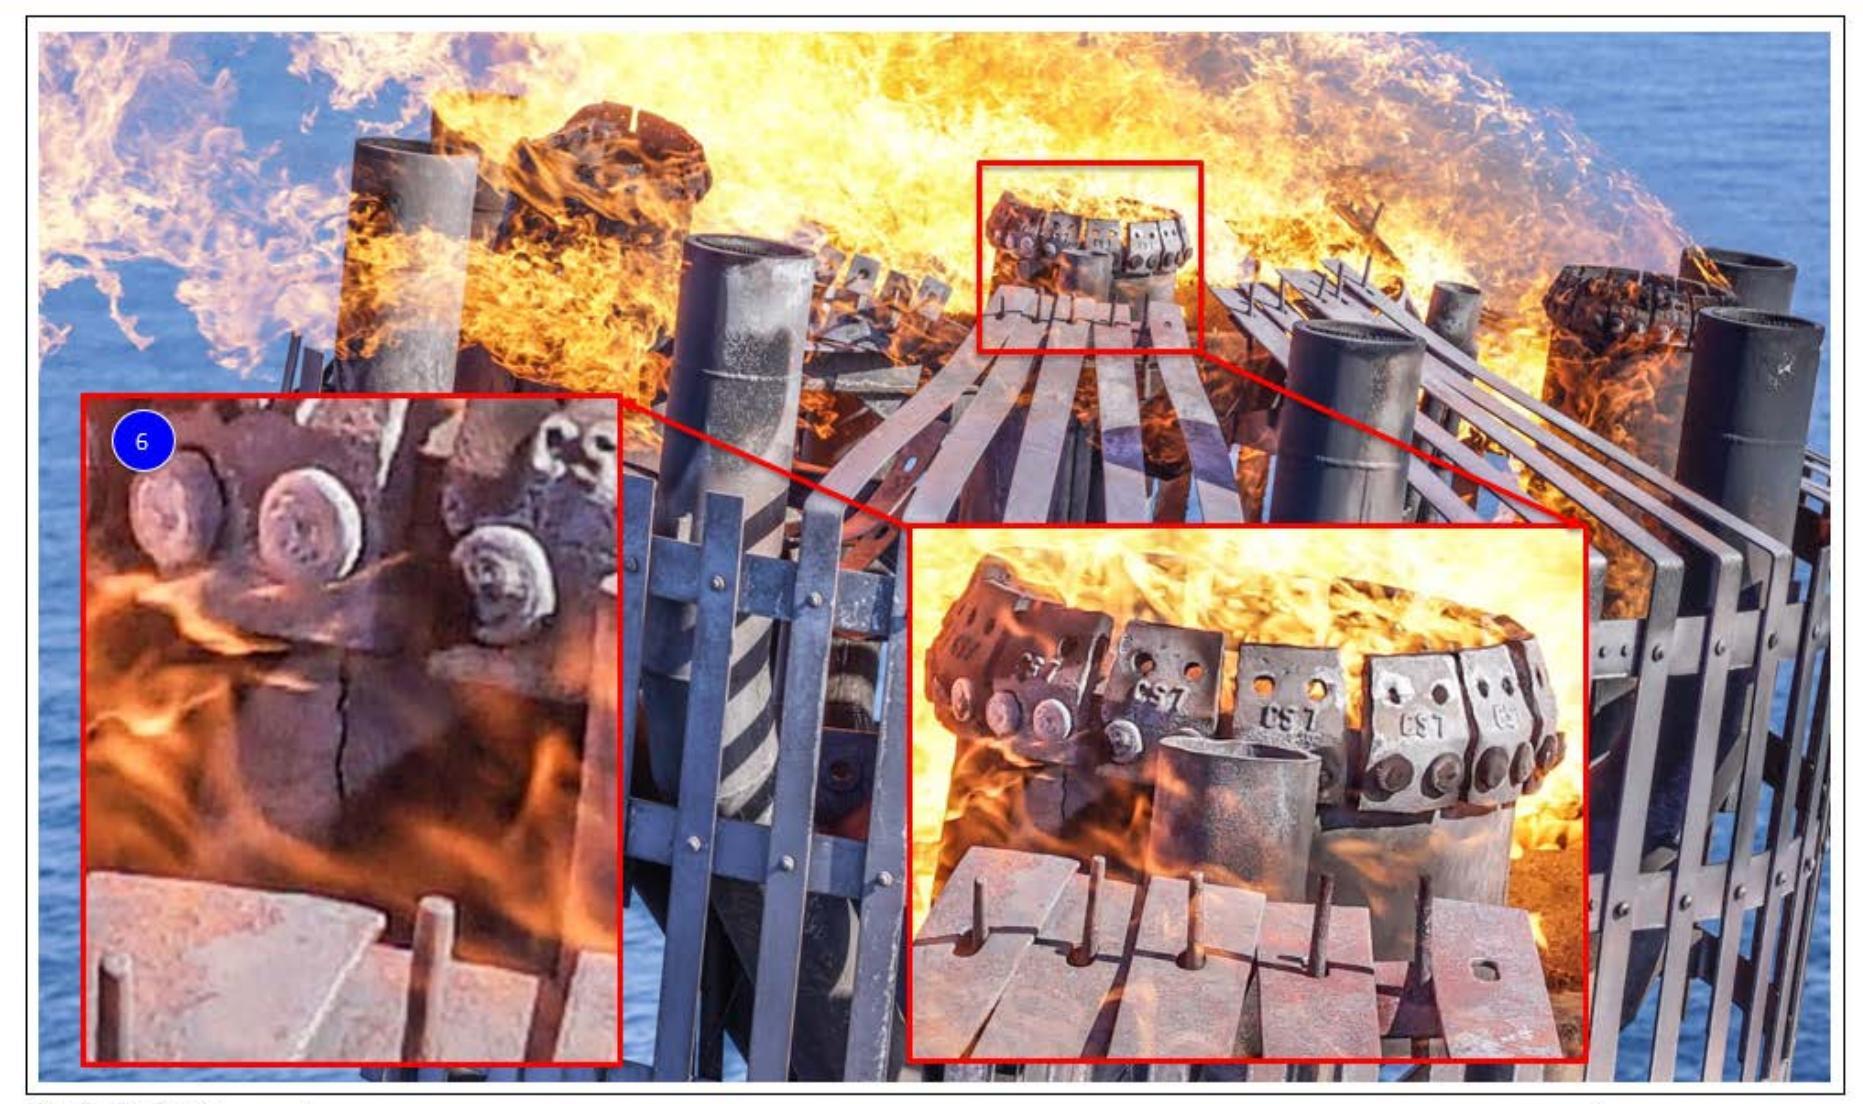
DSC00476.jpg

Small crack-like-indication found on HP upper shell, adjacent to the flame retention segments. Propagation likely under normal operating conditions and shutdown/start up (cooling).

The 14" HP tip was found to be in satisfactory condition with the exception of a possible hairline crack at the tip periphery, further inspection is required to confirm this. The 8" nozzles were found to be in good condition with light carbon build noted.

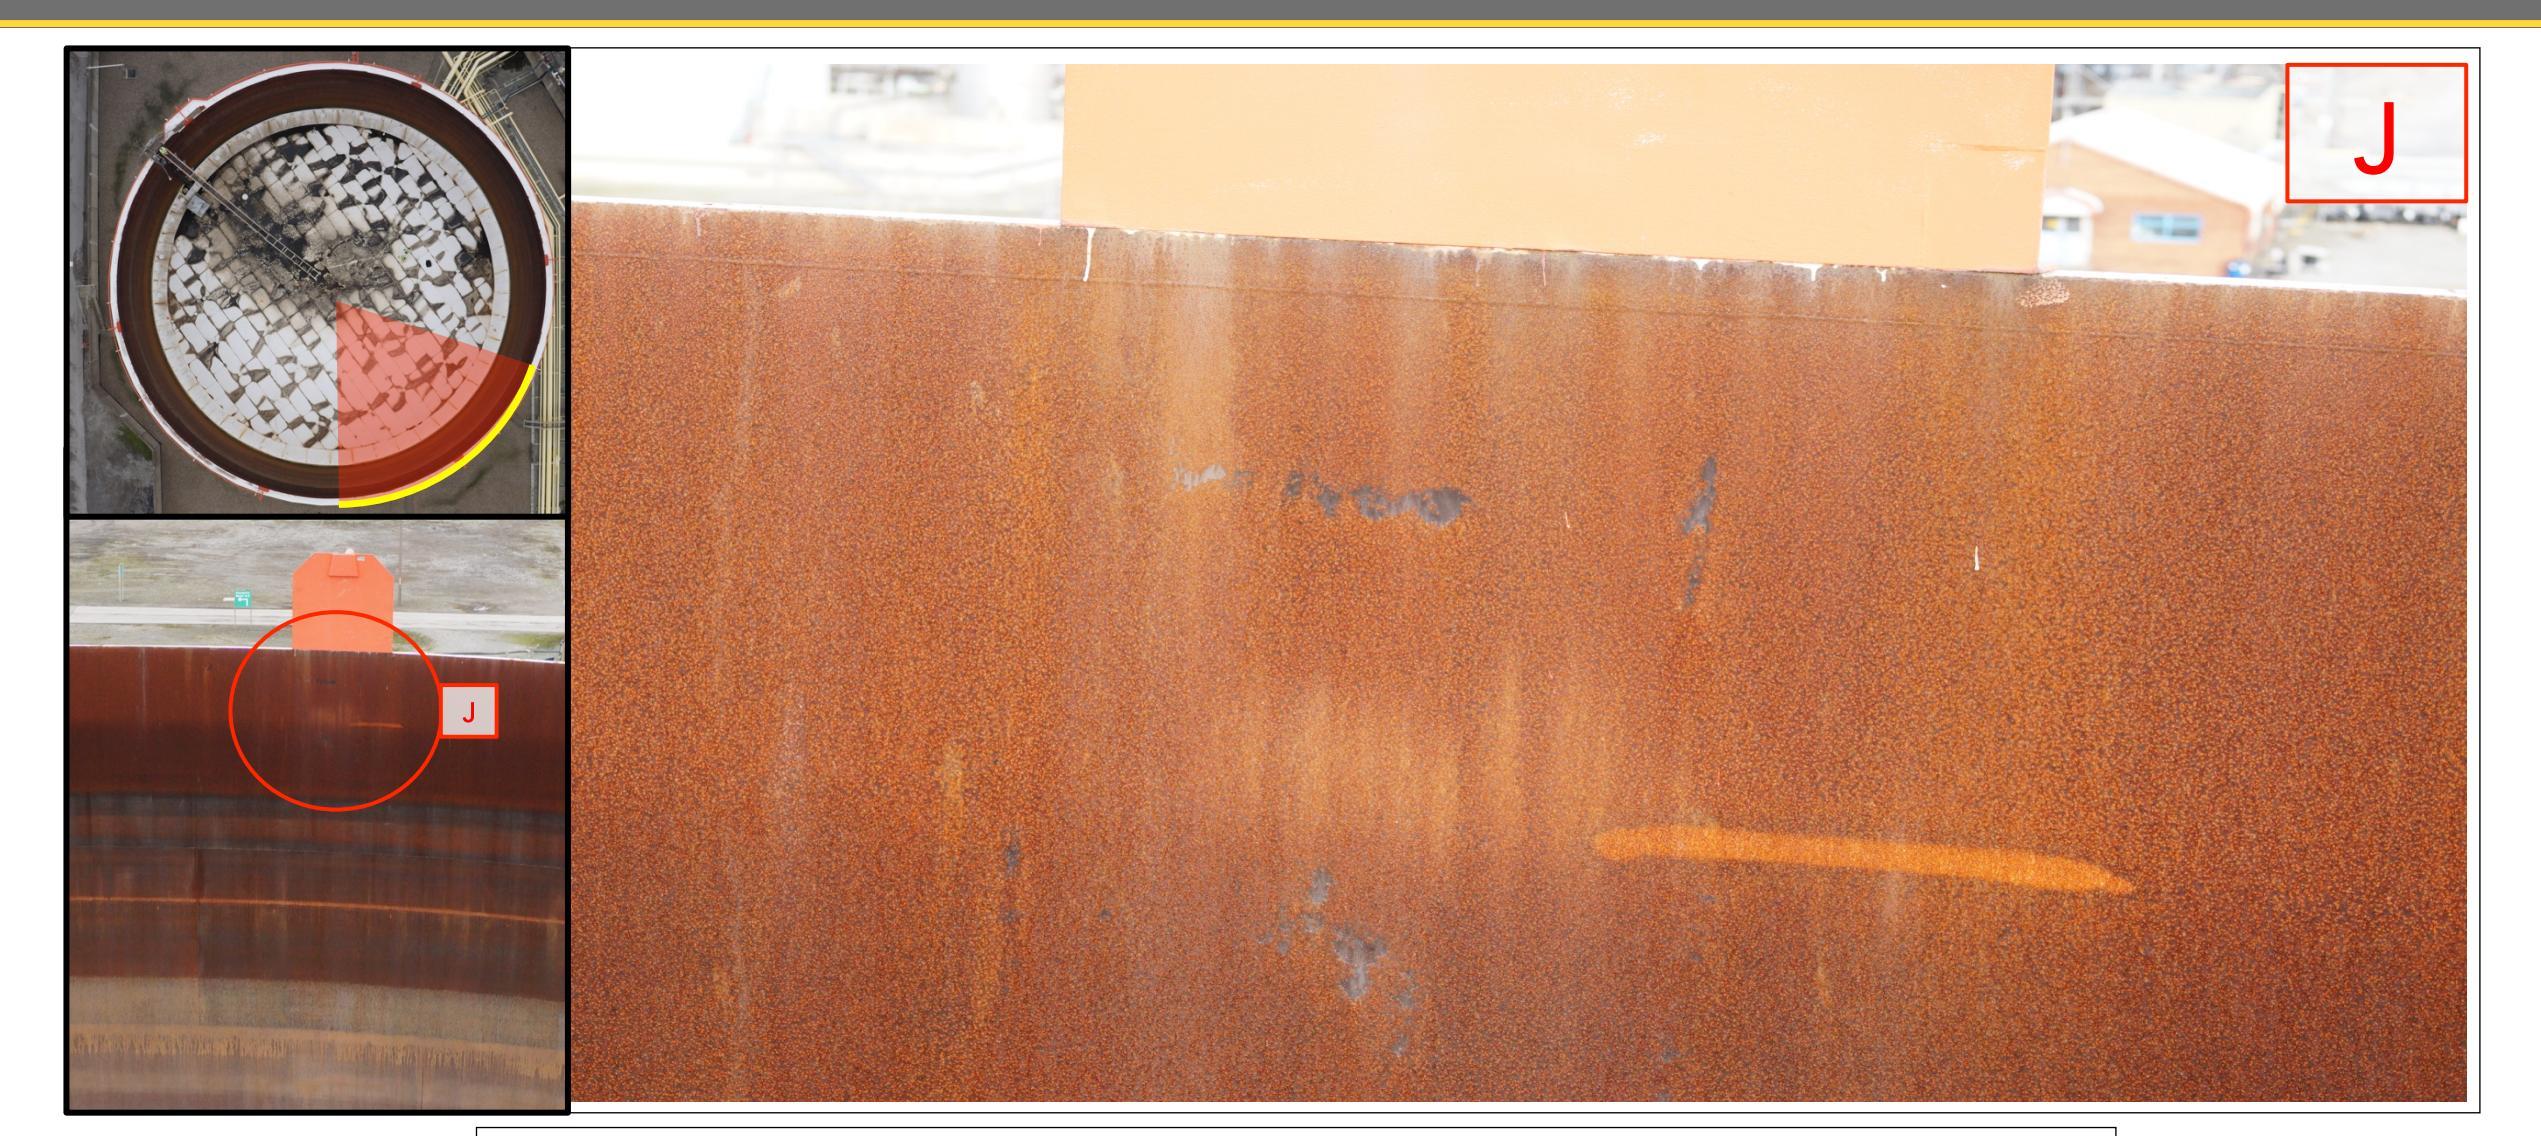
DSC05244.jpg

thecyberhawk.com info@thecyberhawk.com + 44 (0) 1506 592187 Another example of scoring marks found. Do not appear to penetrate surface of internal wall excessively. A more tactile inspection would be recommended to determine actual depth.

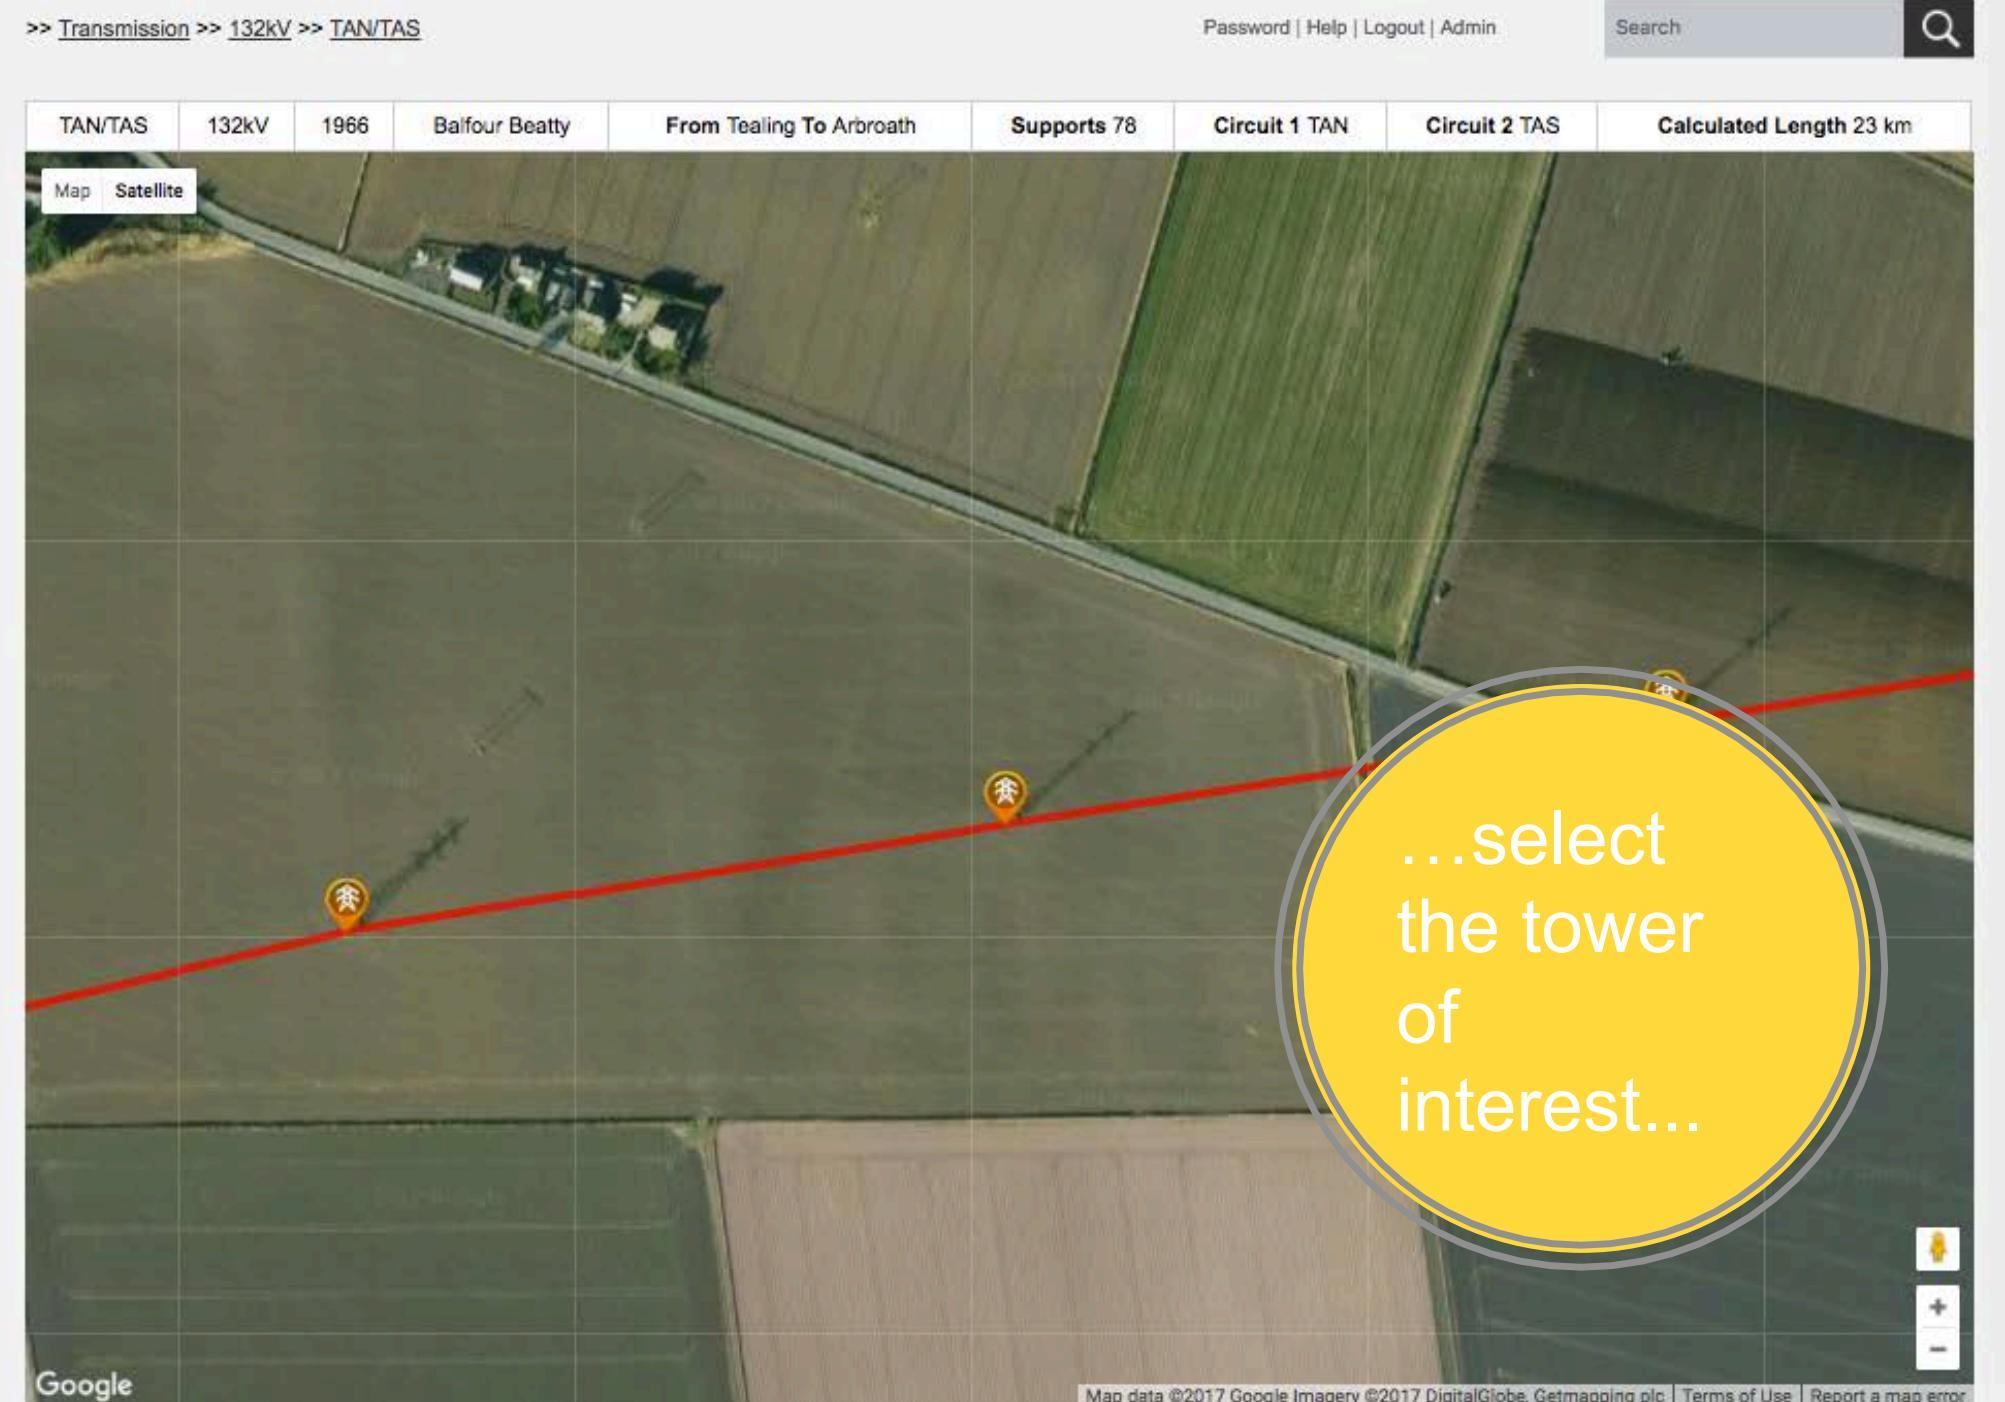
...after selecting a tower, components can be viewed by clicking a parts list or schematic

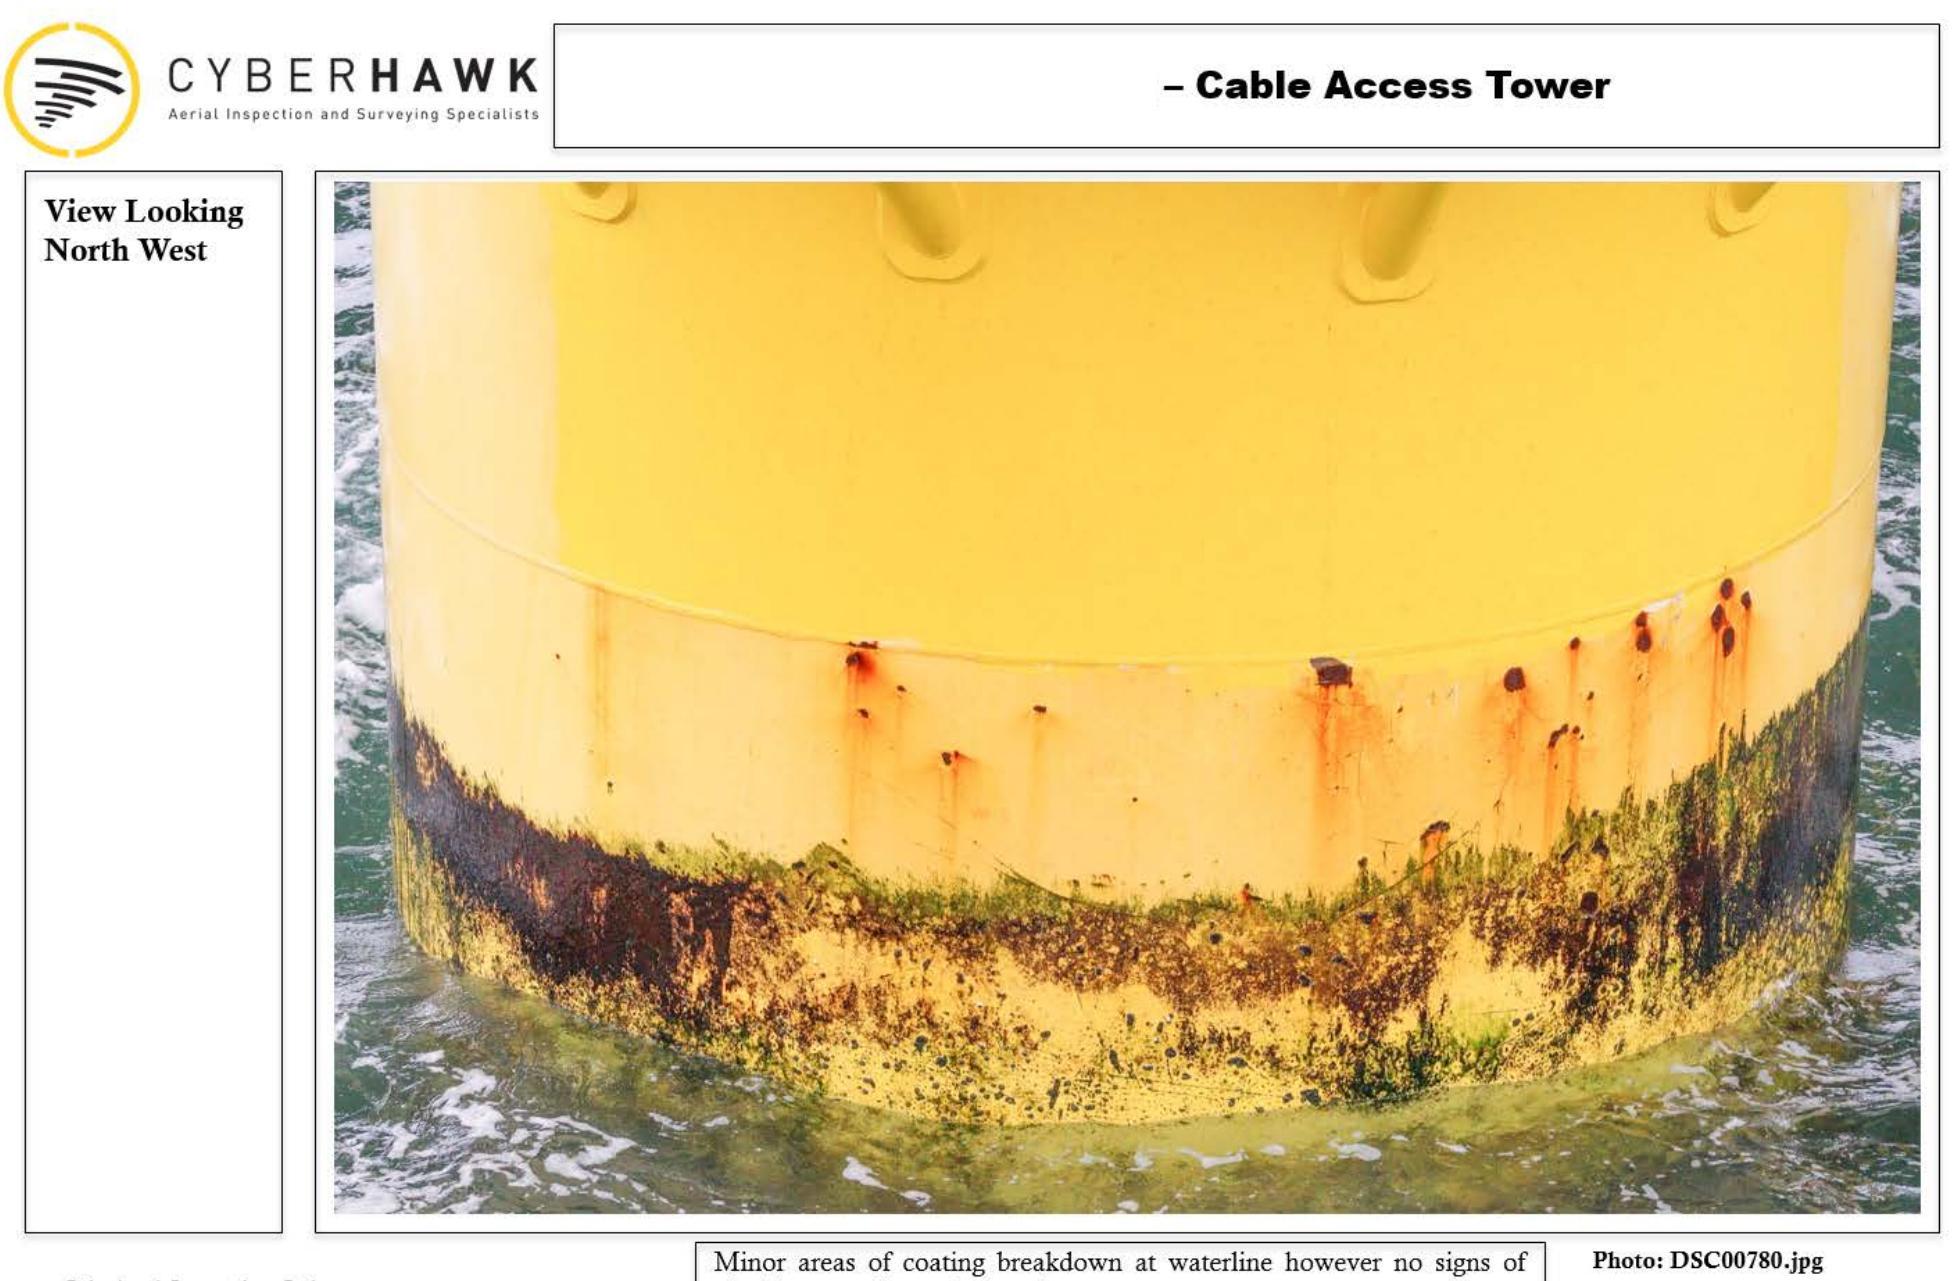
significant scaling and corrosion.

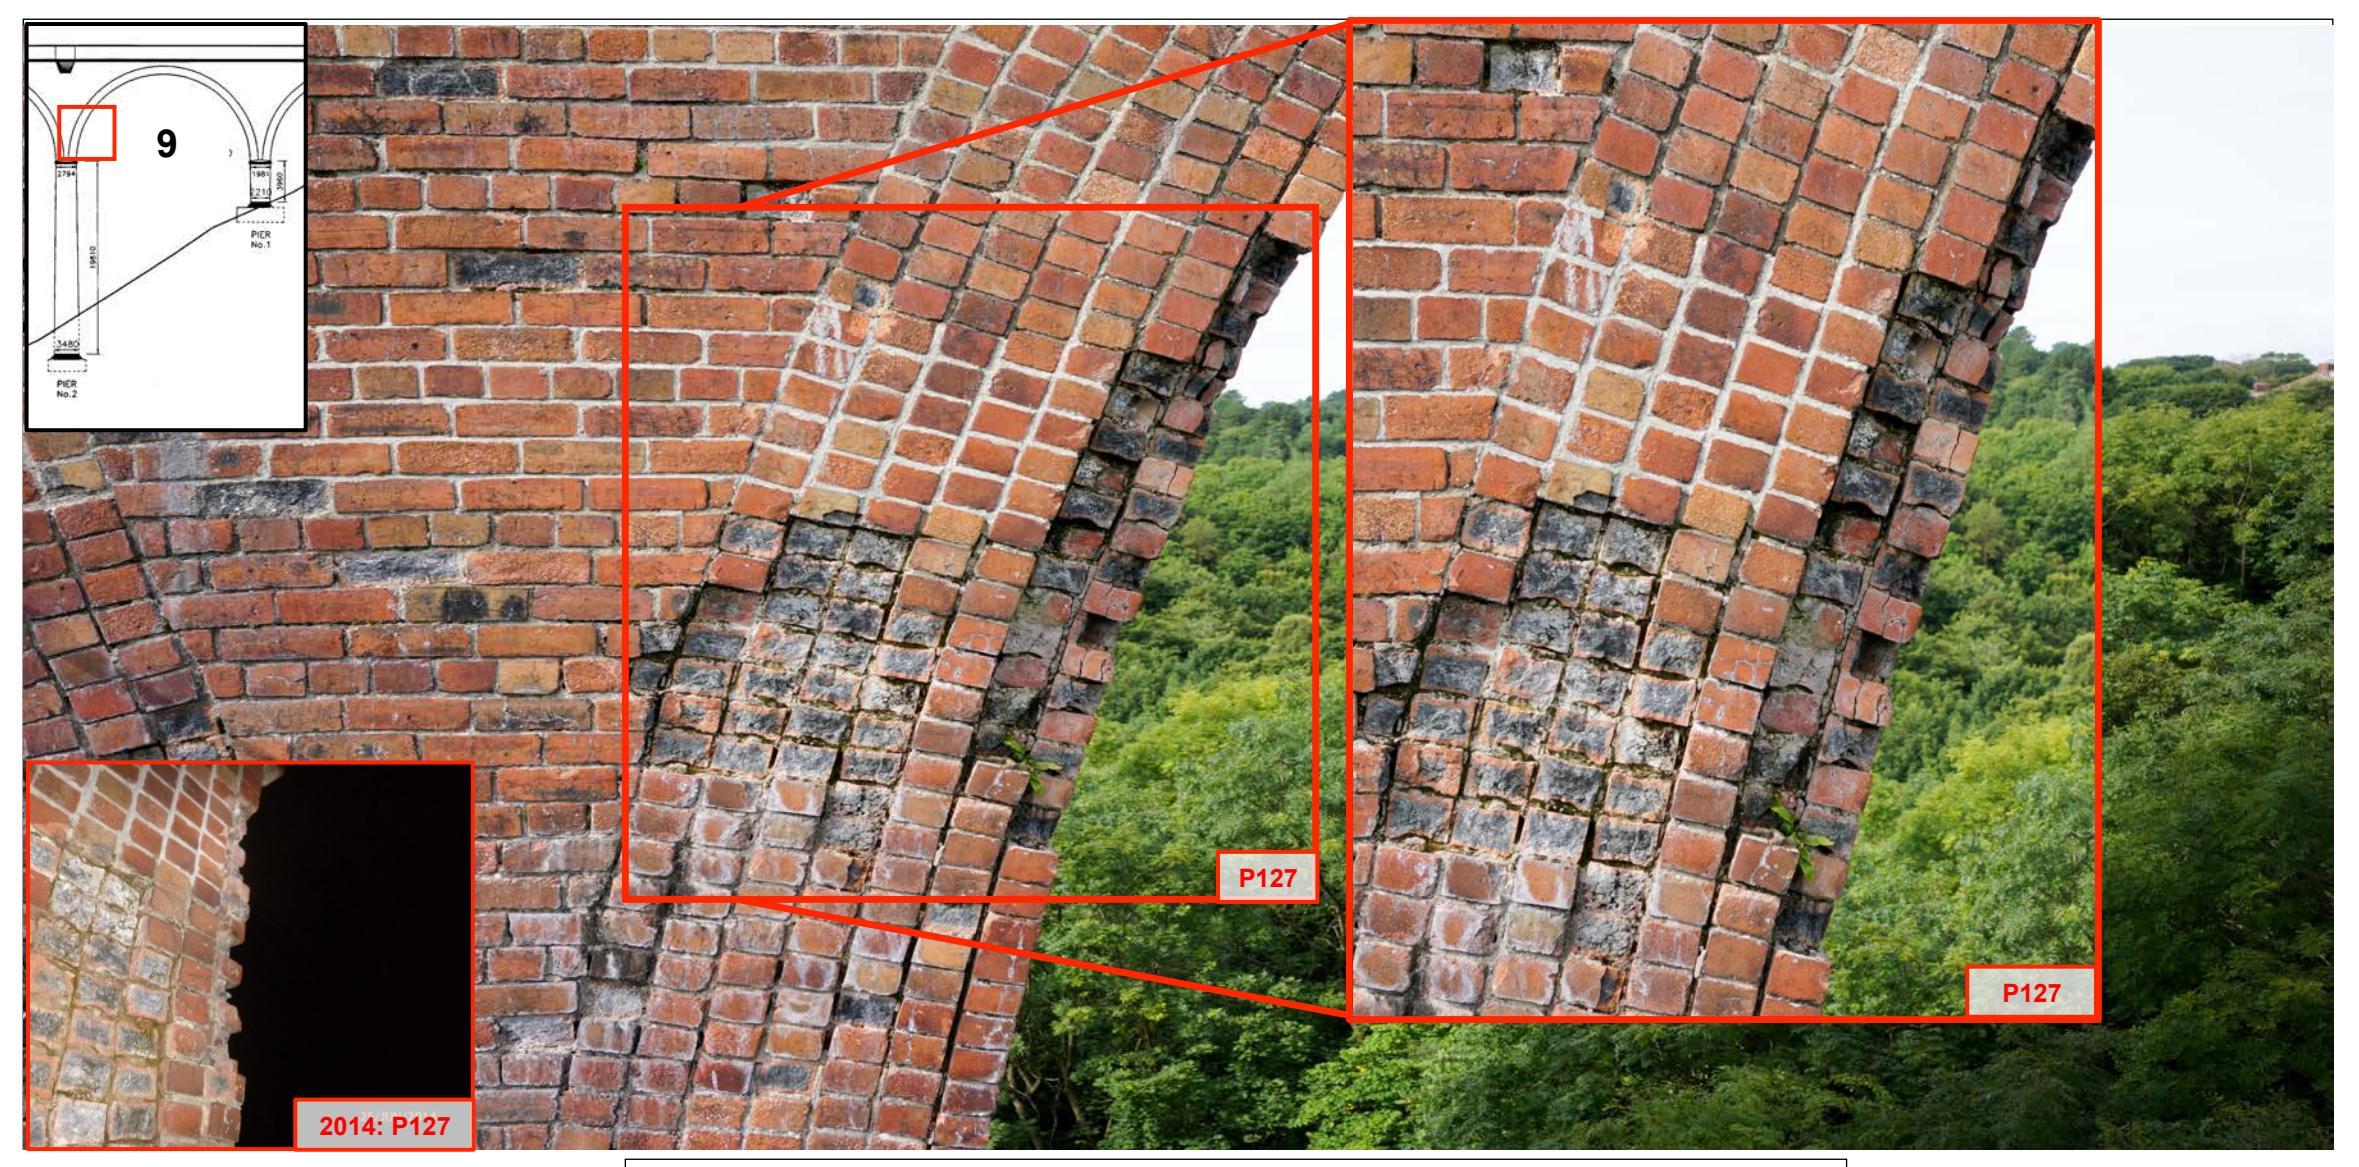
Photo:DSC00023.jpg

Cyberhawk Innovations Ltd Innovation Centre, Alba Campus, Livingston, EH54 7GA Tel: +44 (0) 1506 592187 E: info@thecyberhawk.com P127 Condition deteriorated, brick loss on face ring: 1.7m L x 0.2m D, additional spalling, 0.7x0.6m with 0.1m D.
